Wolf Creek Dam Consensus Report Engineering Risk and Reliability Analysis

April 11, 2007

DSAC Class I Dams
Peer Review Panel

Site Visit Photos Referenced in Consensus Report

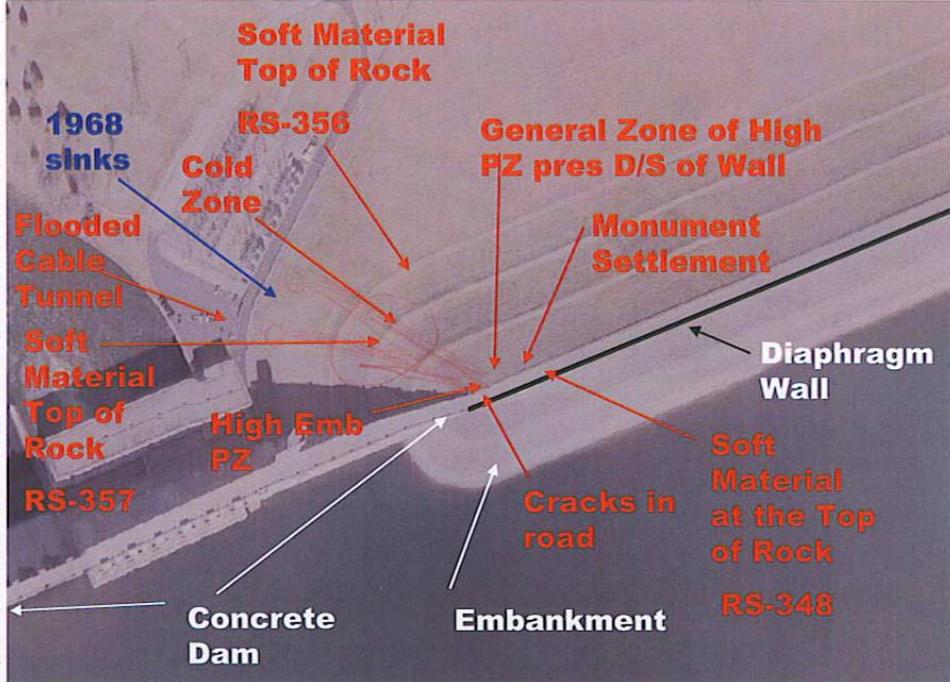
PAGE	QUOTE/CONCLUSION
	<p data-bbox="357 231 909 262"><i>3.2.10 Distress Indicators in the Wraparound or Cone Area.</i></p> <p data-bbox="357 273 1323 430">Figure 3-12 depicts the location of the collective distress indicators identified at the juncture between the earth embankment and the masonry dam where large solution features were encountered in the emergency / exploration program and wall installation between 1968 and 1979. This area is experiencing the most diverse and greatest density of distress indicators on the project.</p>

<p data-bbox="397 1144 868 1176">Figure 3-12 Distress Indicators Station 35 to 40</p> <p data-bbox="332 1186 1356 1291">This emphasizes the critical nature of the cone area: “This area is experiencing the most diverse and greatest density of distress indicators on the project.” (Sta 35+40.)</p>
6-6	<p data-bbox="332 1333 1388 1470">“The wall terminates at Station 57+50. Seepage exit points on the ground surface downstream near this station are the most extensive on the project. These wet areas and high piezometric levels indicate seepage around the right end of the wall.”</p>

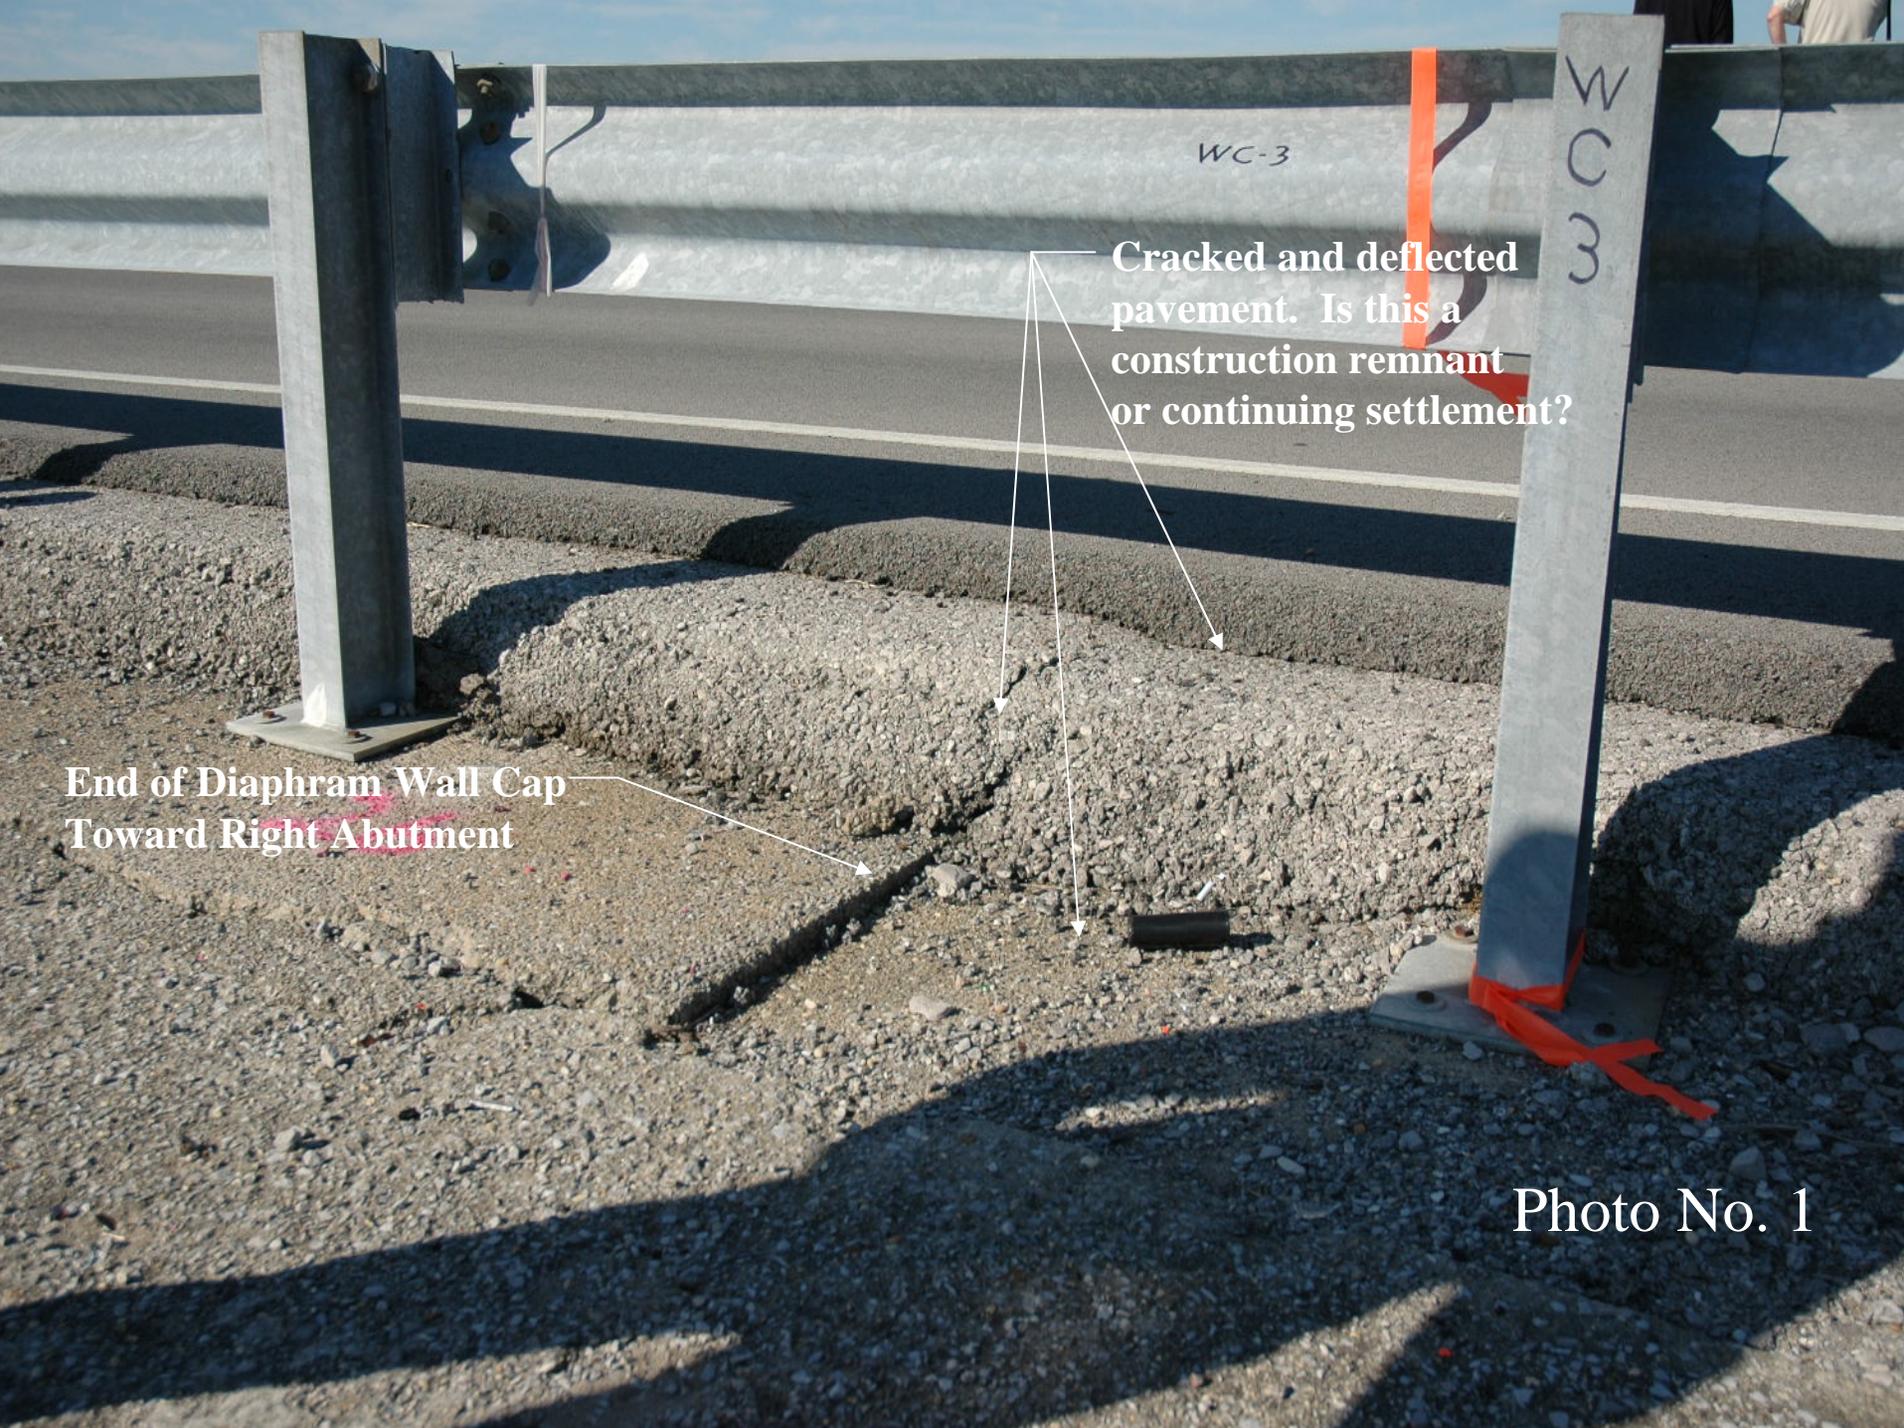
Photo No. 1

End of Diaphragm Wall Cap
Toward Right Abutment

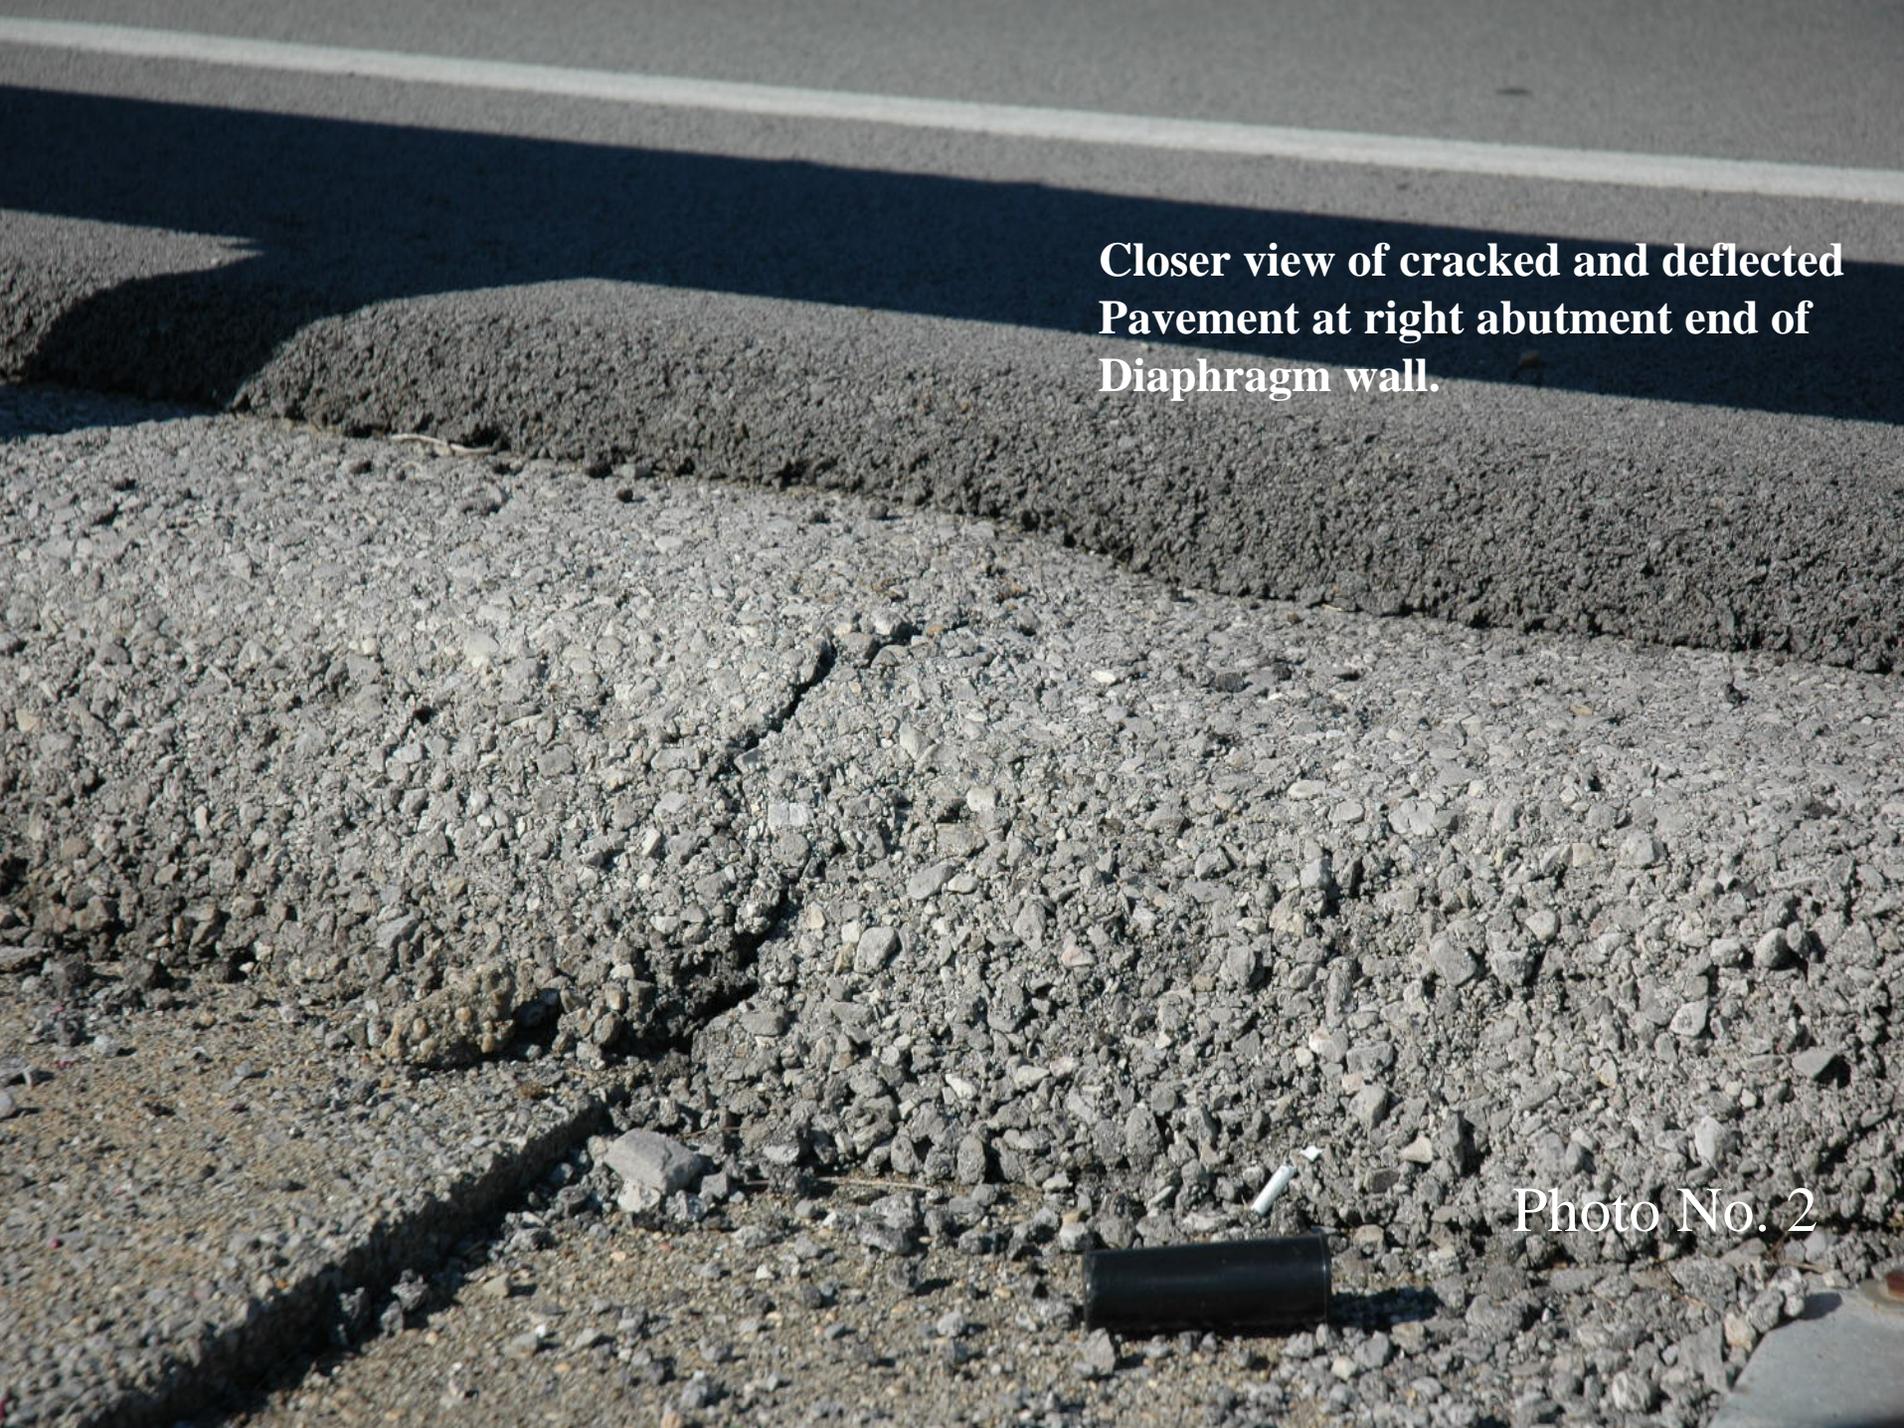
Photo No. 2

**Closer view of cracked and deflected
Pavement at right abutment end of
Diaphragm wall.**

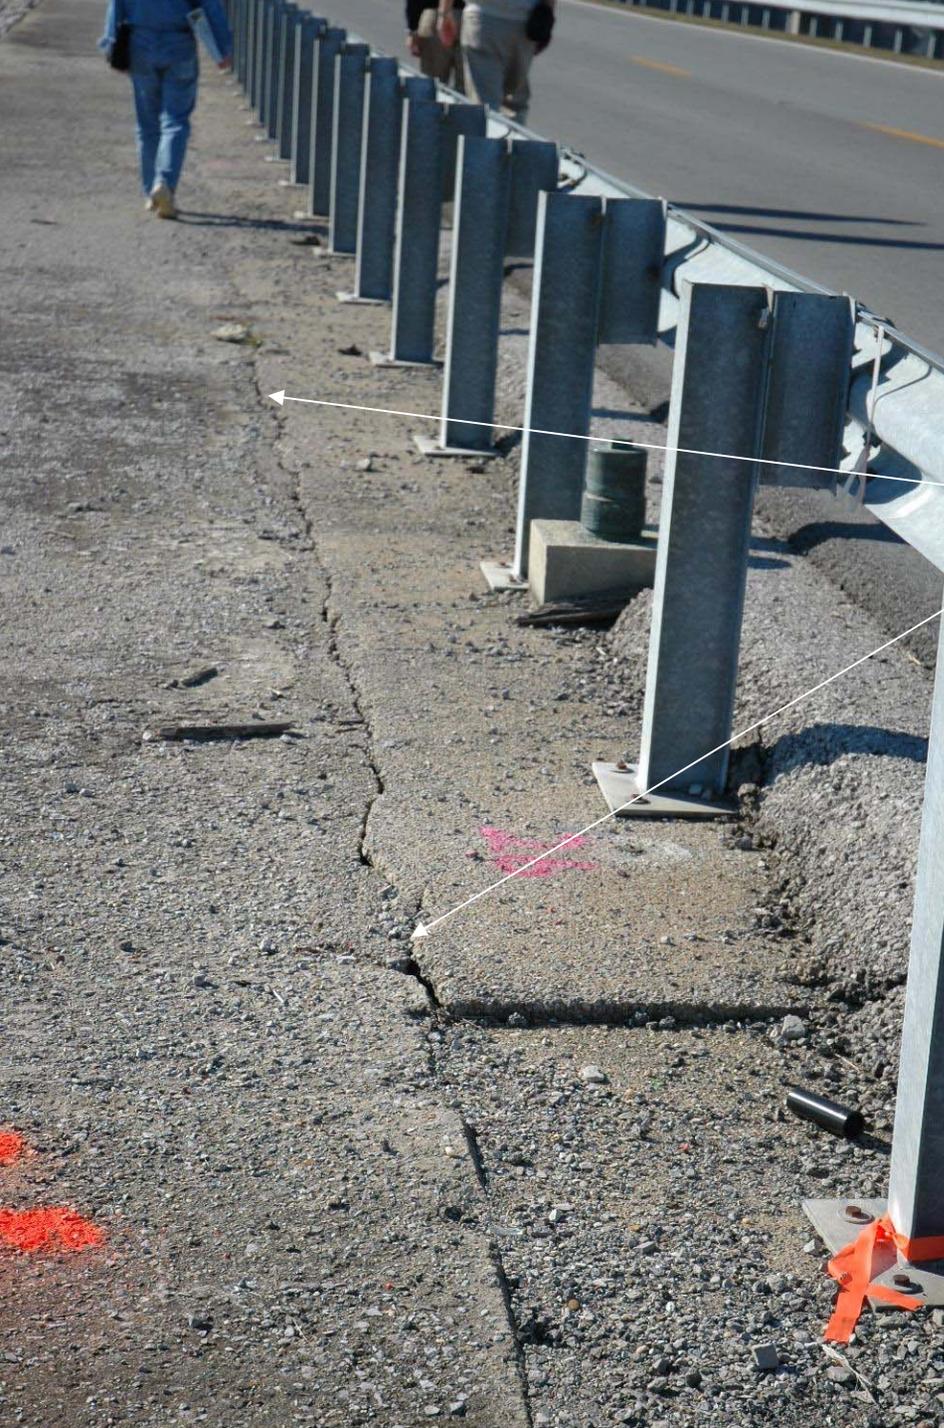
Photo No. 3

**Diaphragm wall cap at end
near right abutment. Note
minor cracking and separation
of concrete overlay from cap**

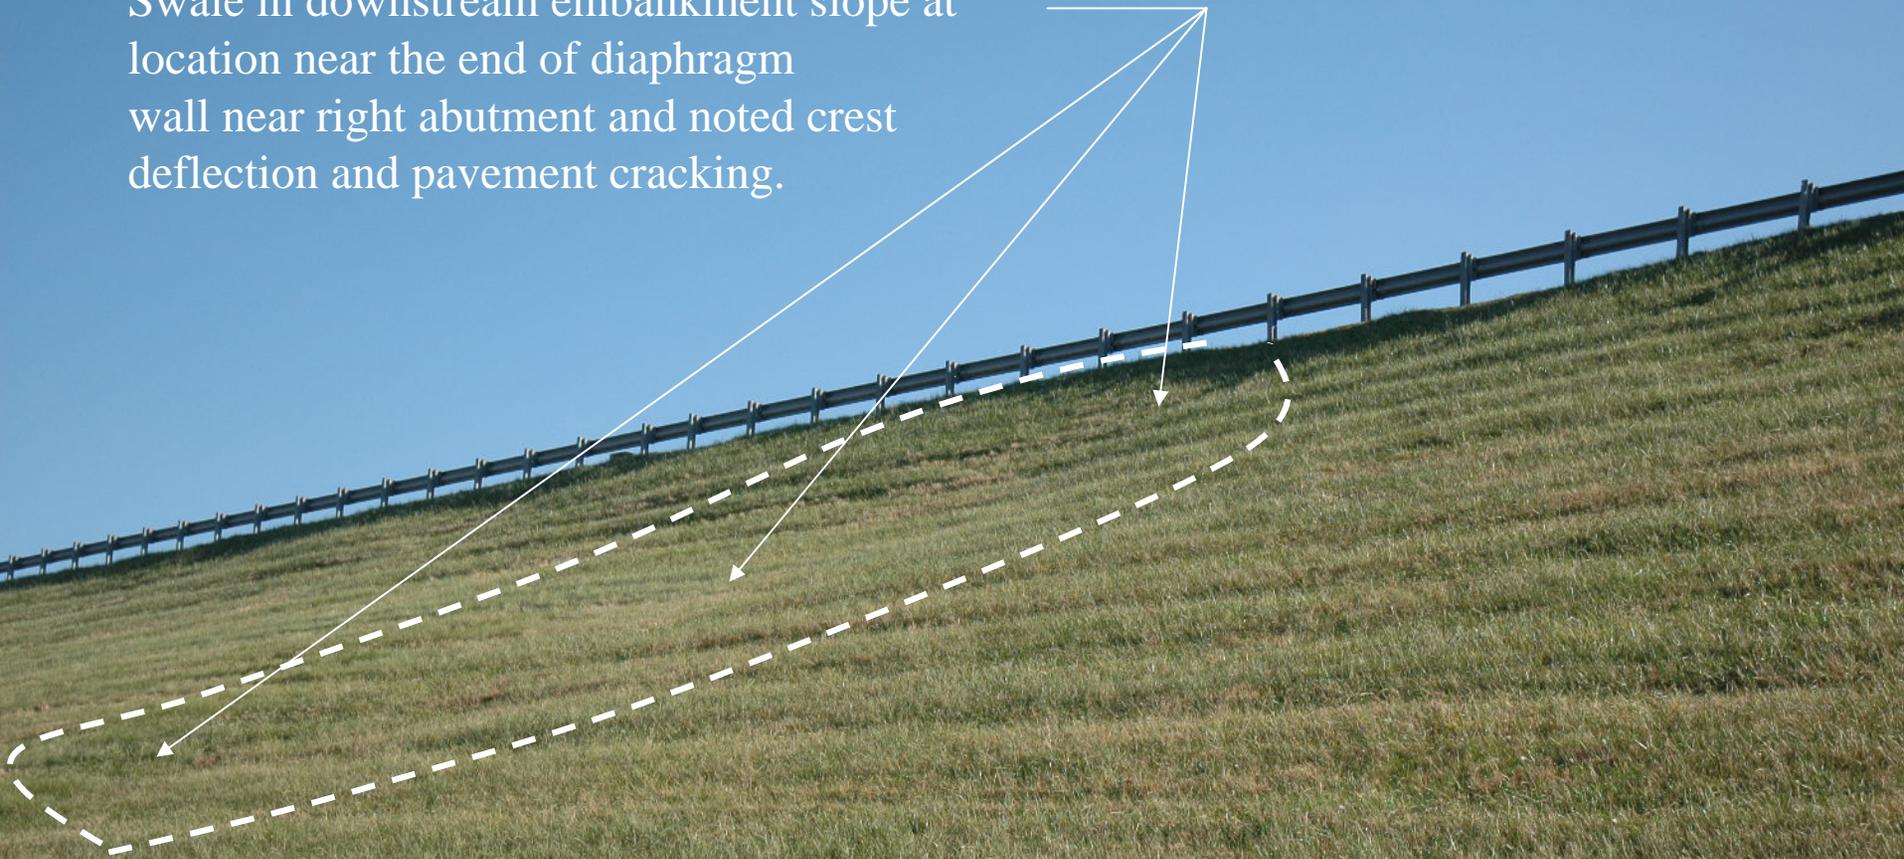
Photo No. 4

Swale in downstream embankment slope at location near the end of diaphragm wall near right abutment and noted crest deflection and pavement cracking.

Note that outline area continues downslope and roughly aligns with known foundation karst feature associated with first sink hole that developed in 1967.

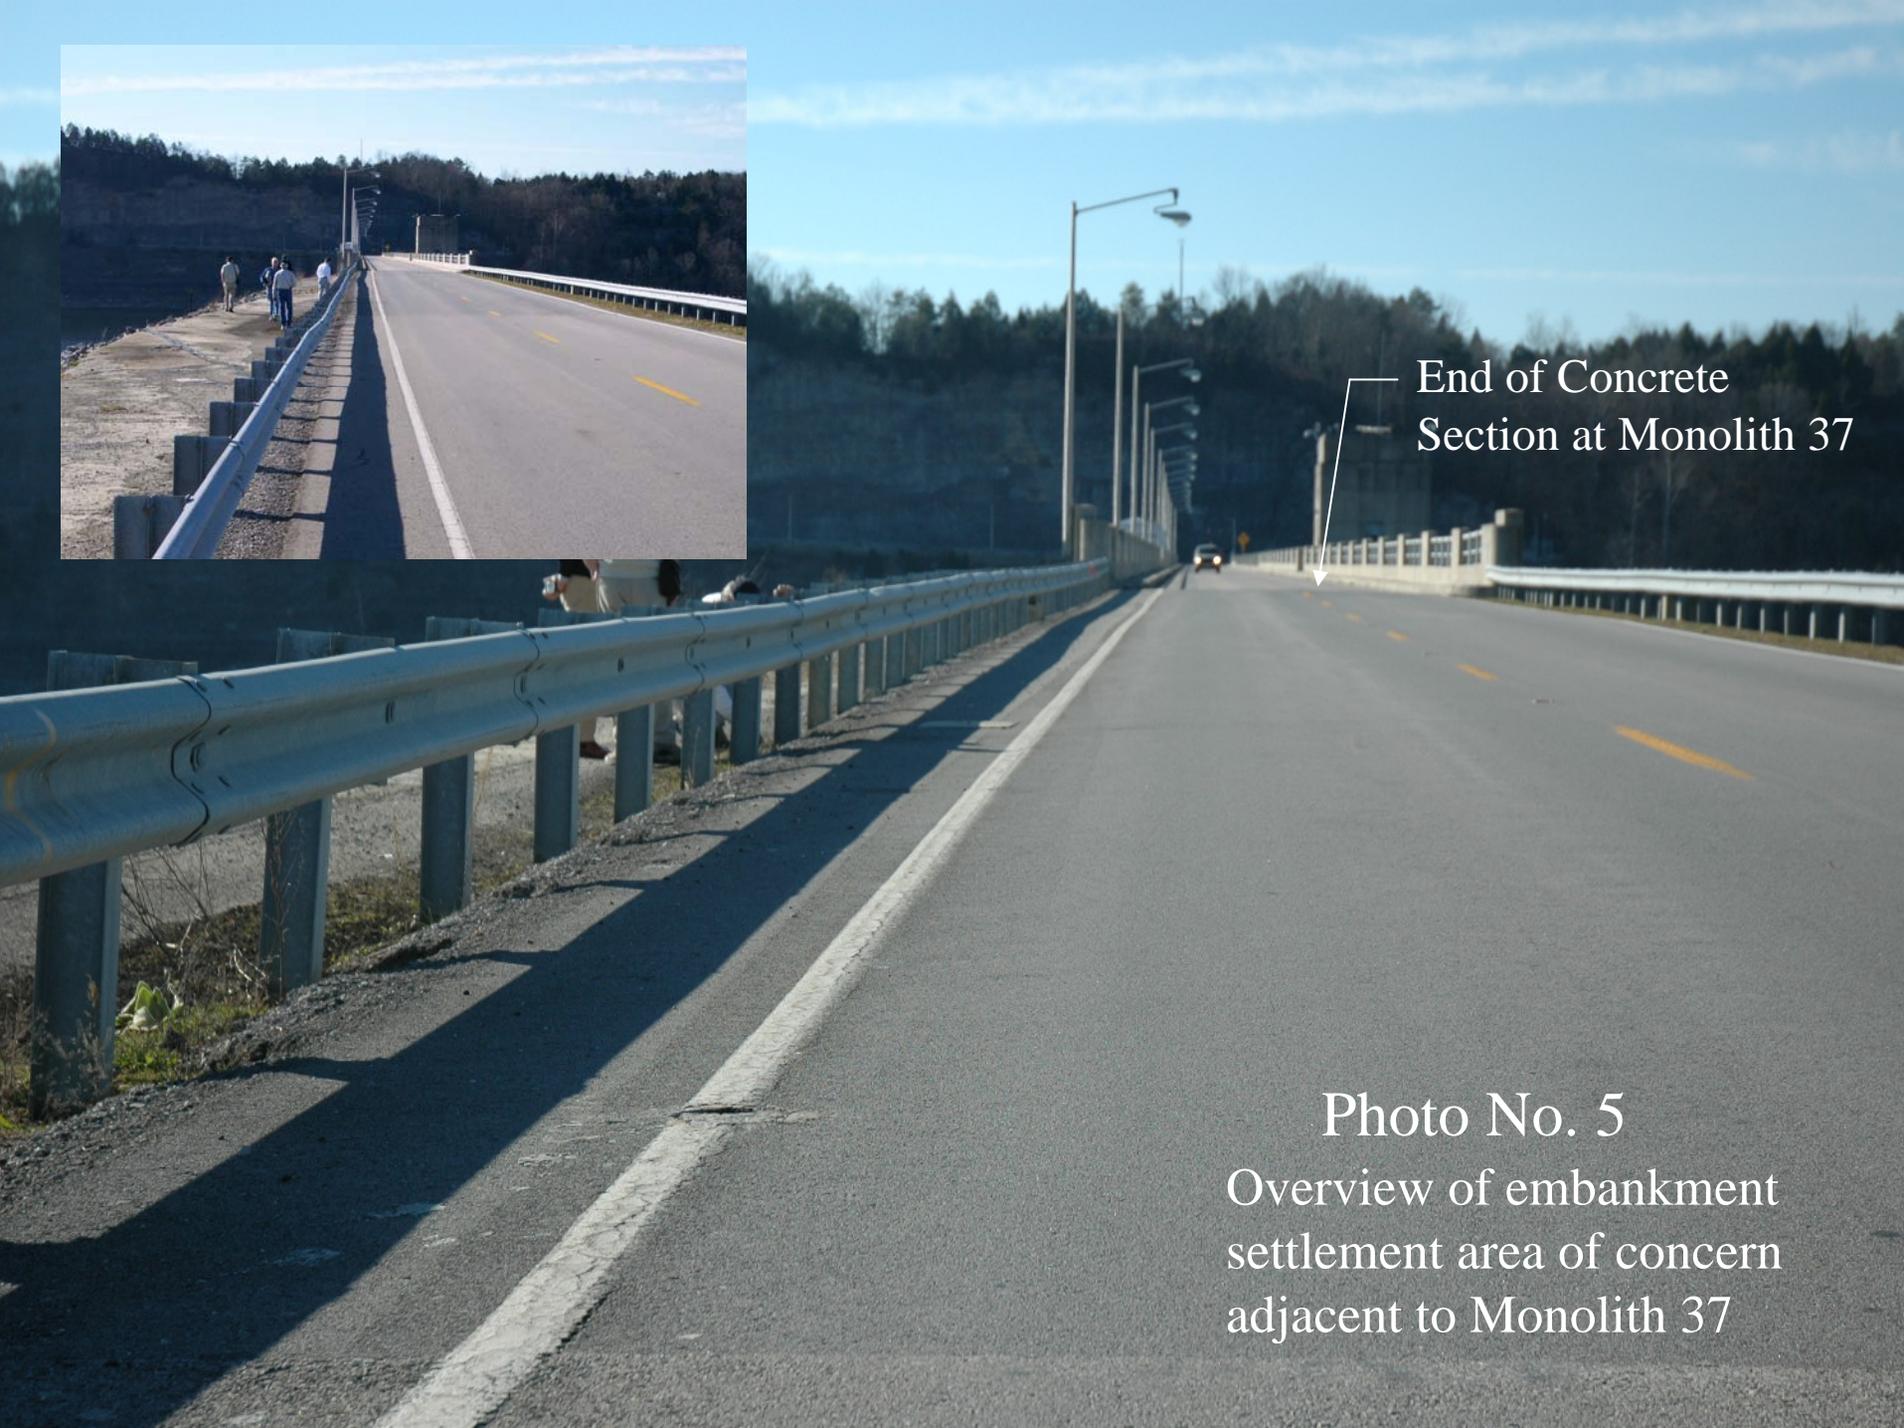
Photo No. 5
Overview of embankment
settlement area of concern
adjacent to Monolith 37

The Panel observed a number of indications that the crest of the existing embankment dam may be actively settling in the area adjacent to Monolith 37. Photographs 5 through 8 illustrate a number of our observations in this area. The Panel also noted signs of possible crest settlement in the area just to the right of where the existing diaphragm cutoff wall was terminated (see Photographs 1 through 4). Settlement at these locations, if it is occurring, is a significant indicator with regard to the overall safety of the structure and the development of expert judgments of the progression of the piping and erosion failure mode.

End of Concrete
Section at Monolith 37

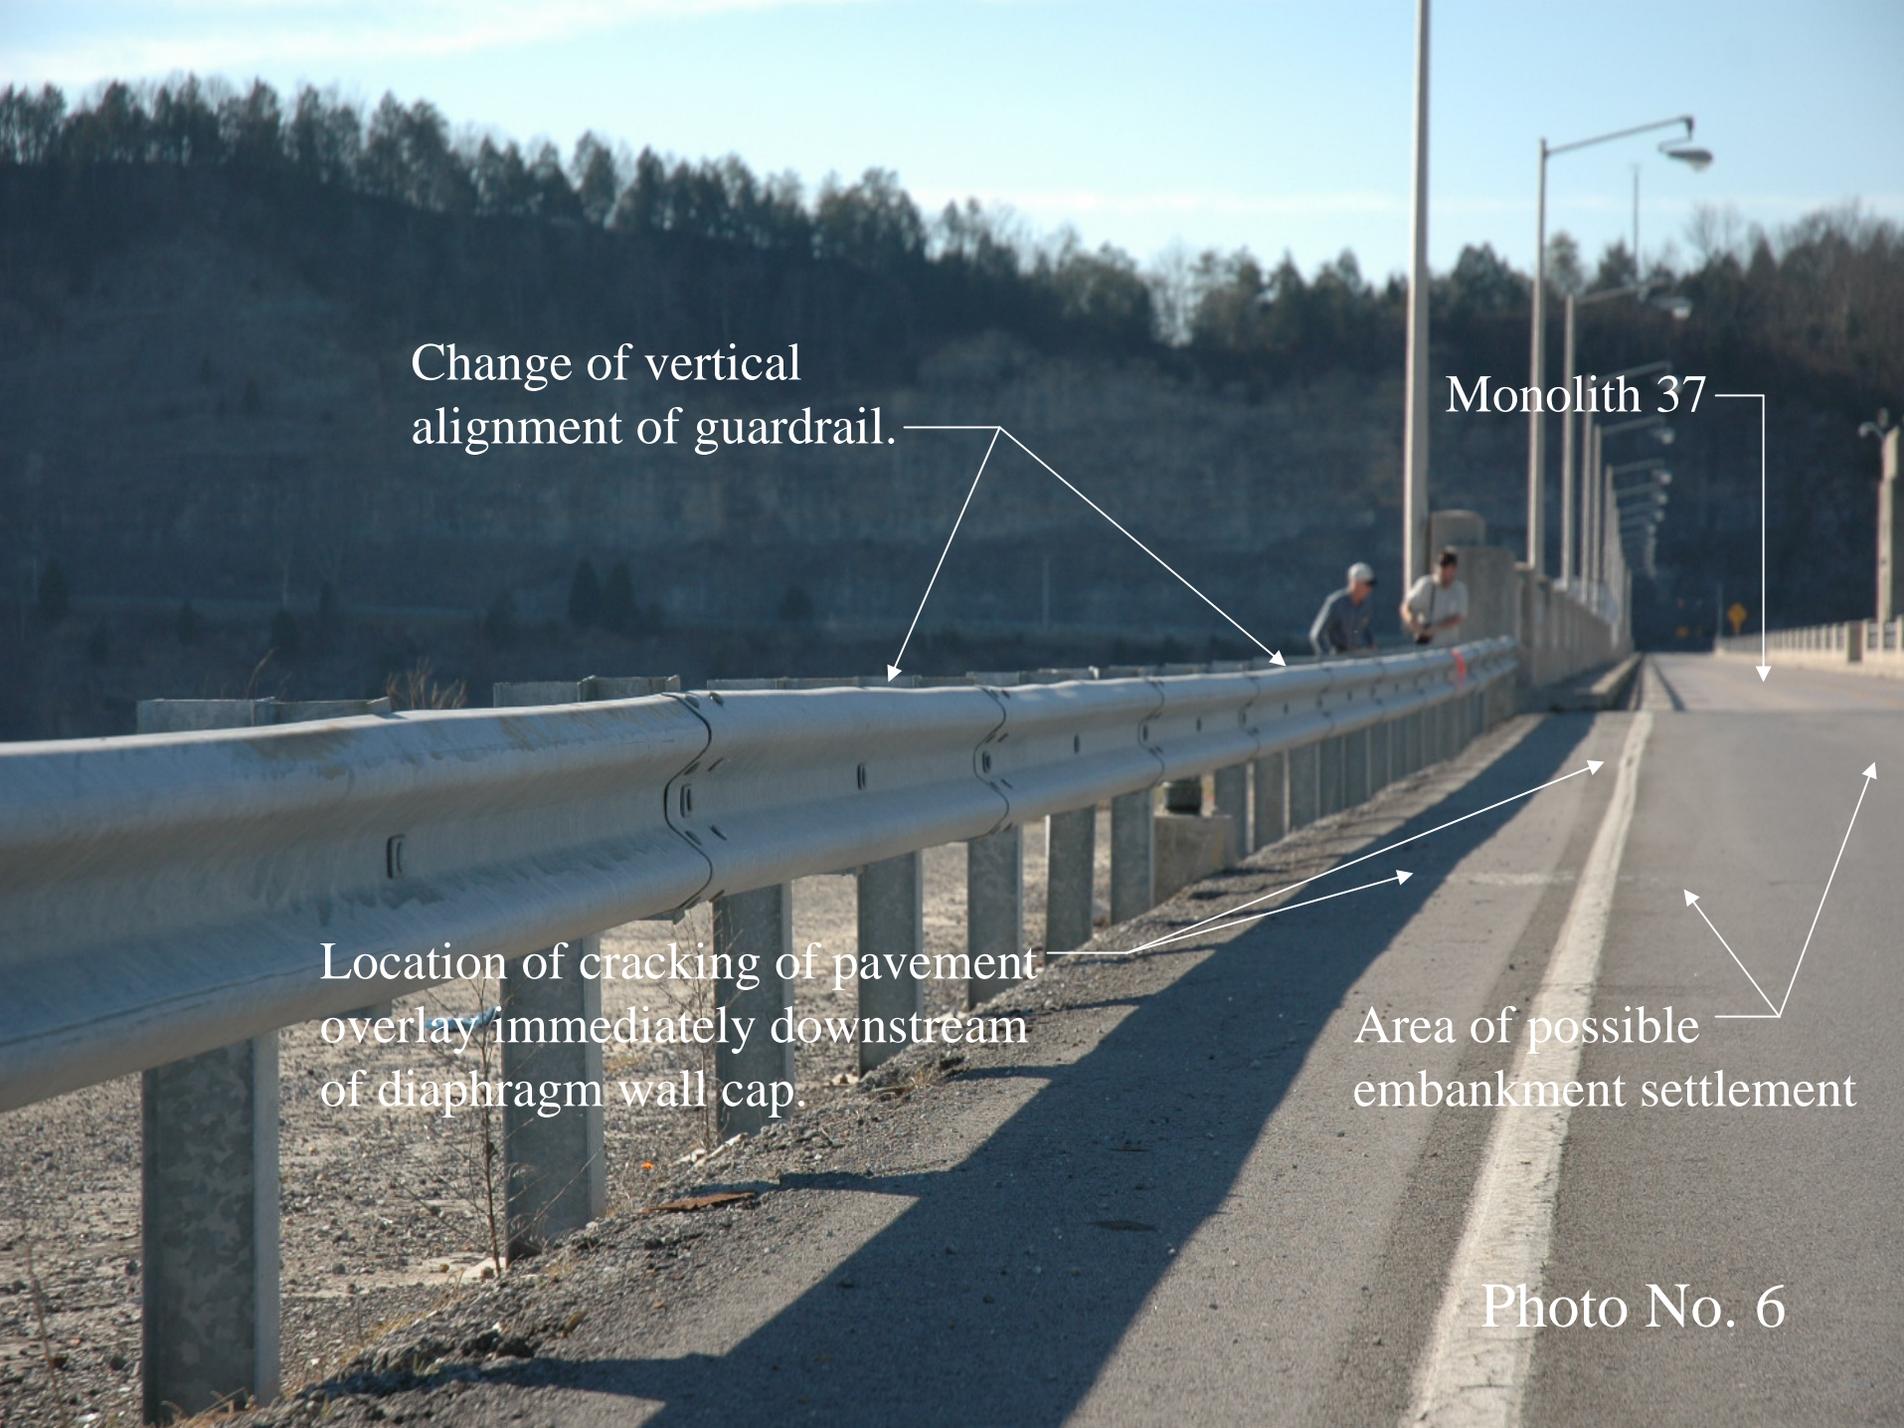
Photo No. 6

Change of vertical alignment of guardrail.

Area of possible embankment settlement

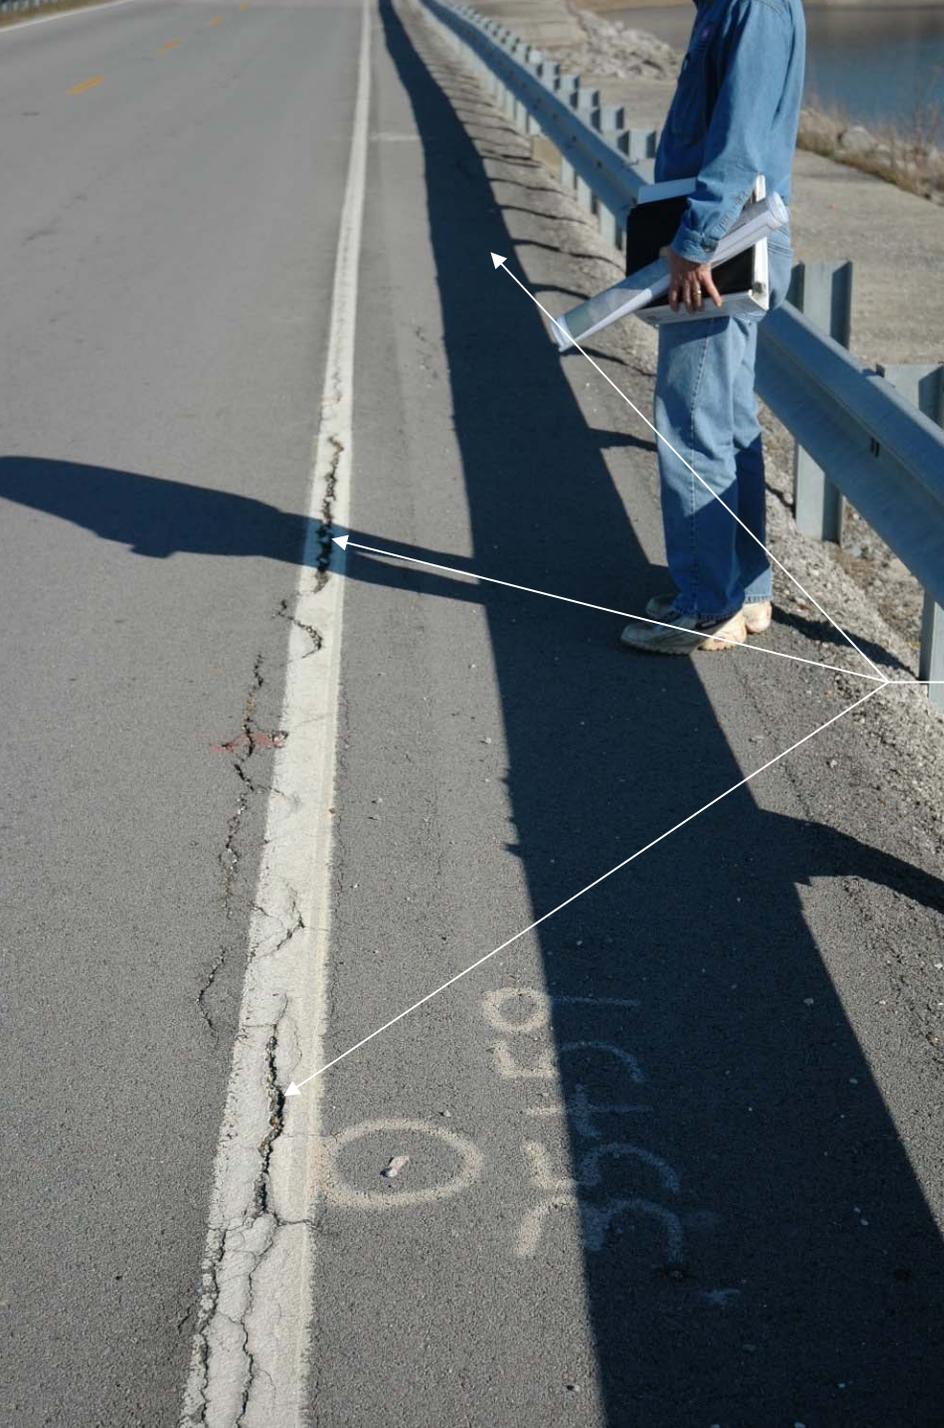
Photo No. 7

Closer view of pavement cracking. Note embankment stationing. Survey monument at stations 35+00 and 36+00

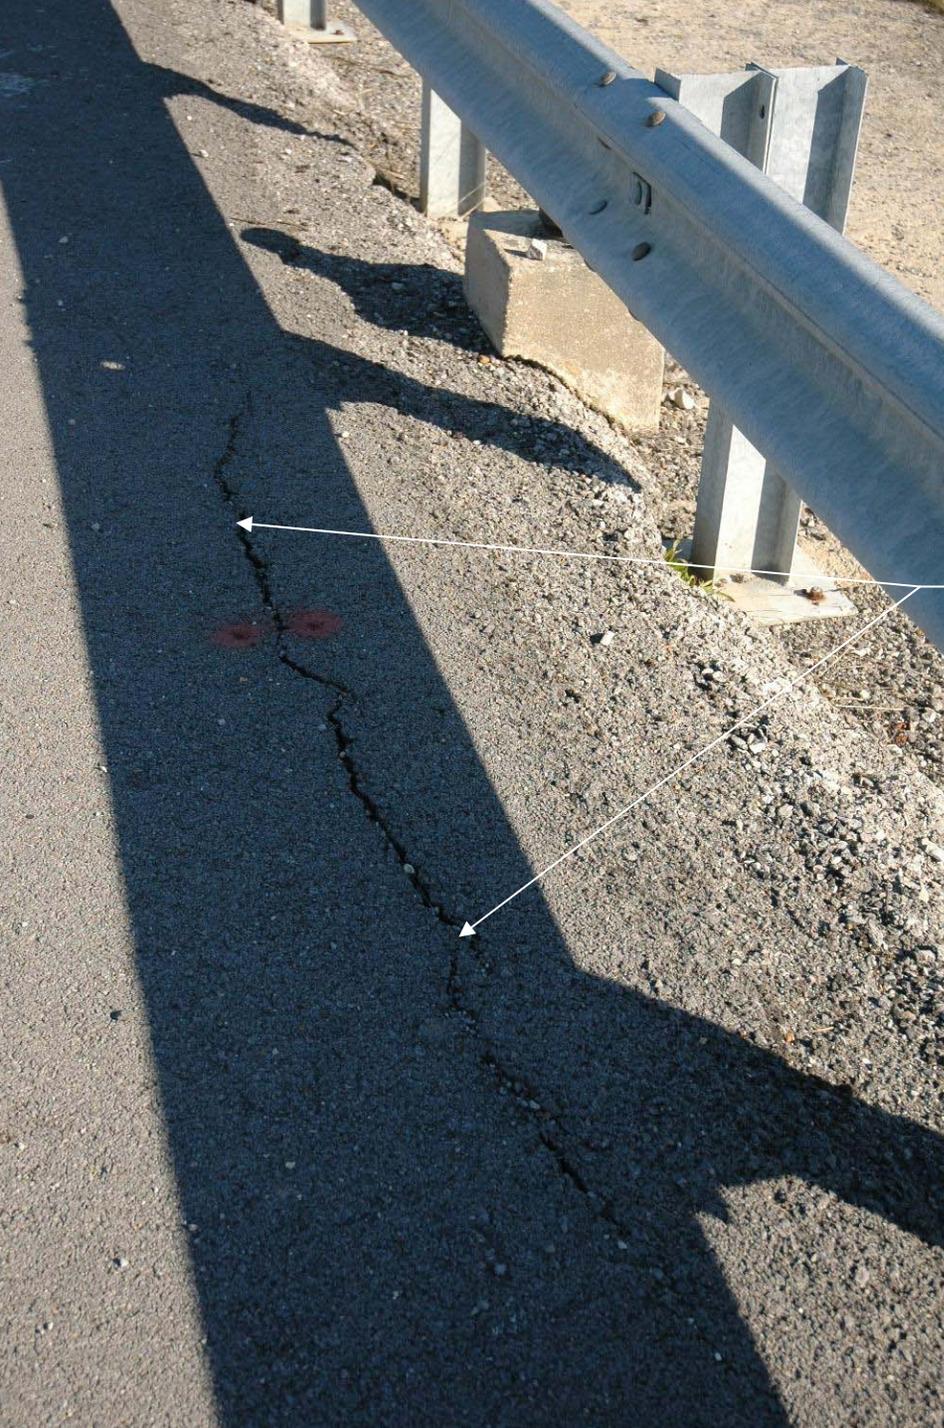
Photo No. 8

Additional cracking of pavement overlay immediately downstream of diaphragm wall cap.

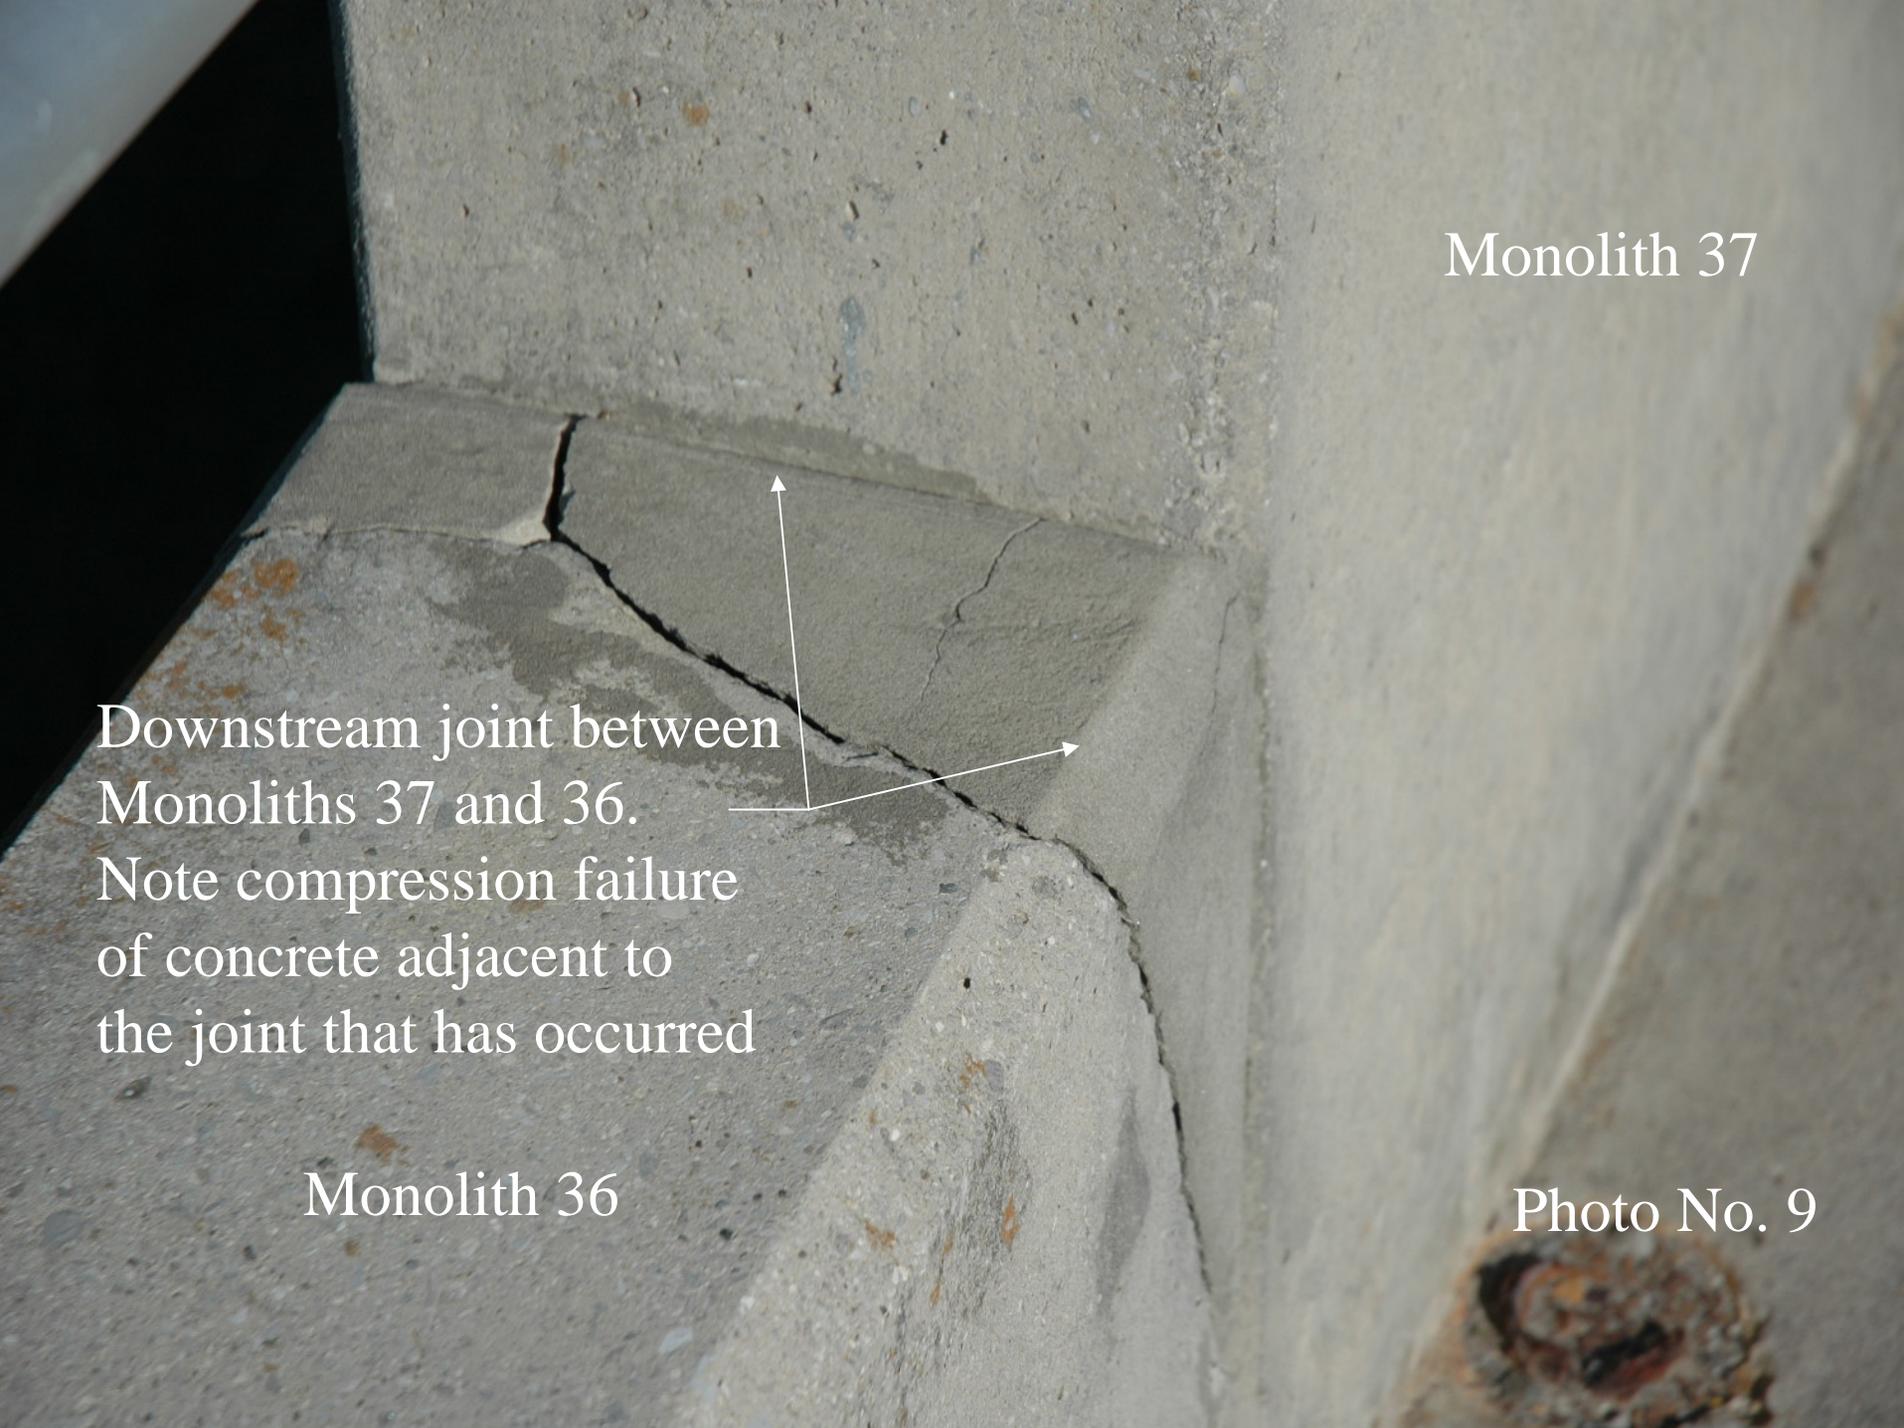
Photo No. 9

The Panel observed an opening (1/4 to 1/2 inch) along the upstream portion of the joint between Monoliths 36 and 37 (see Photograph 10) as well as evidence that the downstream portion of the same Monolith joints in compression (Photograph 9). These observations are consistent with the movement monitoring data for Monolith 37.
