Wolf Creek Dam Consensus Report Engineering Risk and Reliability Analysis

April 11, 2007

DSAC Class I Dams
Peer Review Panel

Site Visit Photos Referenced in Consensus Report

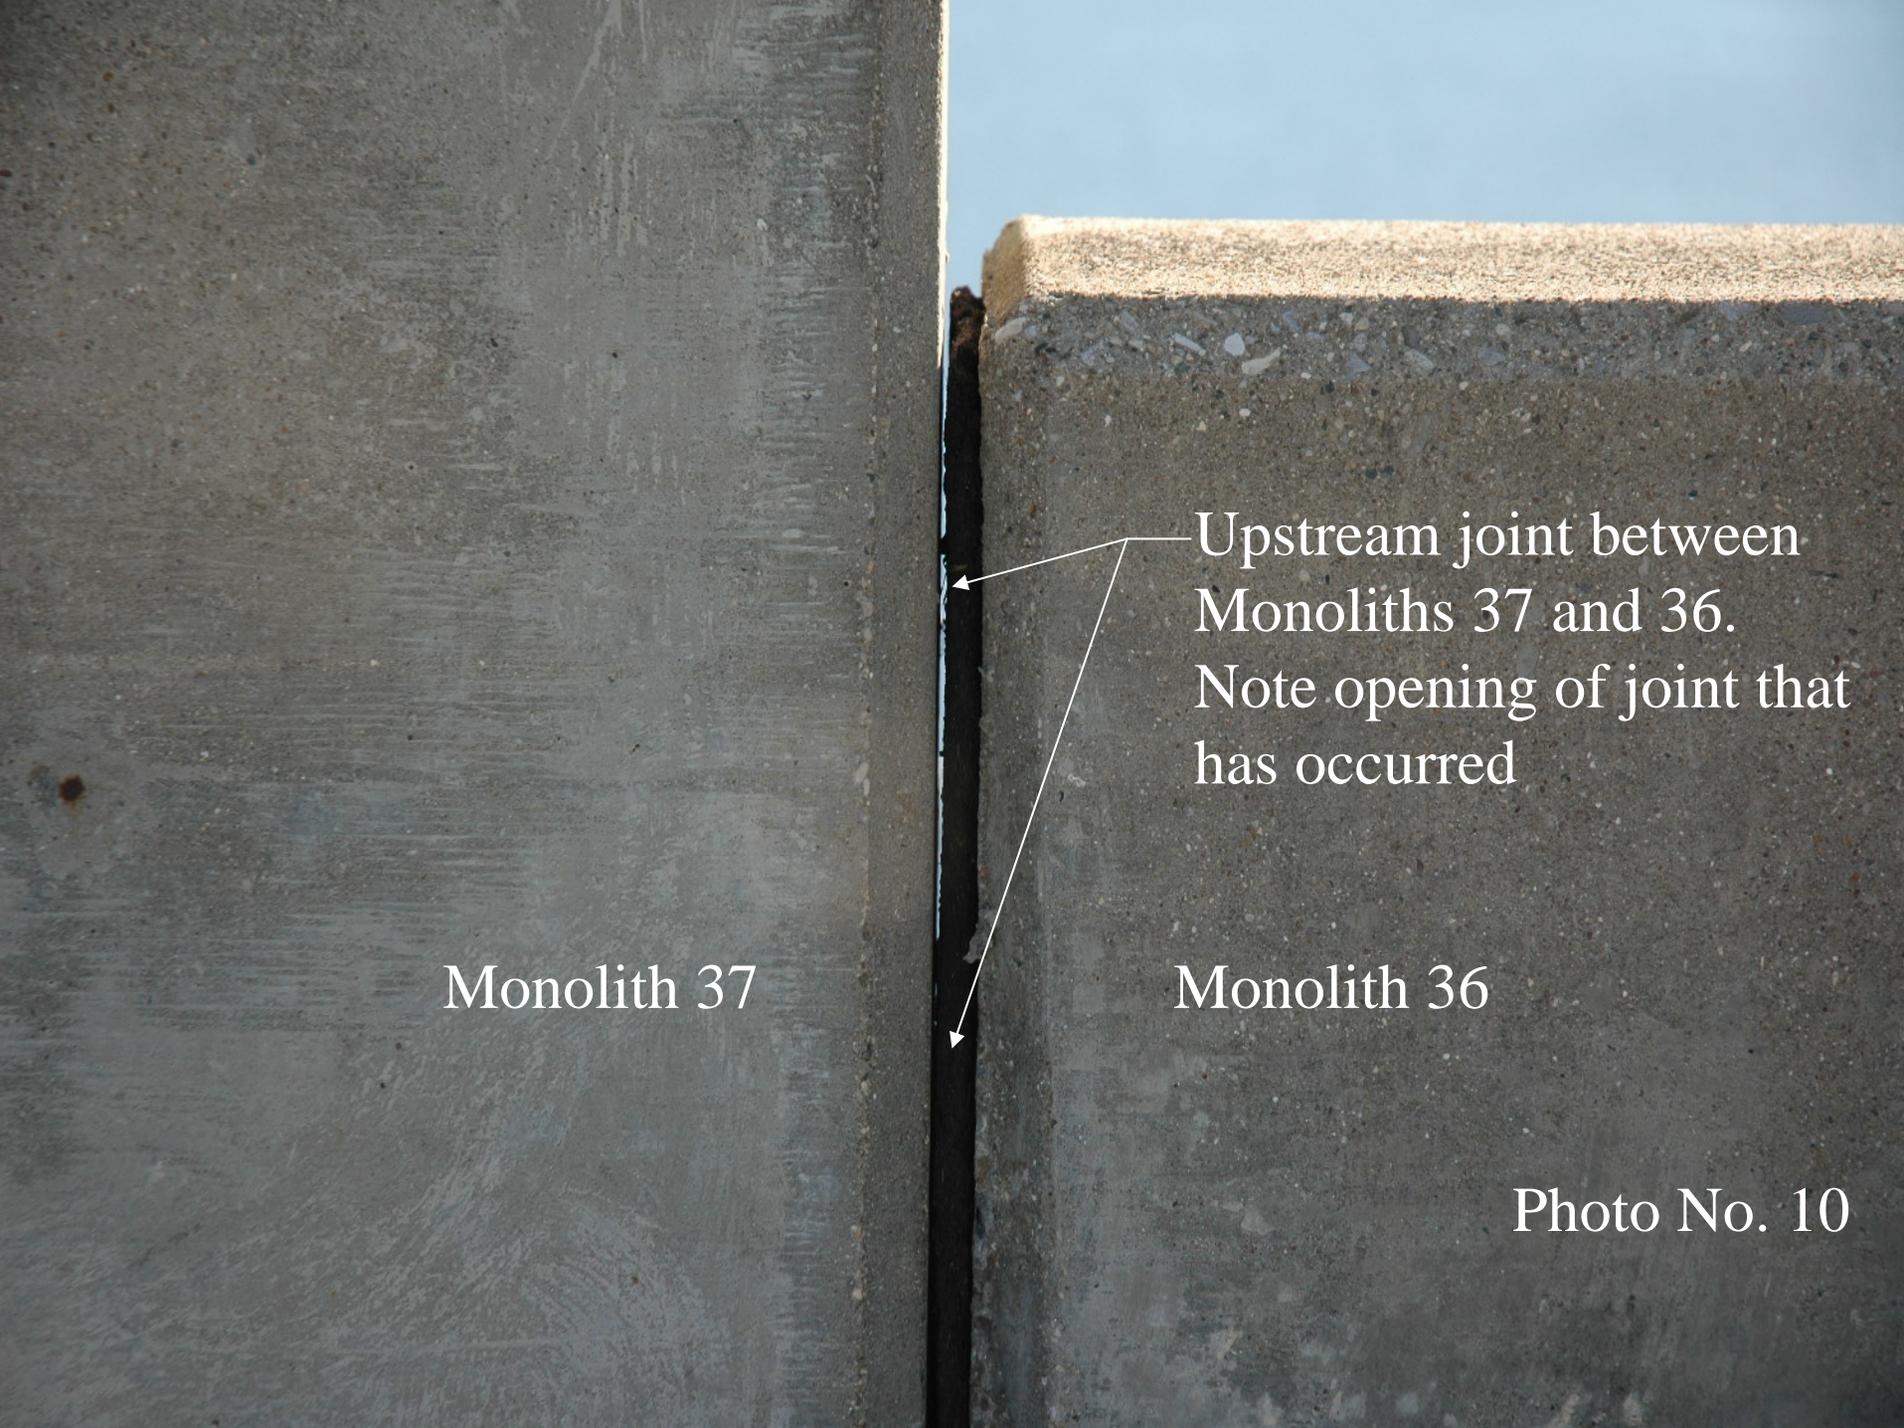
Photo No. 10

The Panel observed an opening (1/4 to 1/2 inch) along the upstream portion of the joint between Monoliths 36 and 37 (see Photograph 10) as well as evidence that the downstream portion of the same Monolith joints in compression (Photograph 9). These observations are consistent with the movement monitoring data for Monolith 37.

Upstream joint between
Monoliths 37 and 36.
Note opening of joint that
has occurred

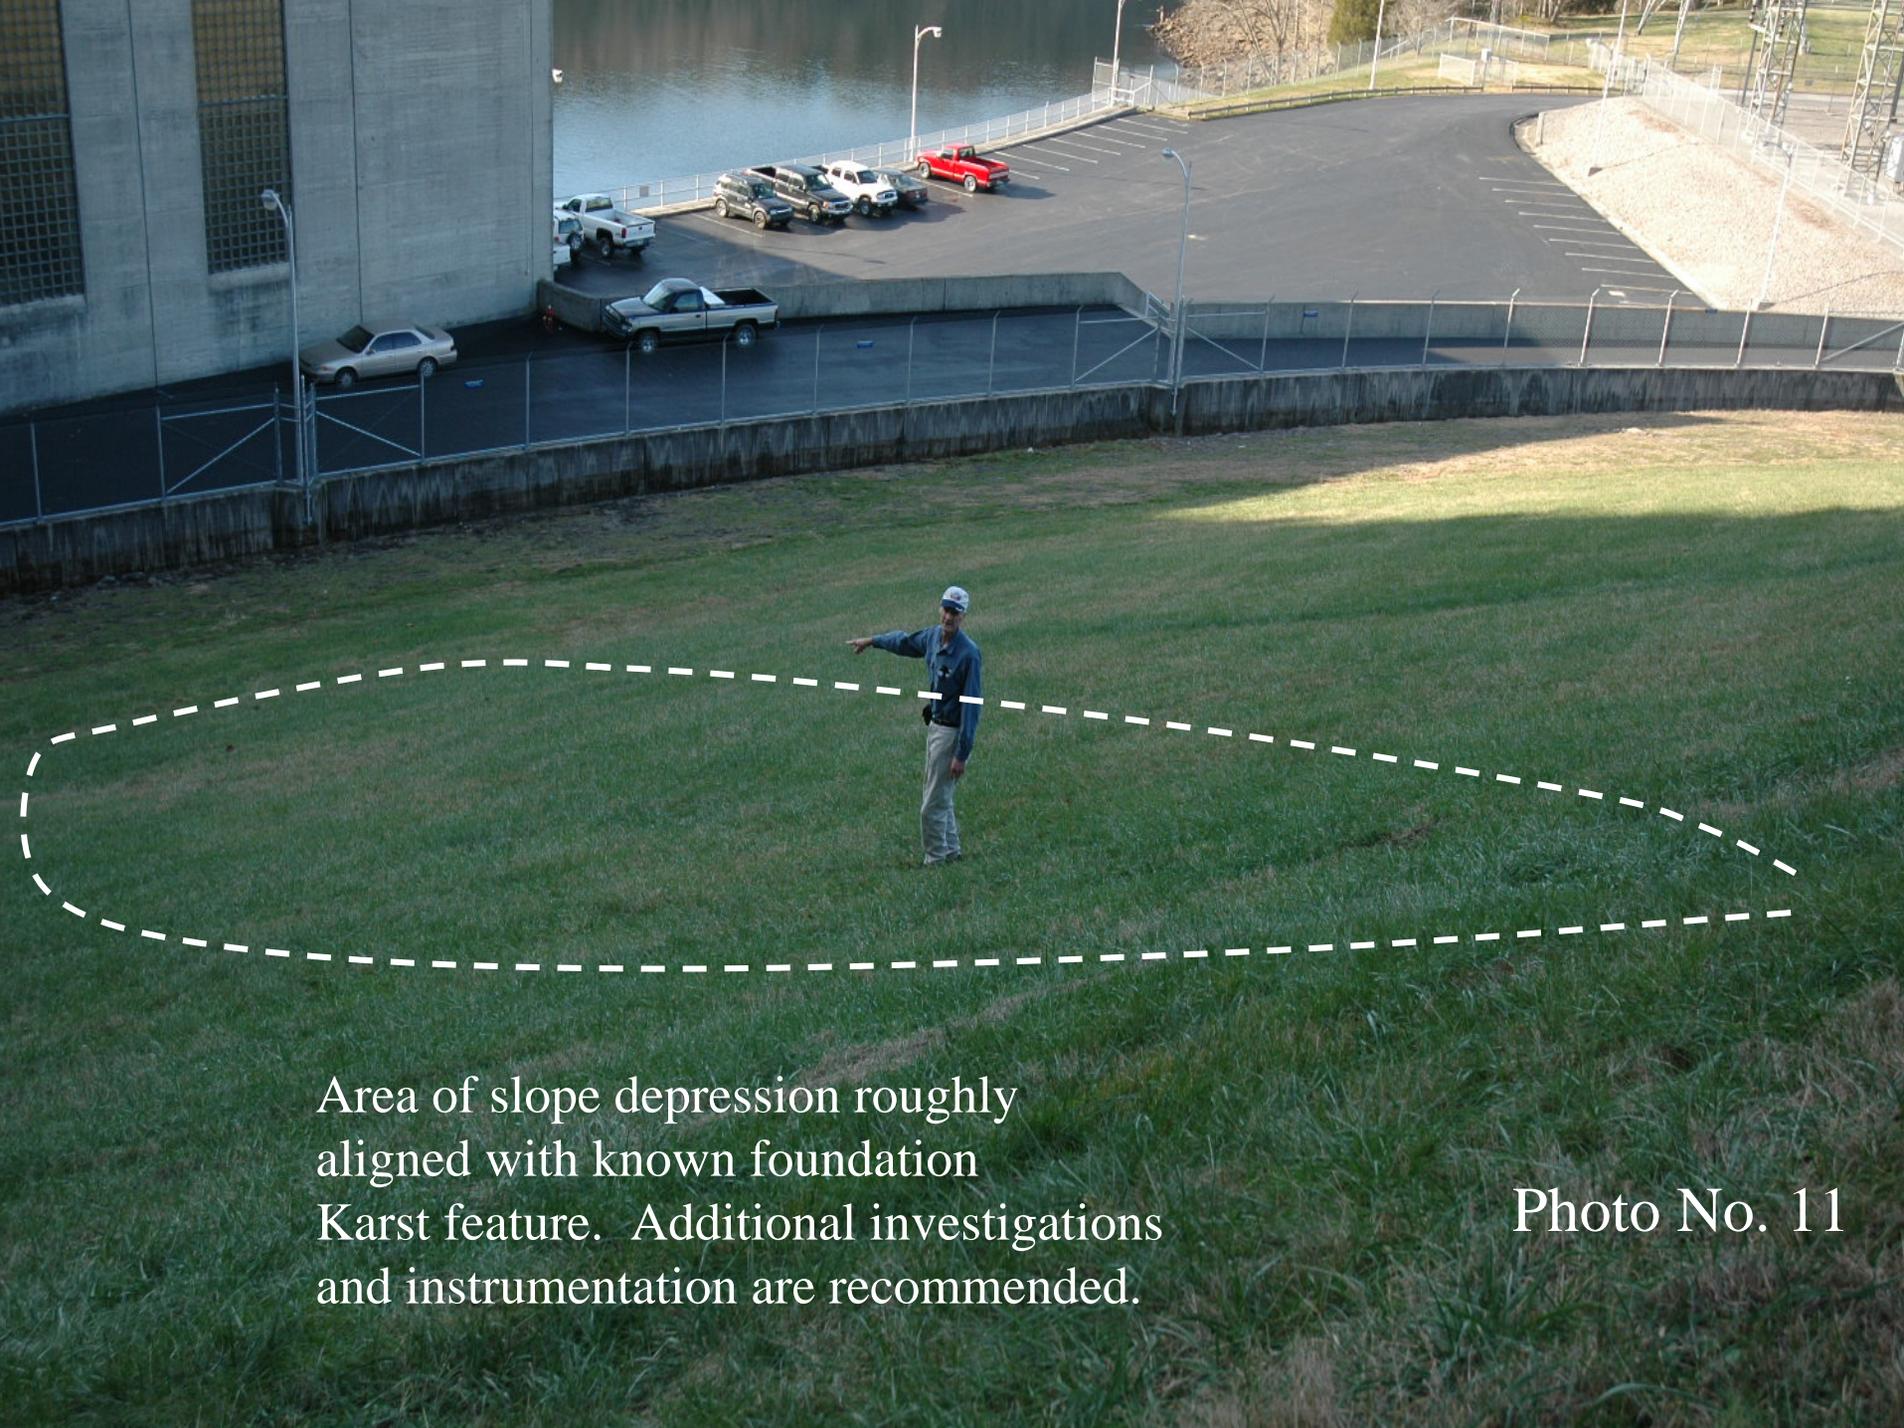
Photo No. 11

A line of wet areas was noted further up the slope of the embankment roughly aligned with the “depressed” area discussed above (Photographs 11 and 12). A picture of a typical wet area is shown in Photograph 14. District personnel have noted that this line of wet areas has been monitored for some time and appear to get worse during rainy periods and dry up during dry periods. They suspect that the cause is due to beam drainage problems and channeling of surface water through vole holes. The Panel notes that the location and alignment of these features are in an area that previously has not been explored or instrumented to any significant degree. The location and condition of these features should be mapped and further explorations and monitoring should be performed to determine if any significant changes are occurring.

Area of slope depression roughly aligned with known foundation Karst feature. Additional investigations and instrumentation are recommended.

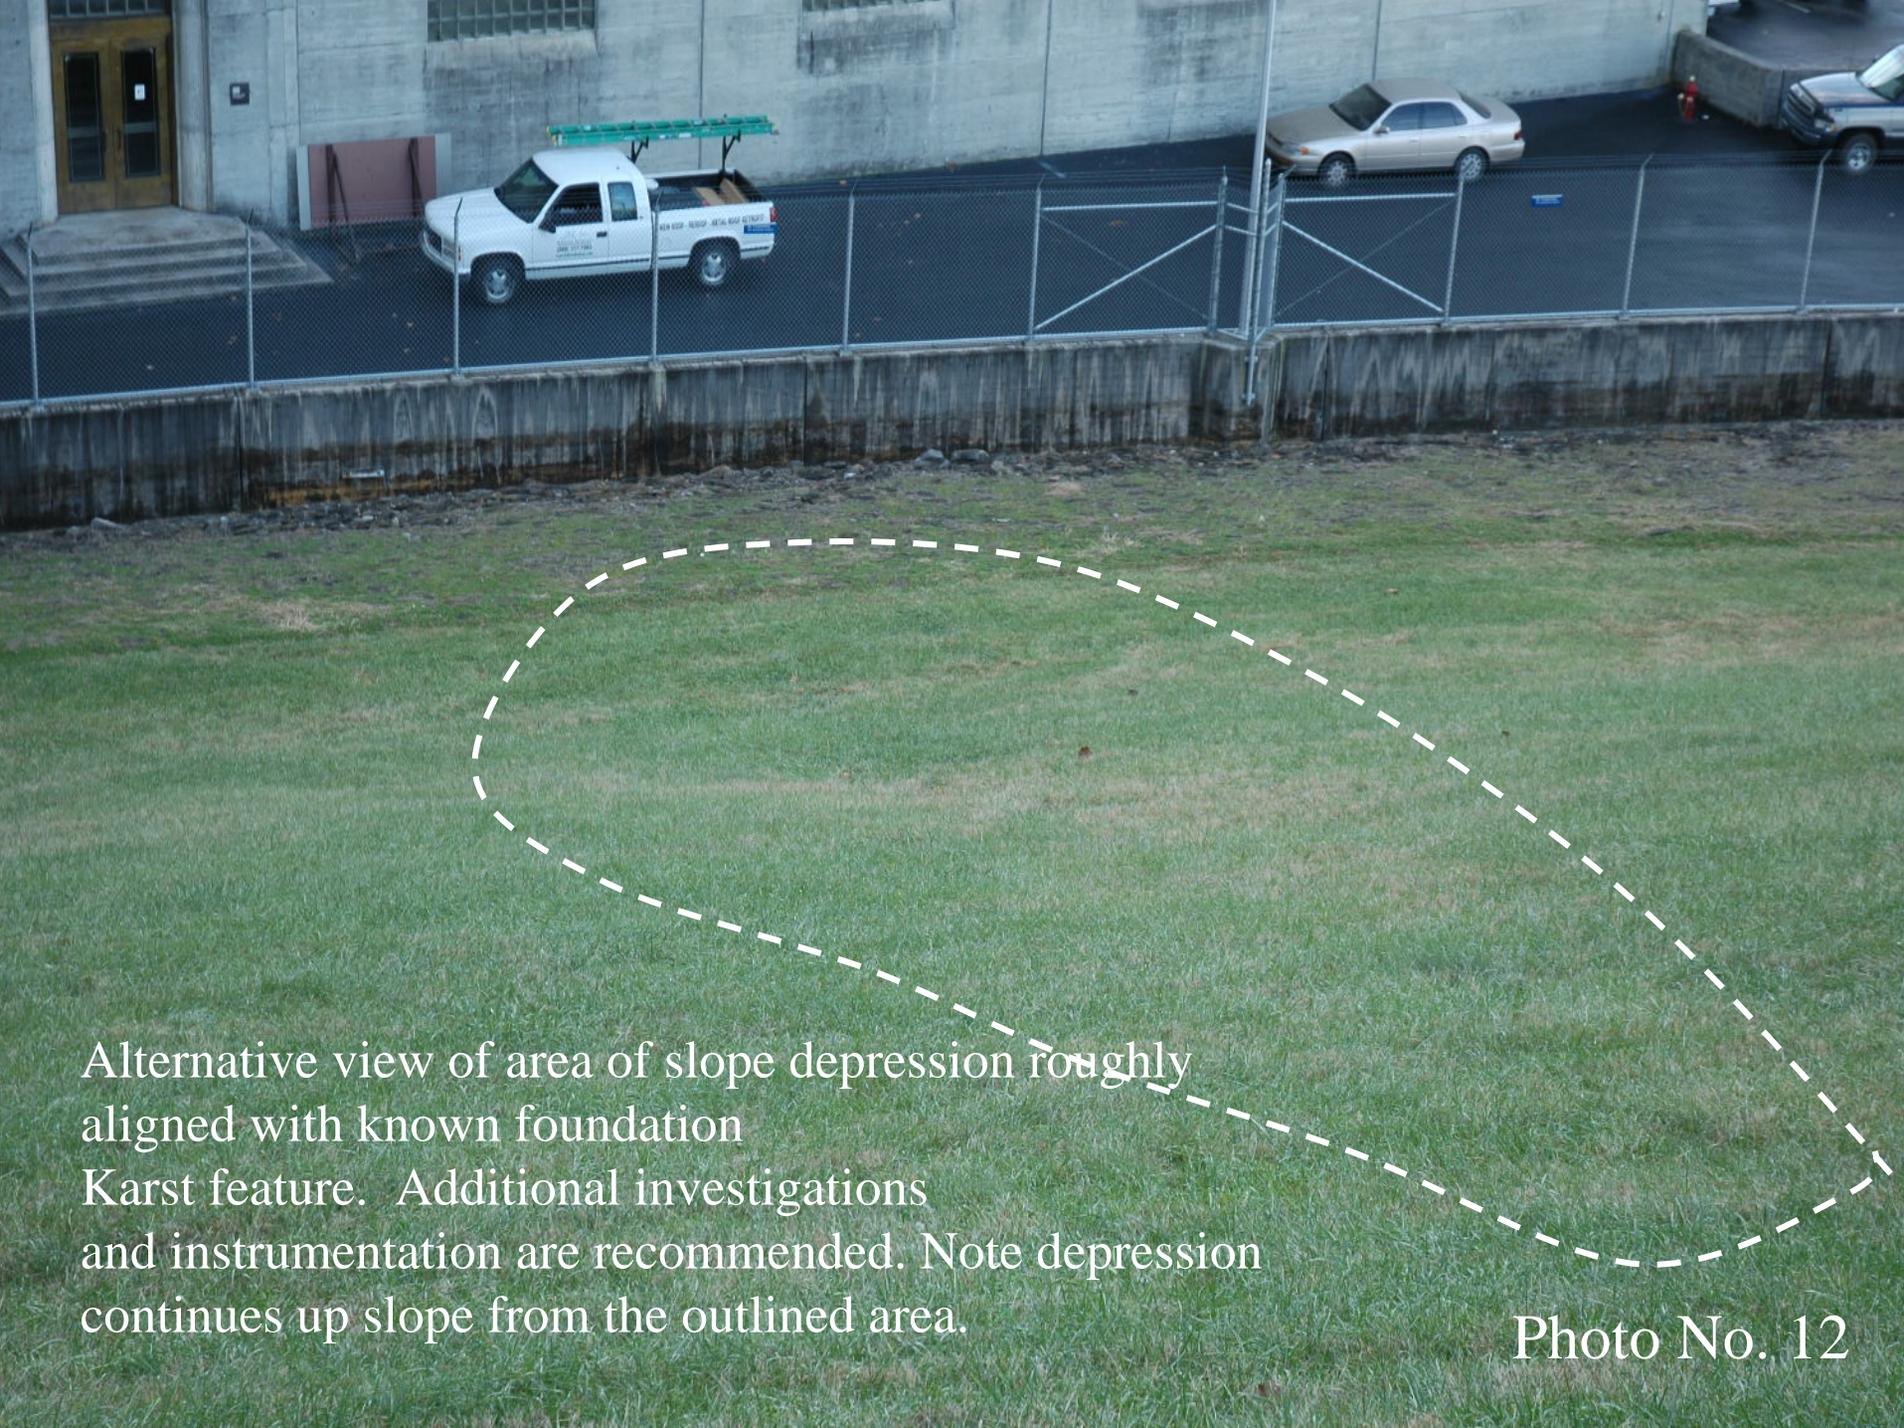
Photo No. 12

Alternative view of area of slope depression roughly aligned with known foundation Karst feature. Additional investigations and instrumentation are recommended. Note depression continues up slope from the outlined area.

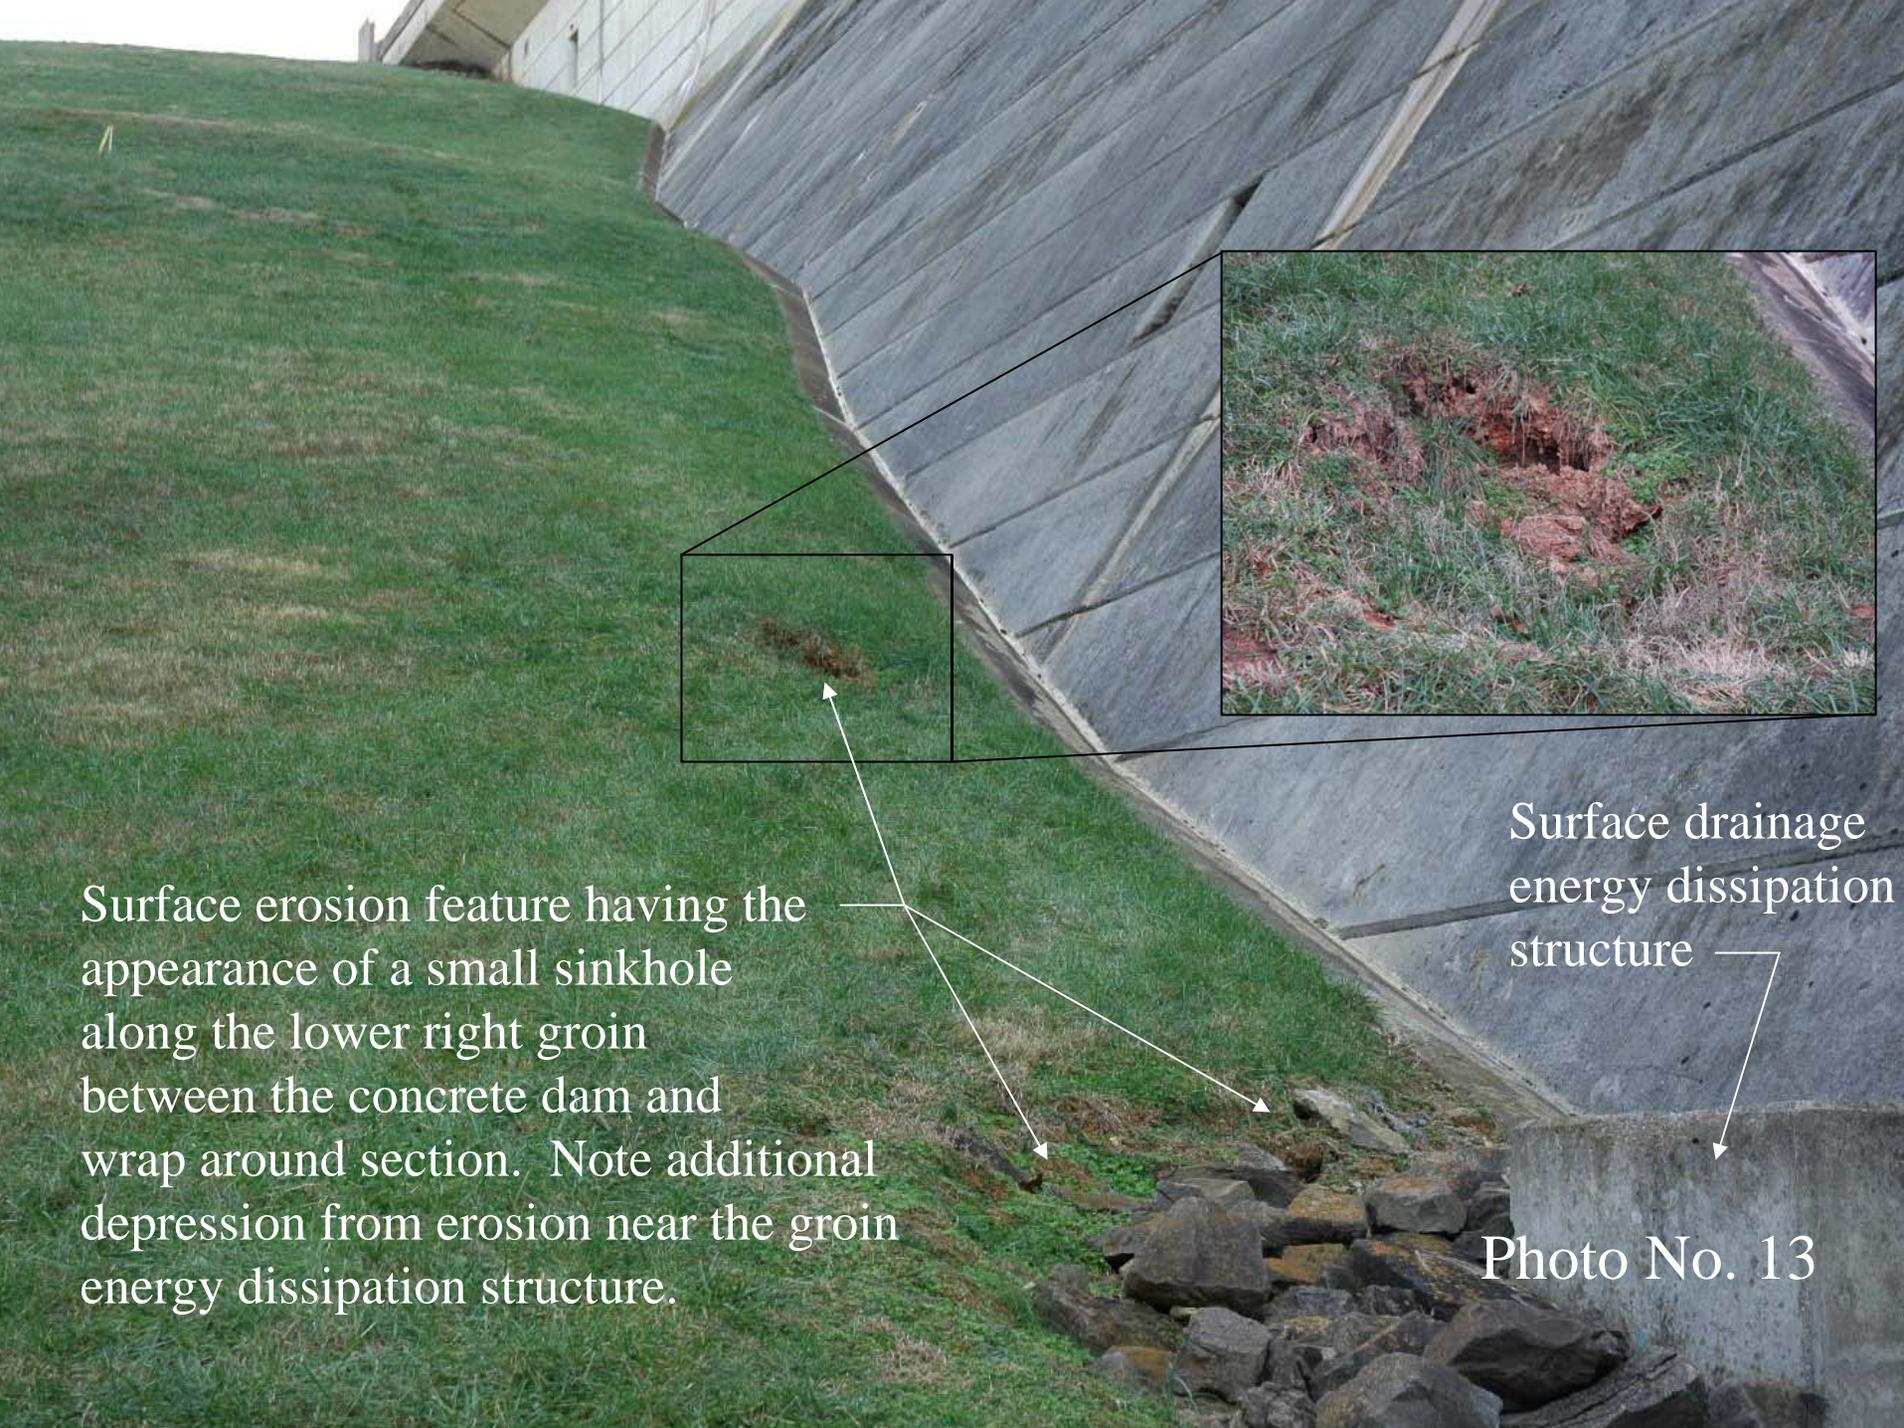
Photo No. 13

Surface erosion feature having the appearance of a small sinkhole along the lower right groin between the concrete dam and wrap around section. Note additional depression from erosion near the groin energy dissipation structure.

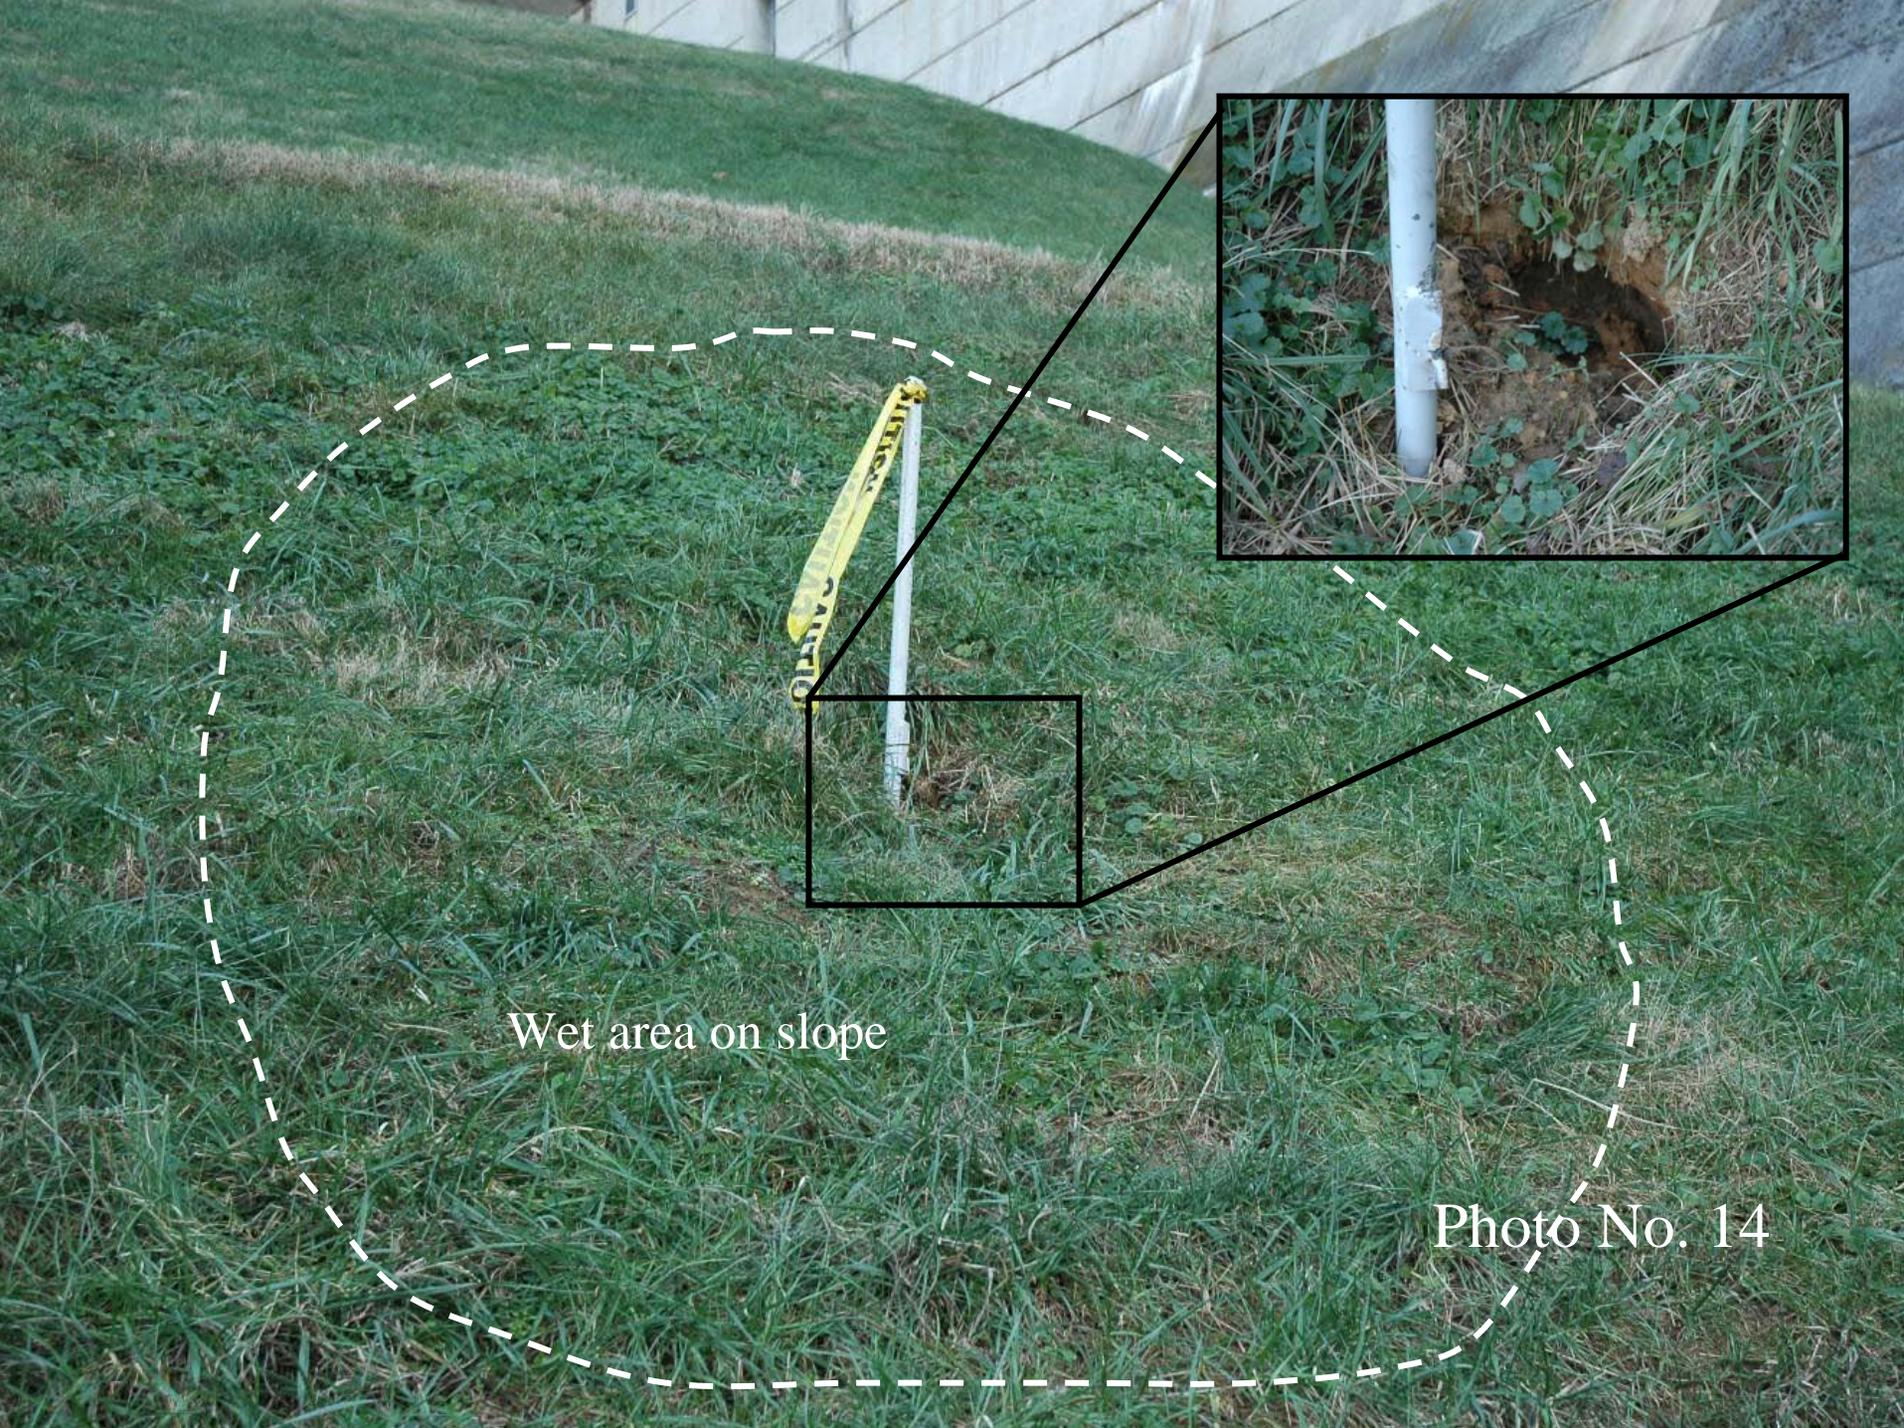
Photo No. 14

Wet area on slope
