Figure 3. Healthcare Corporation of America Glenbrook South Site Watercourses, Hendersonville, TN

GLENBROOK SOUTH - HCA
FOR
HCA CORPORATE REAL ESTATE
CITY OF HENDERSONVILLE, SUMNER COUNTY, TENNESSEE

Compensatory mitigation is proposed to offset impacts to 2,105 linear feet of jurisdictional streams to be filled.

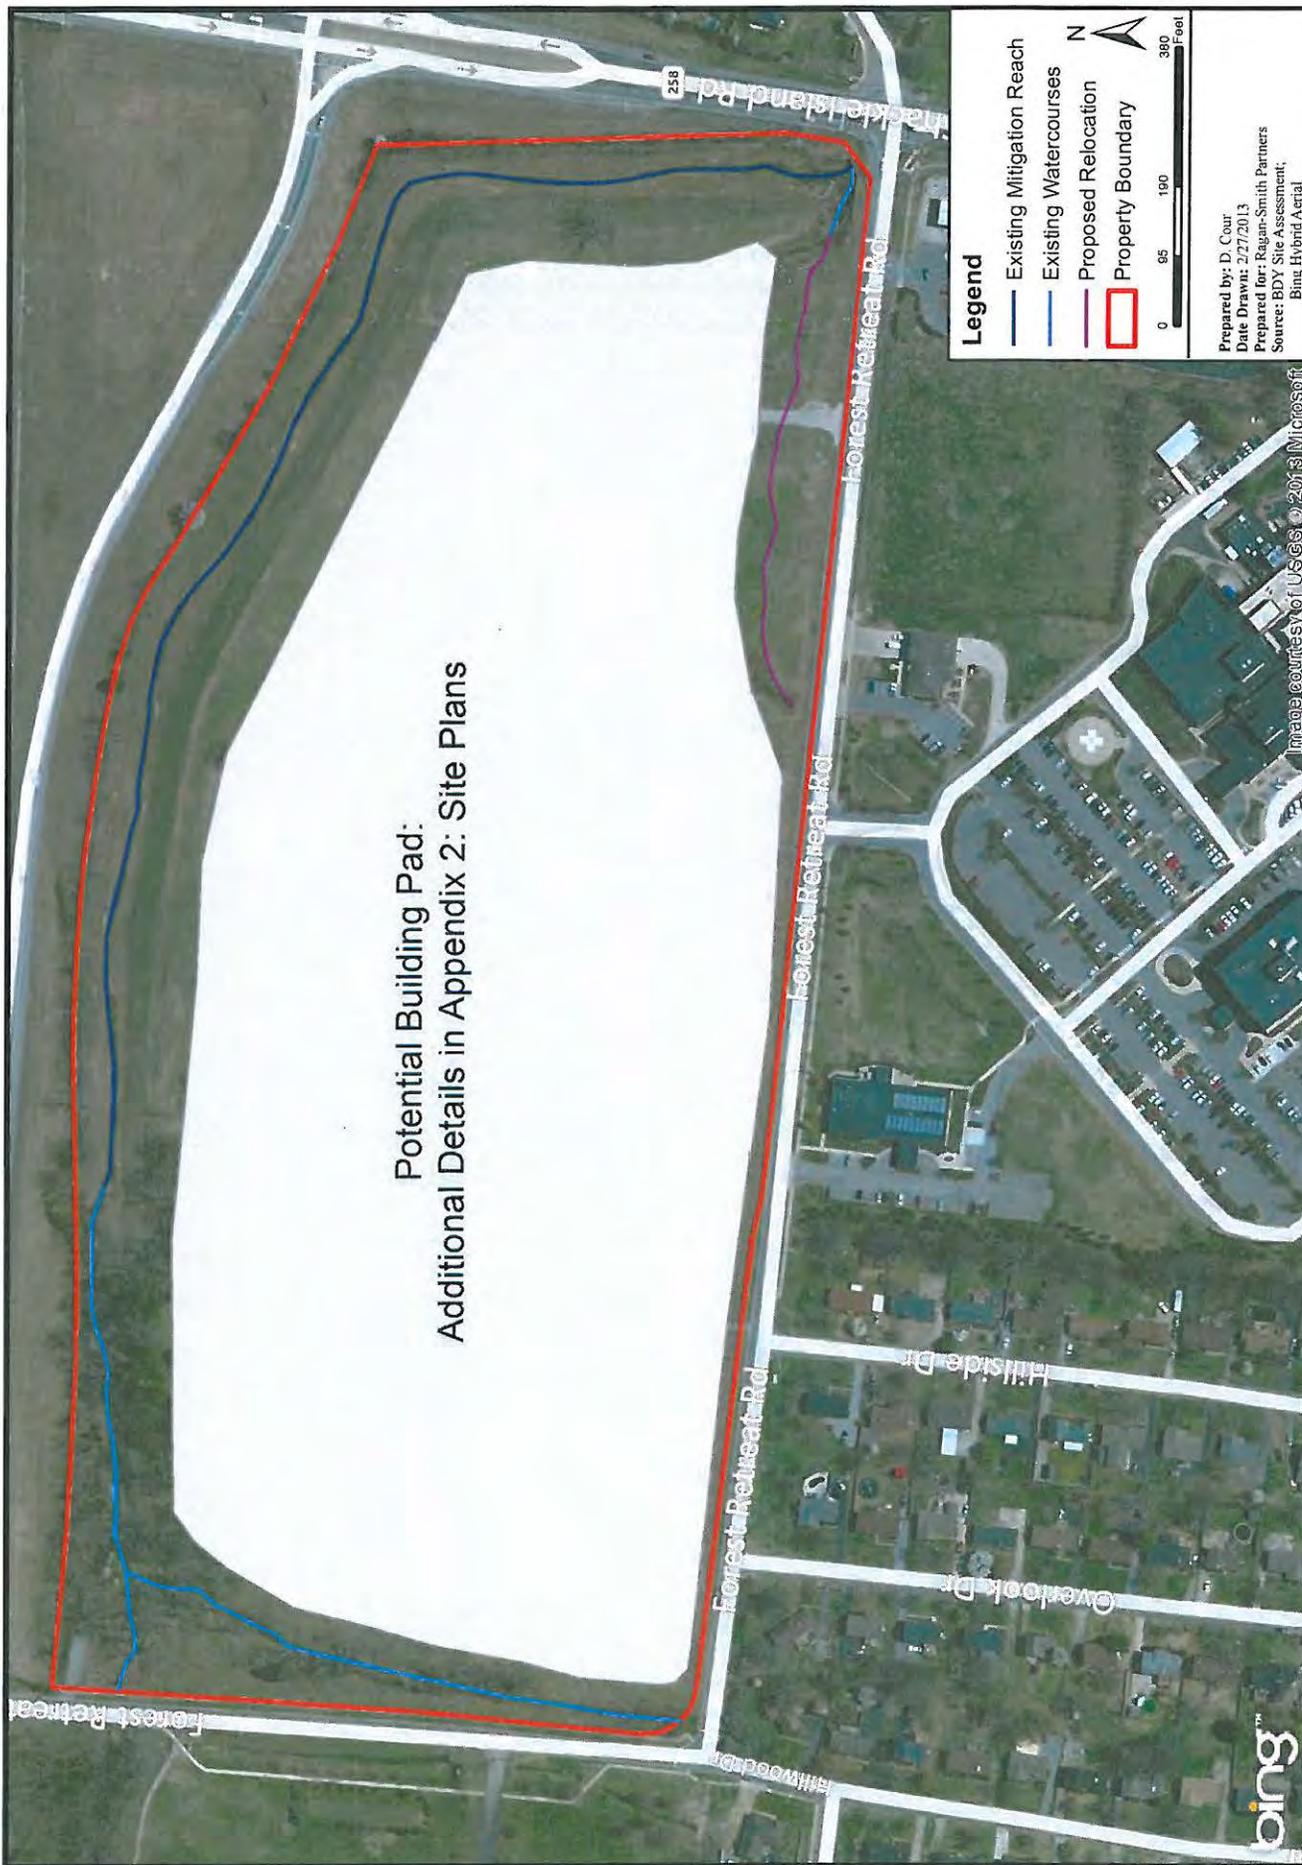
Figure 4. Glenbrook South Site Proposed Conditions, Hendersonville, TN

The applicant is proposing to provide compensatory mitigation for the 2,105 linear feet of stream impacts (including 215 feet of S-2 previously filled, 1,560 feet of S-2 proposed, and 330 feet of S-3 proposed) via the previously constructed 2,060 linear feet of mitigation channel (S-4) and the proposed 675 linear feet of relocated stream channel for S-3.

The new stream channel will be constructed according to the enclosed plans. In-stream habitat will be provided by the introduction of clean cobble and gravel material. Banks will be seeded with native grasses and stabilized with erosion control matting.

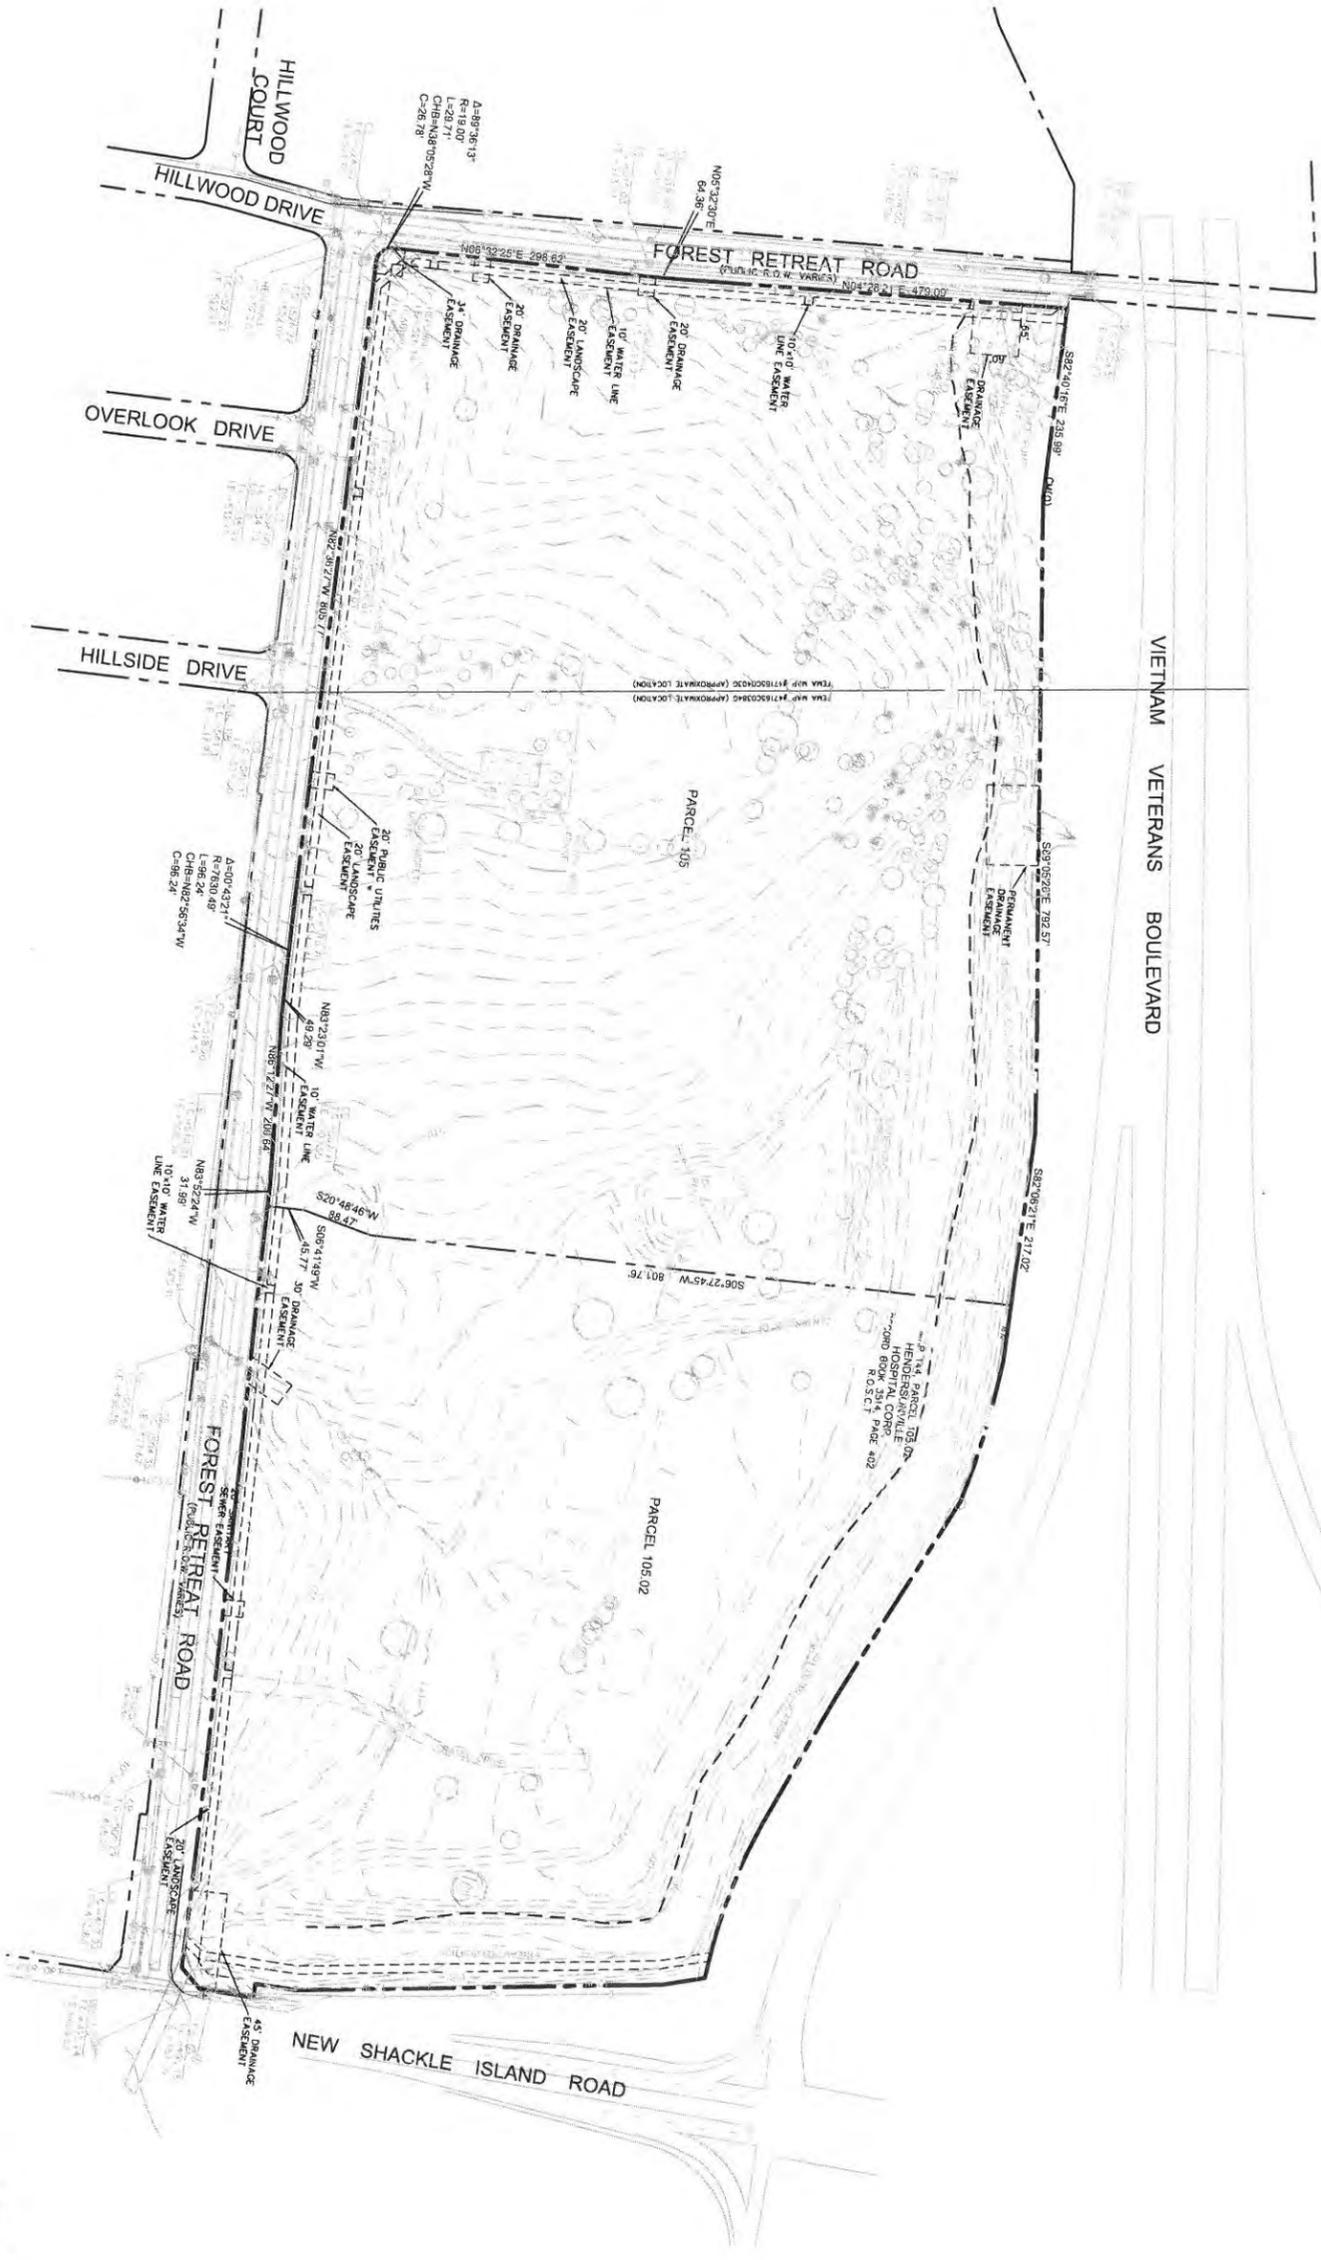
C1.1 EXISTING CONDITIONS PLAN	JOB NO.	WK. ORDER	
	99-028	9428	
	DESIGNED:	XXX	
	DRAWN:	XXX	
	SCALE:	#-##	
DATE:	PROJ. DATE	REVISIONS

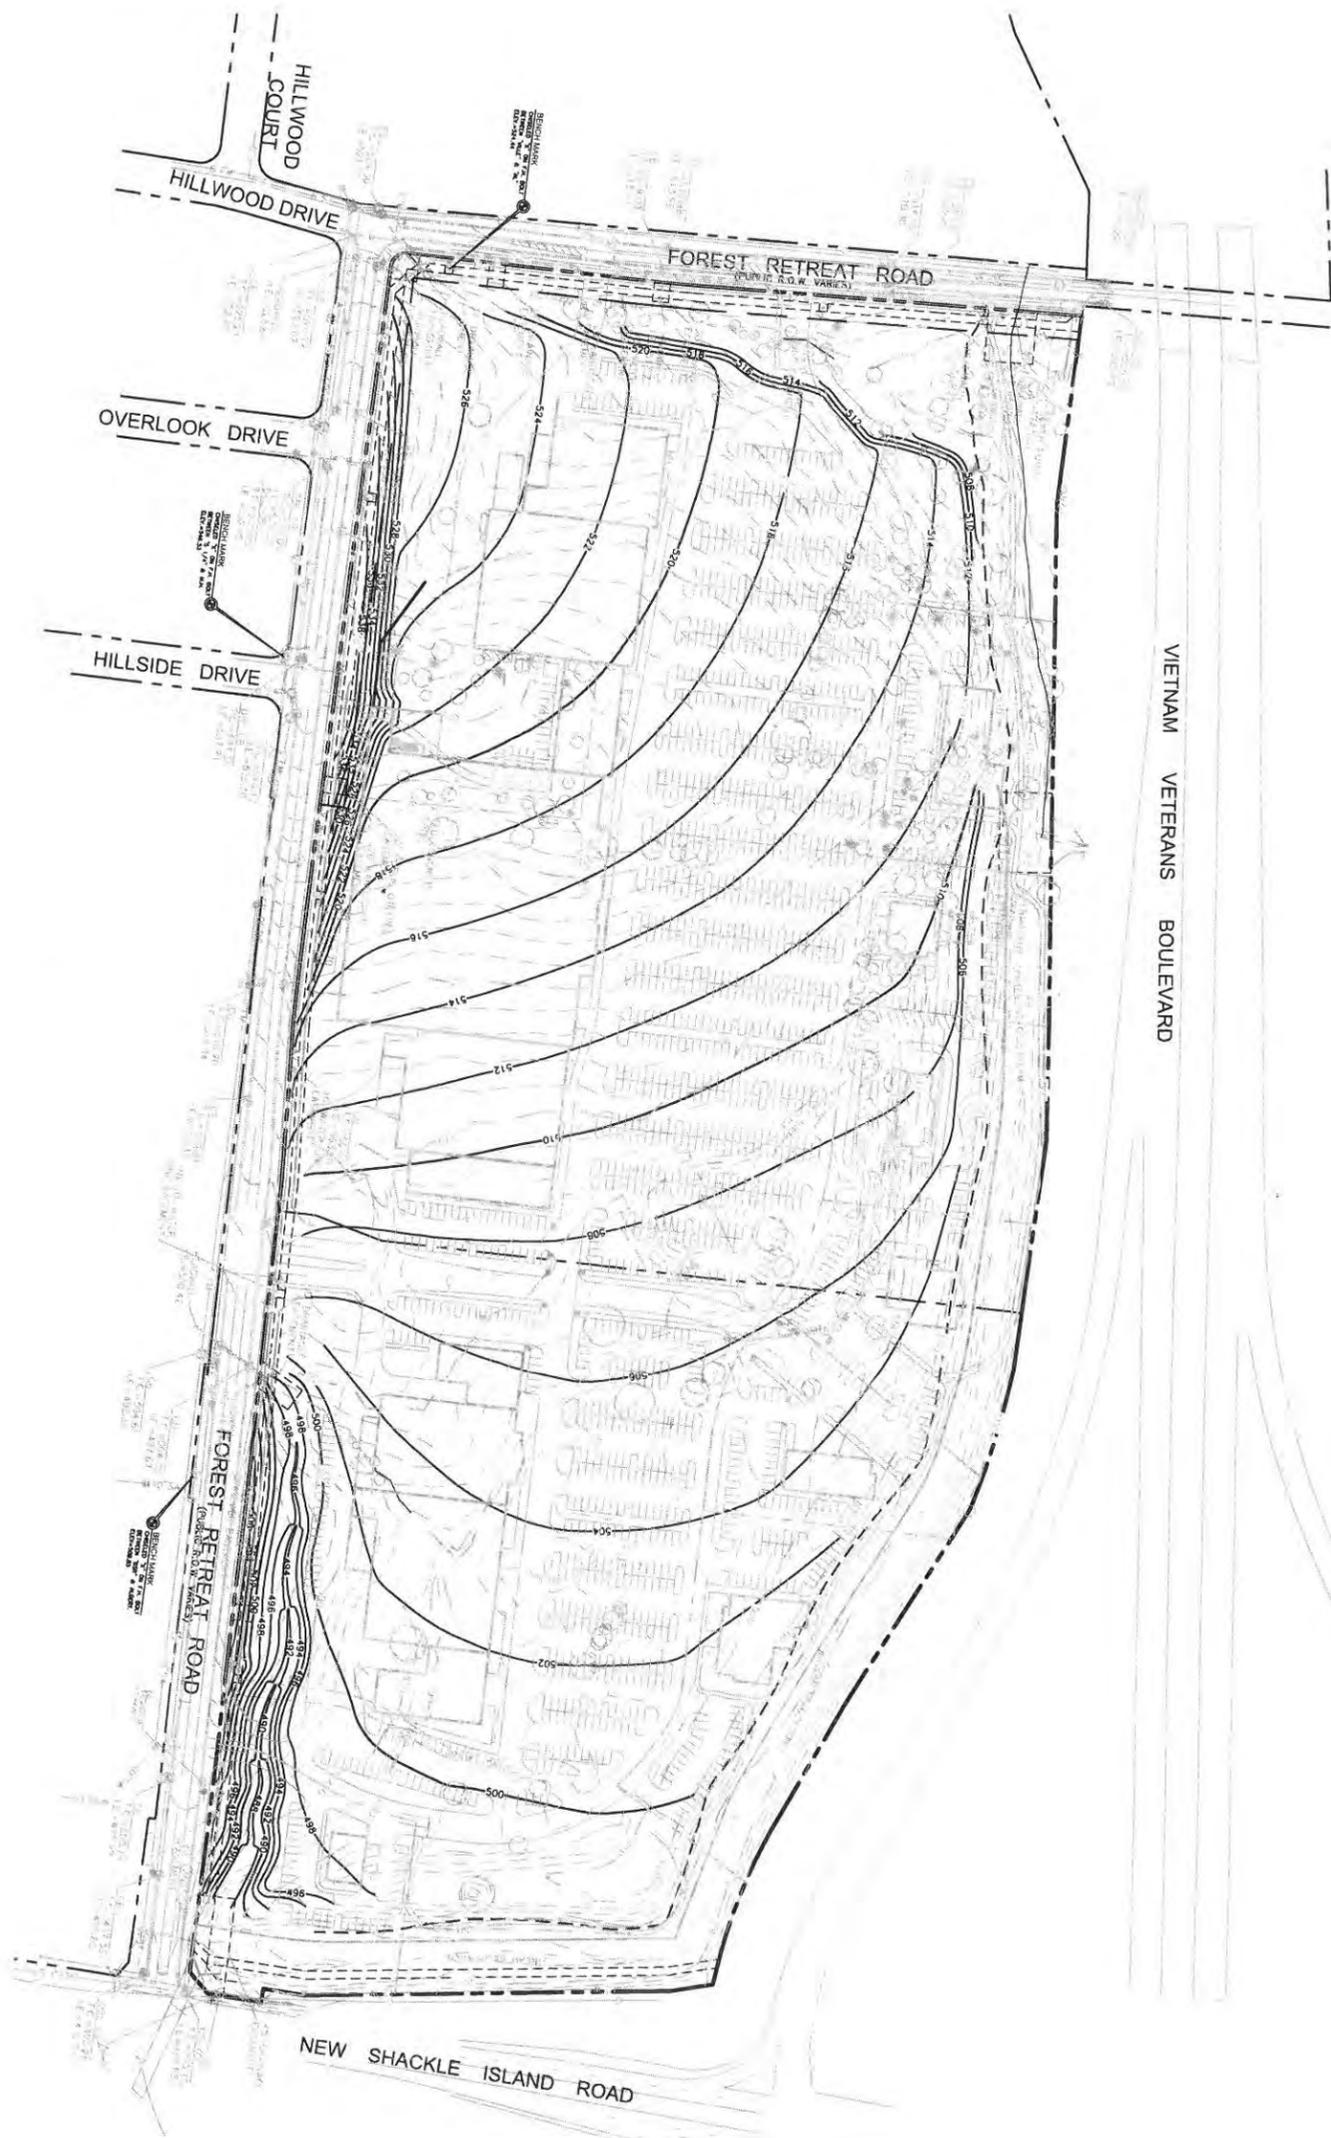
C3.0	OVERALL GRADING PLAN	
	JOB NO.	WK. ORDER
	DESIGNED:	DRAWN:
	SCALE:	#'-##"
	DATE:	PROJ. DATE
	REVISIONS

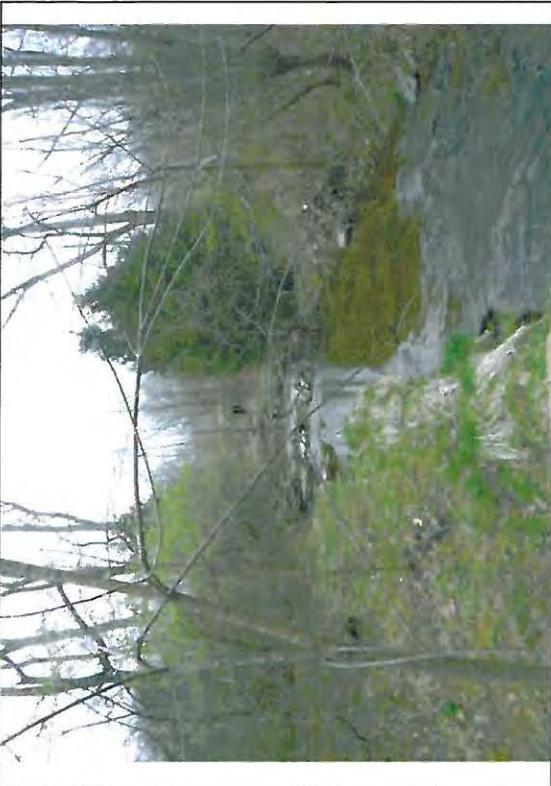
Photo 1. Unnamed Tributary to Drake's Creek (Watercourse 1), from confluence with Watercourse 5, facing upstream (3/22/2013)

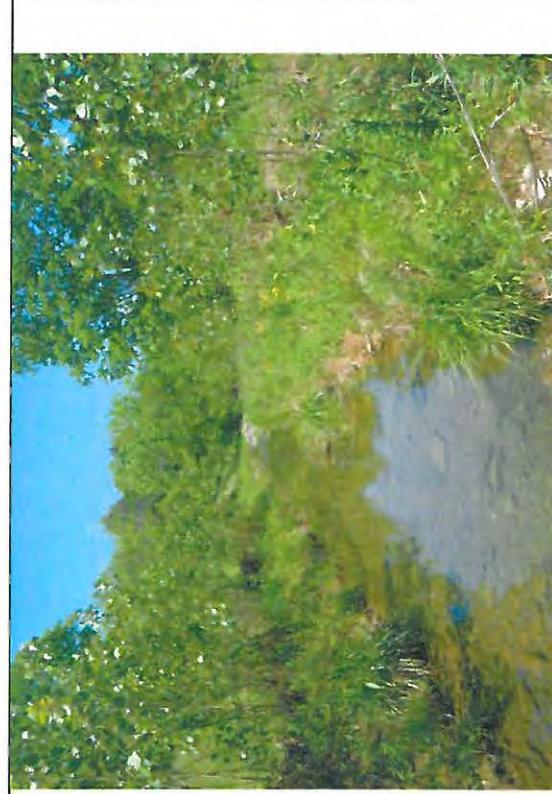
Photo 4. Unnamed Tributary to Drake's Creek mitigation reach (Watercourse 4), facing upstream (5/14/2013)

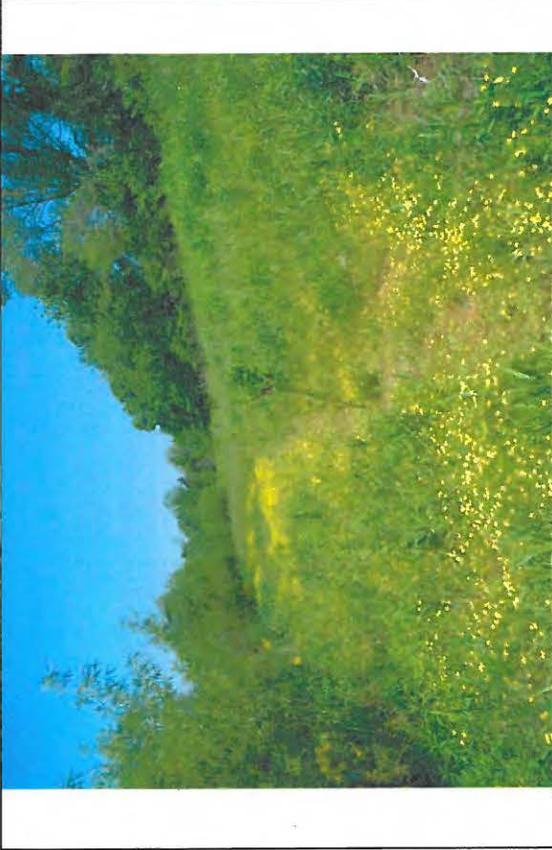
Photo 6. Unnamed Tributary to Drake's Creek mitigation reach buffer plantings by HCA (Watercourse 4), facing upstream (5/14/2013)

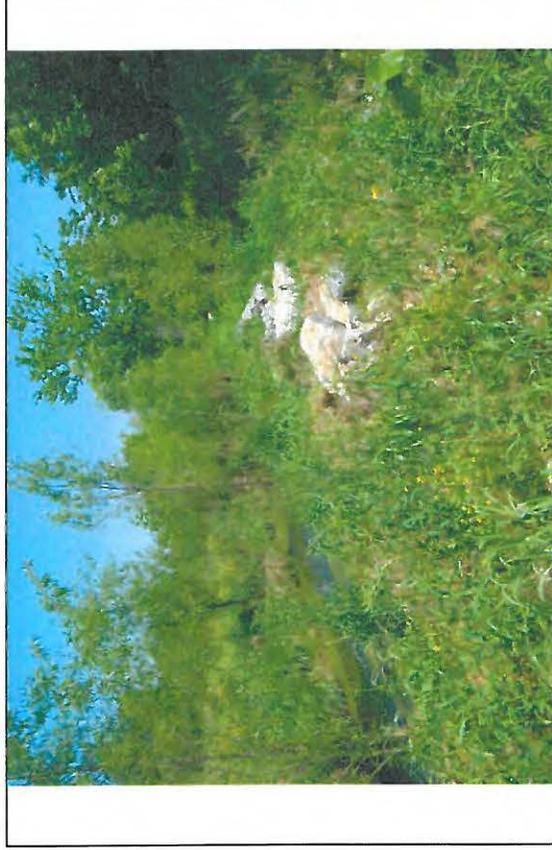
Photo 8. Unnamed Tributary to Drake's Creek mitigation reach with buffer plantings (Watercourse 4), facing upstream (5/14/2013)

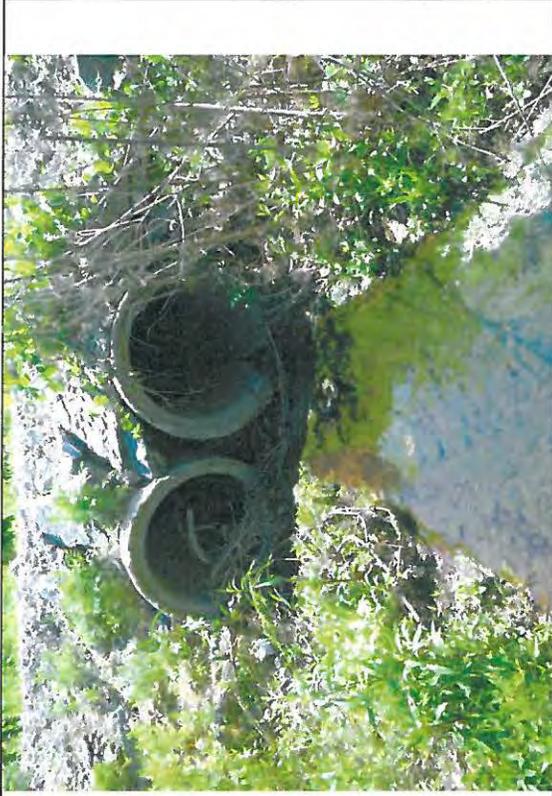
Photo 10. Unnamed Tributary to Drake's Creek relic channel at construction crossing (Watercourse 2), facing downstream (5/14/2013)

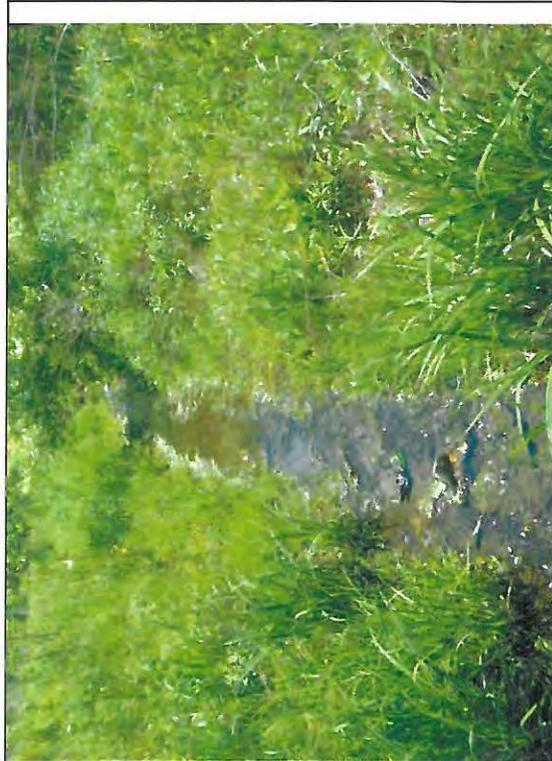
Photo 11. Unnamed Tributary to Drake's Creek relic channel at relocation channel (Watercourse 2 and Watercourse 3 confluence), facing downstream (5/14/2013)

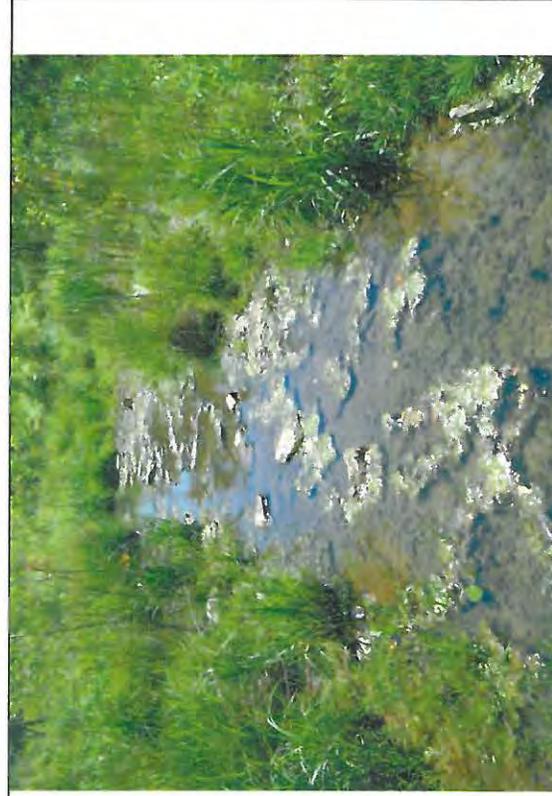
Photo 12. Unnamed Tributary to Drake's Creek relic channel with stagnant water (Watercourse 2), facing downstream (5/14/2013)

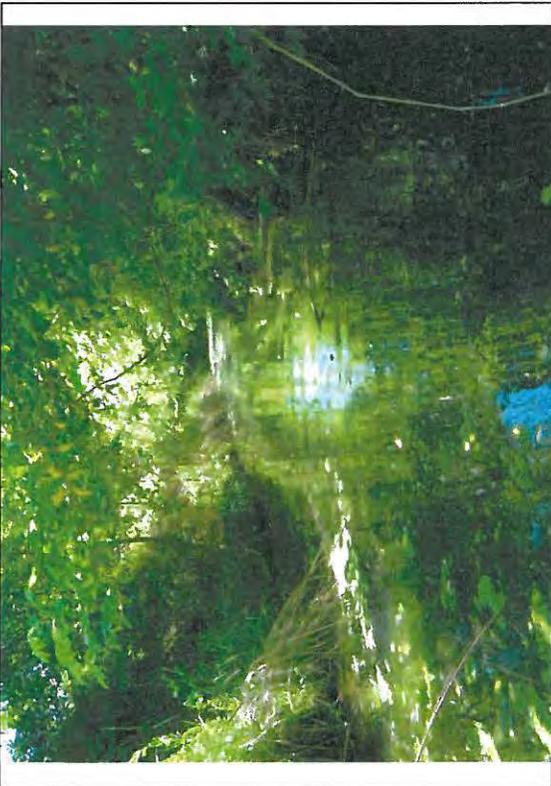
Photo 13. Unnamed Tributary to Drake's Creek relic channel with stagnant water (Watercourse 2), facing downstream (5/14/2013)

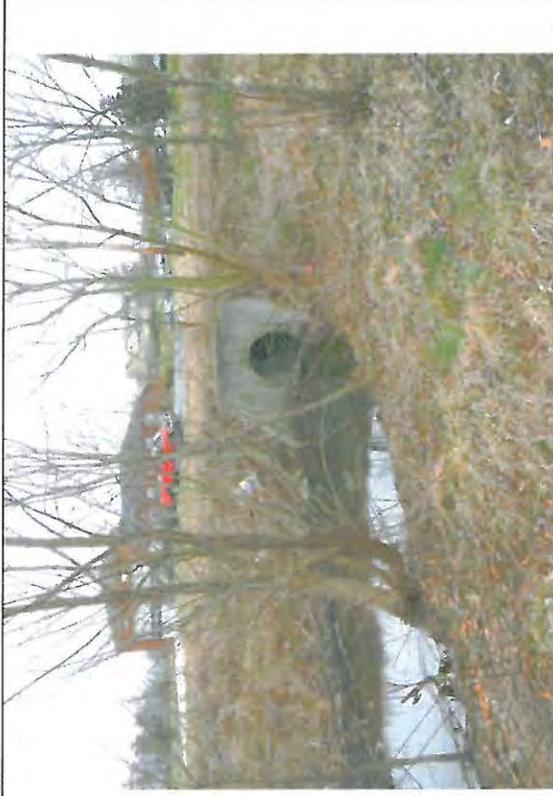
Photo 18. Tributary to Unnamed Tributary to Drake's Creek (Watercourse 3) as it enters the property, with stagnant water due to water line, facing upstream (2/20/2013)

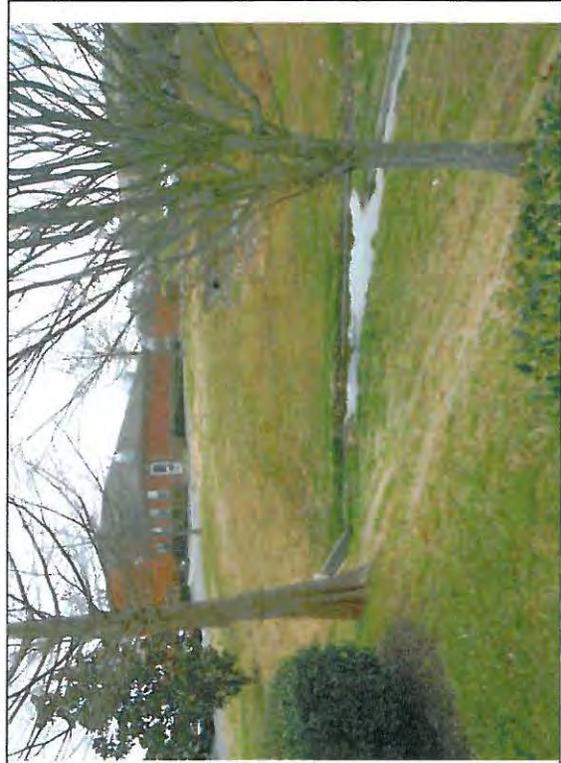
Photo 19. Tributary to Unnamed Tributary to Drake's Creek (Watercourse 3) cement channels and culvert from Tri-Star (2/20/2013)

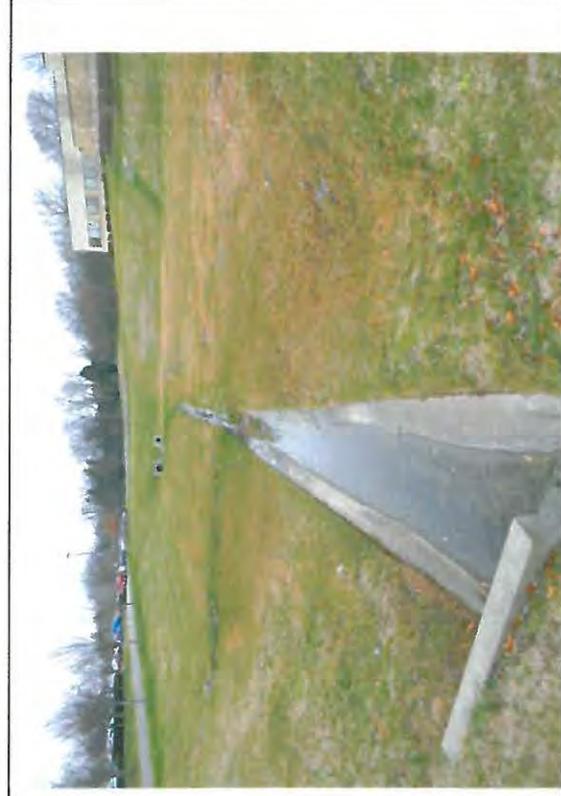
Photo 20. Tributary to Unnamed Tributary to Drake's Creek (Watercourse 3) cement channels and culvert from Tri-Star (2/20/2013)

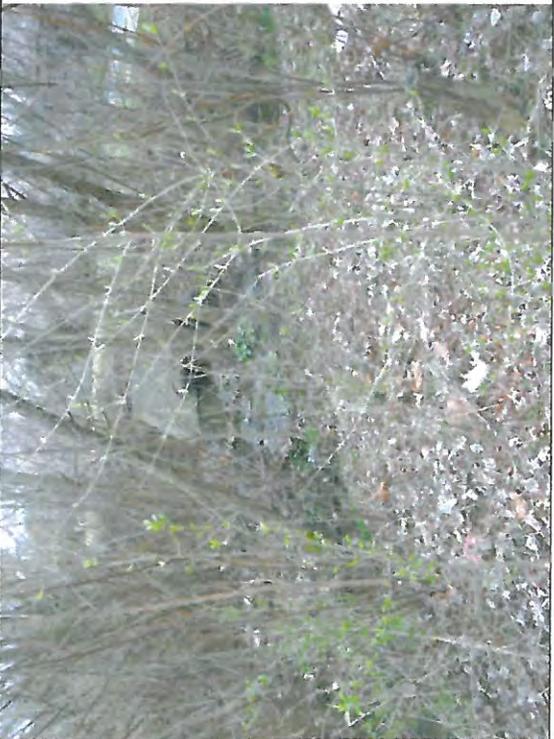
Photo 21. Tributary to Unnamed Tributary to Drake's Creek as it enters property, depicting stagnant water from water line (Watercourse 5), facing upstream (3/22/2013)

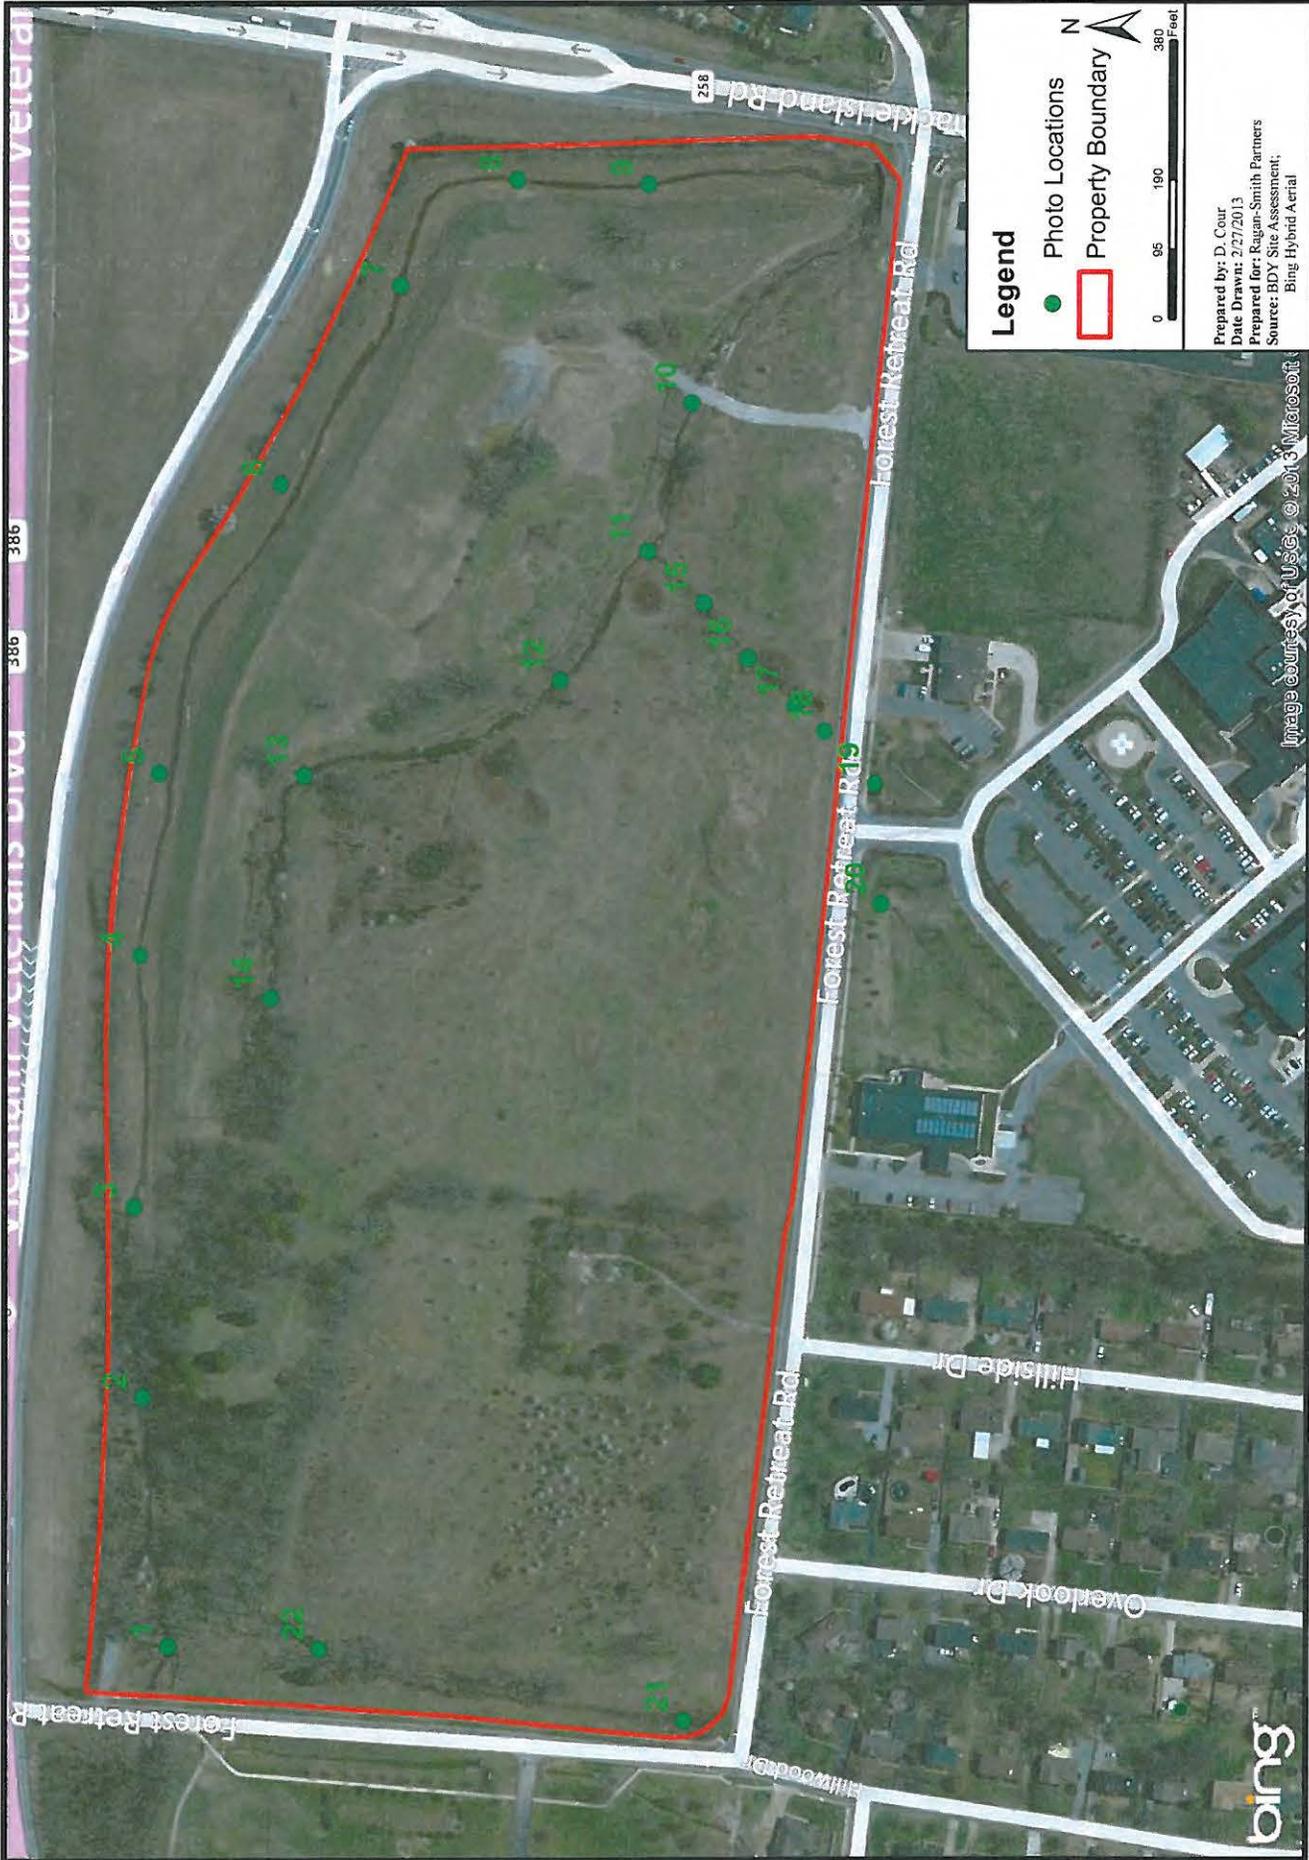
Figure 2. Healthcare Corporation of America Glenbrook South Site Photo Locations, Hendersonville, TN
