Prospectus For MITIGATION BANKING INSTRUMENT

SWAMP ROAD WETLAND MITIGATION BANK #2

Prepared by:
Jeffrey T. Duke, PWS, CPESC
Wetlands Reserve, LLC
7379 Old Cox Pike
Bon Aqua, TN 37028
July 15, 2013
Revised August 27, 2013

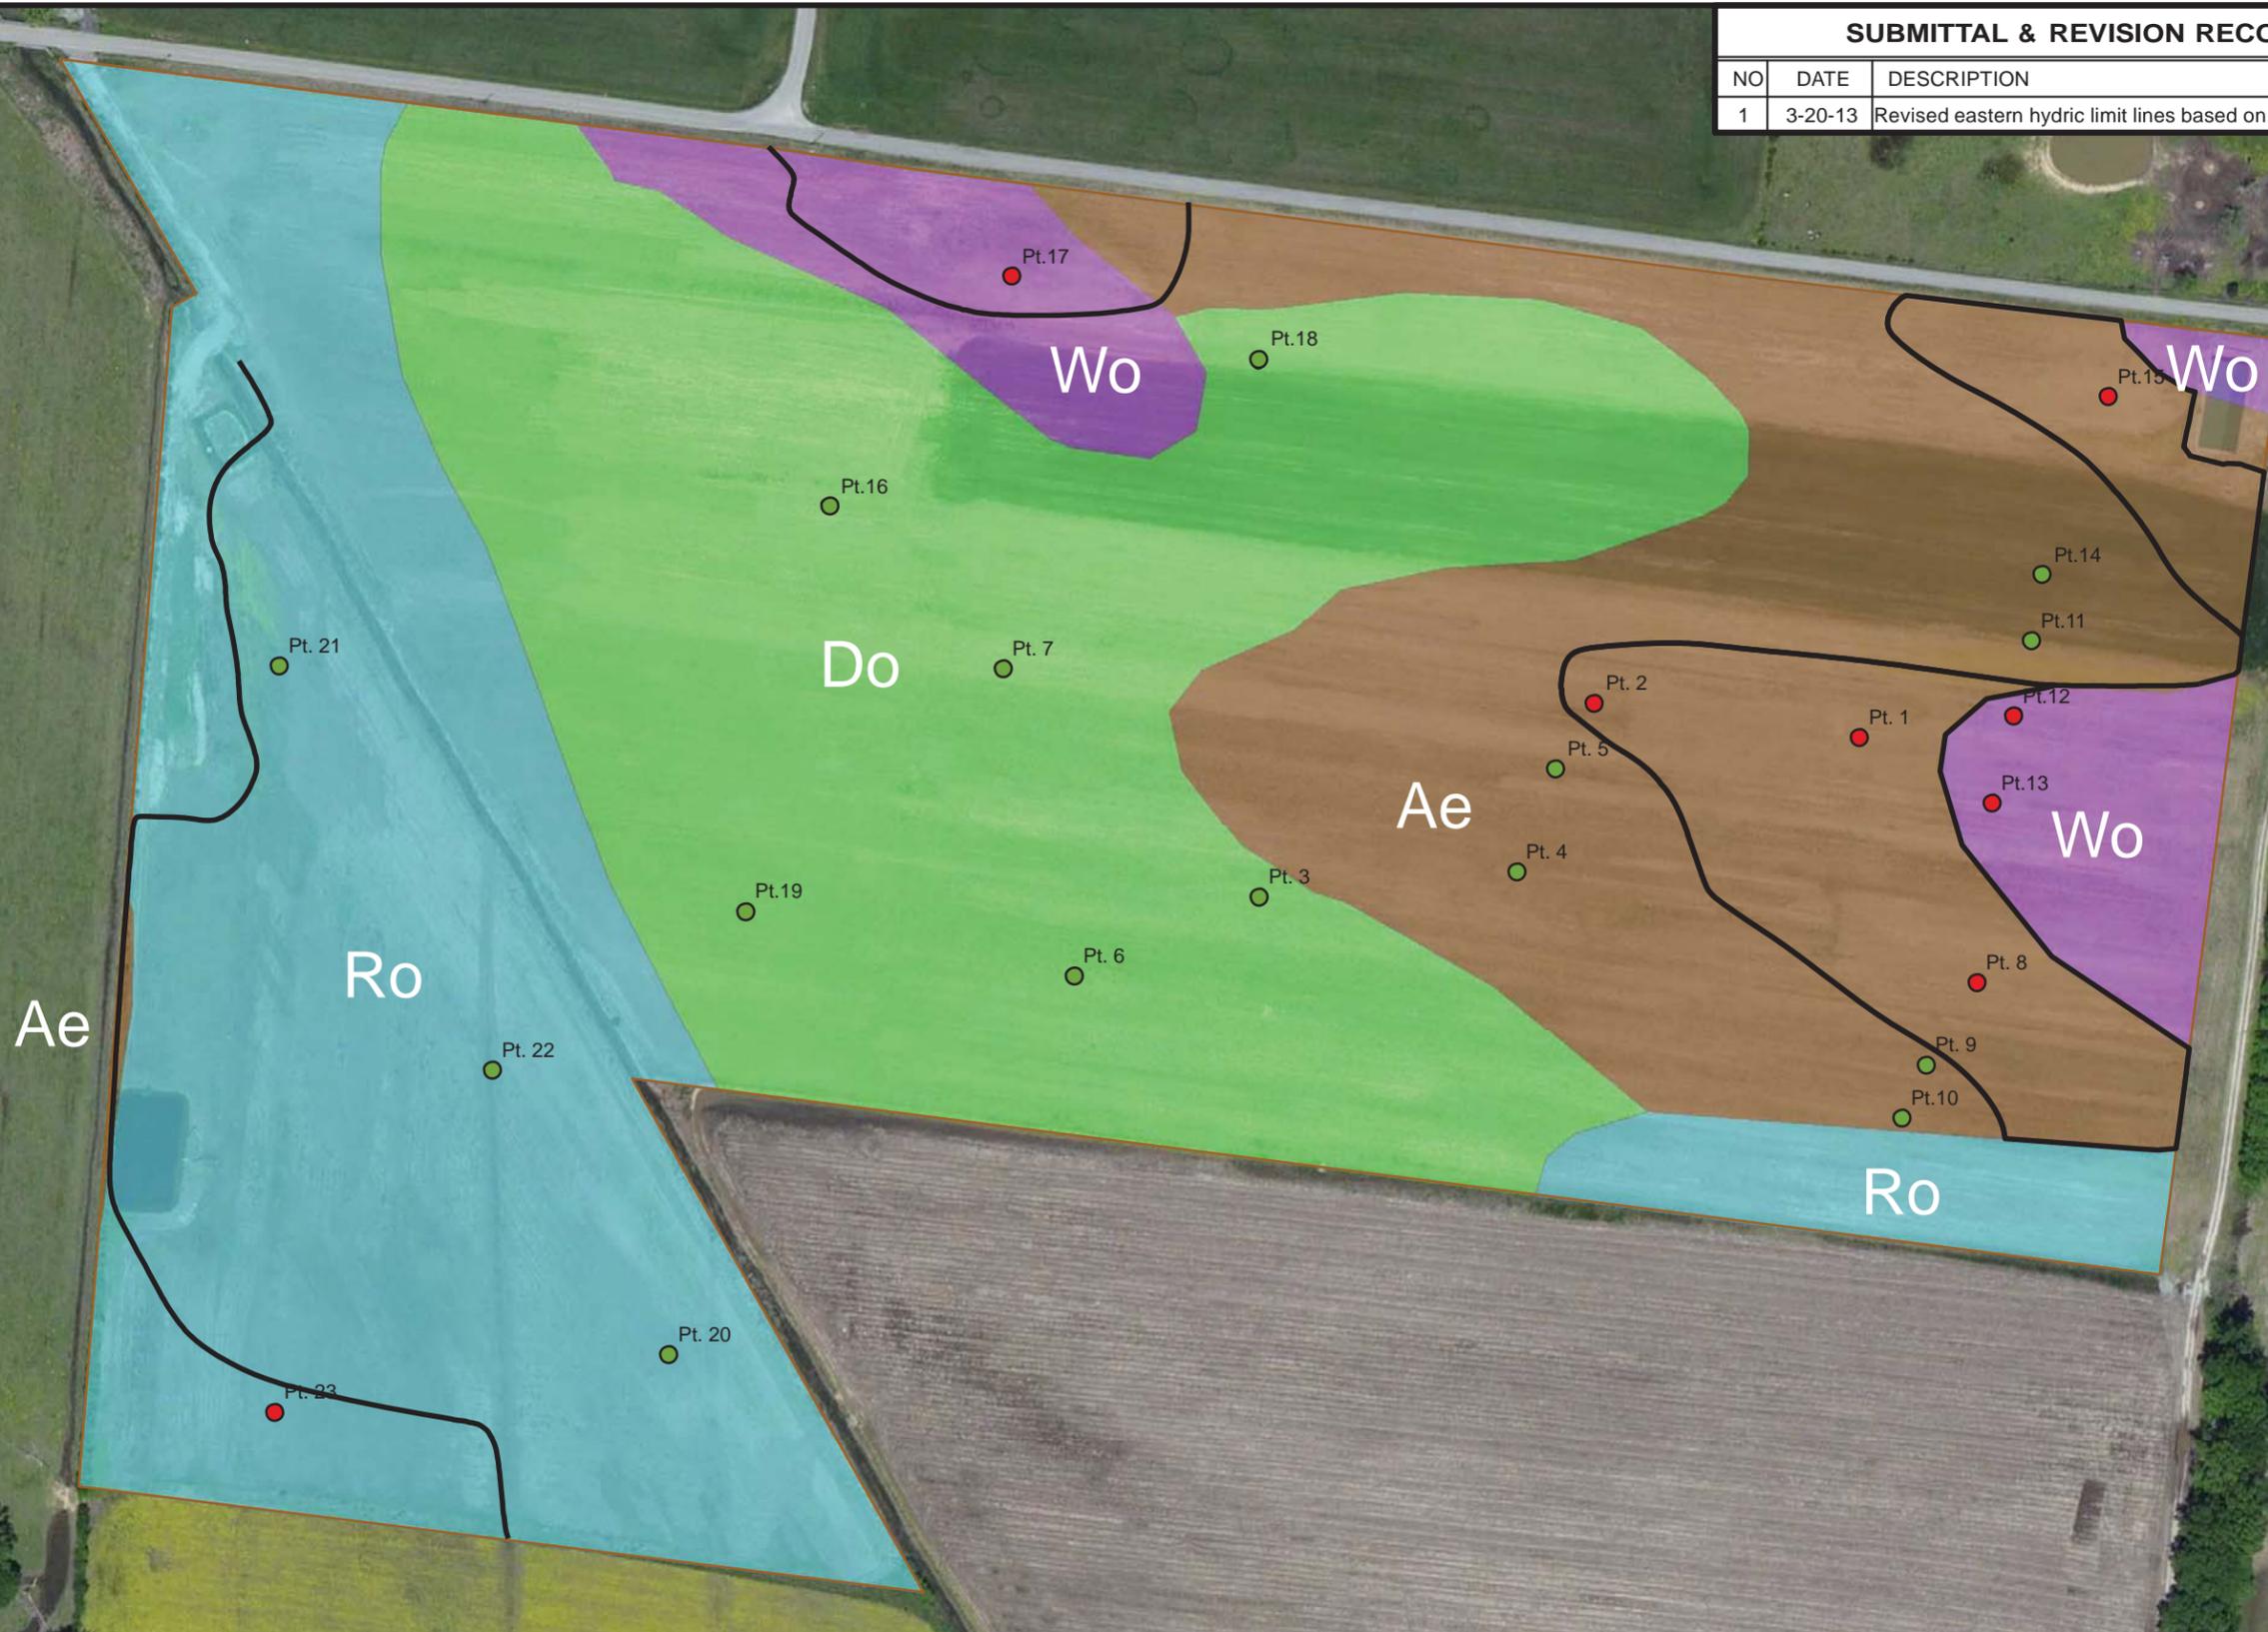
NO	DATE	DESCRIPTION
1	3-20-13	Revised eastern hydric limit lines based on Agency review.

- hydric_Limits_export
- Revised_HydricLimit_Polygons

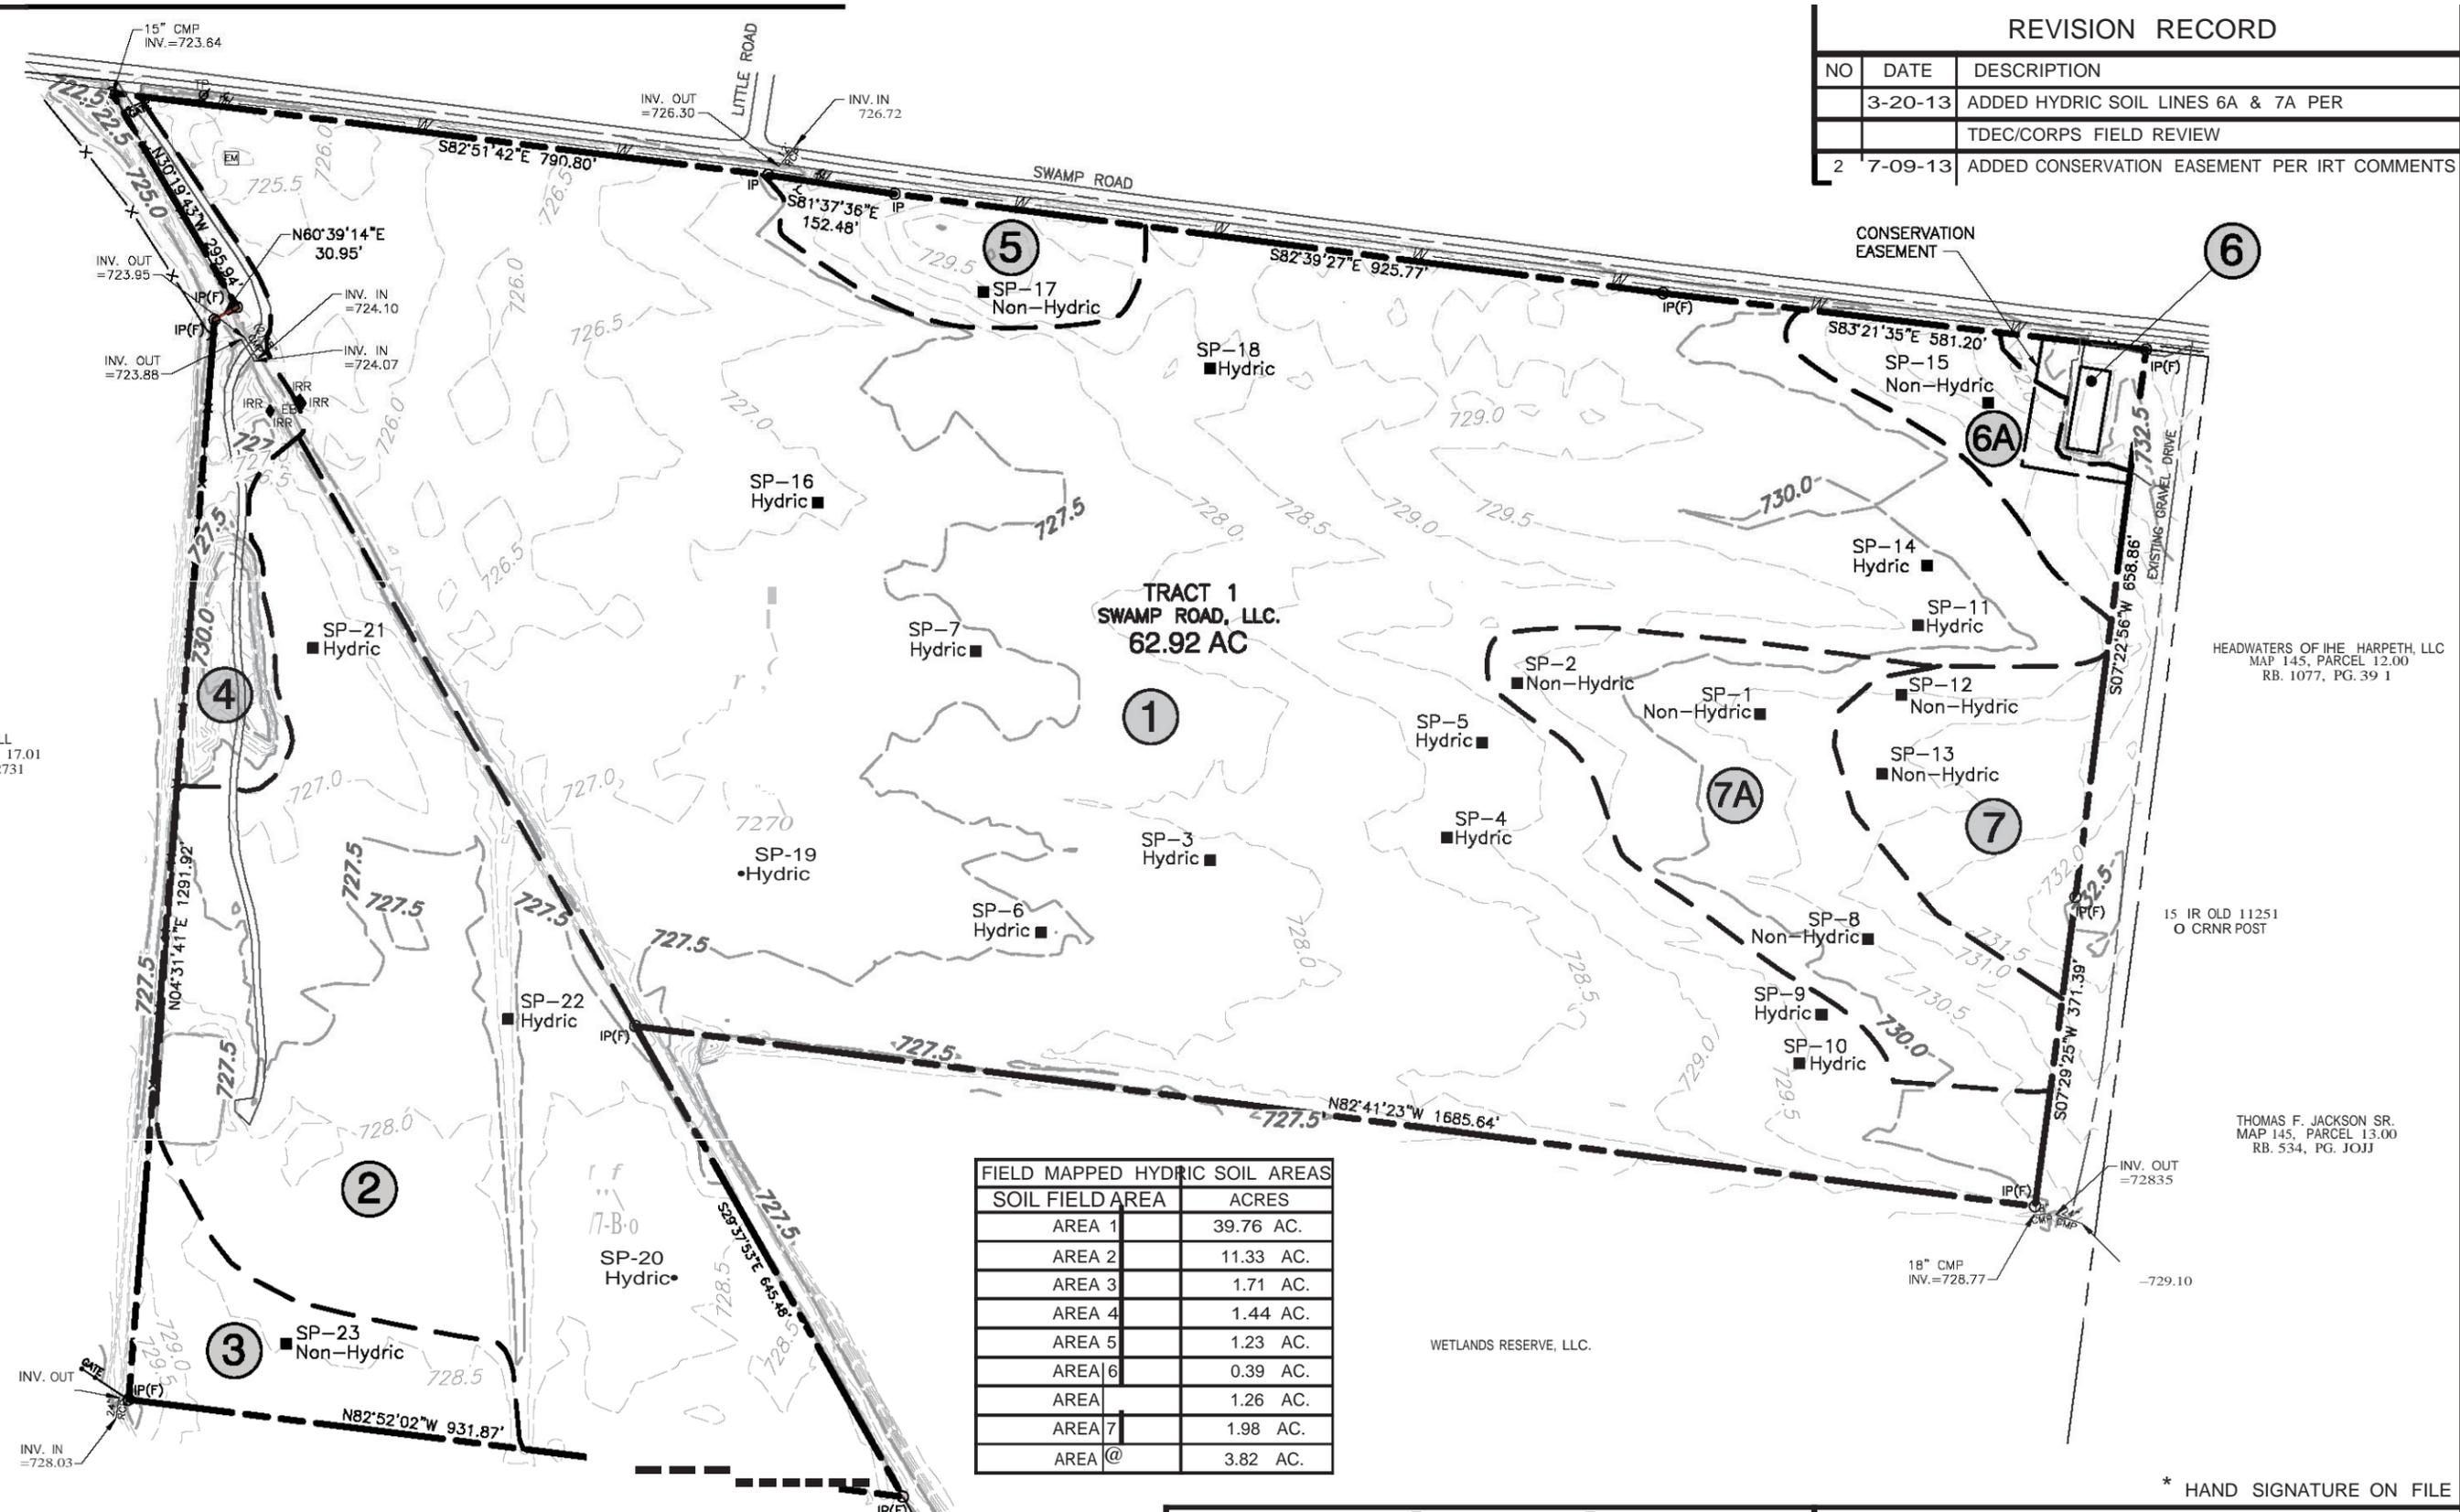
REVISION RECORD		
NO	DATE	DESCRIPTION
	3-20-13	ADDED HYDRIC SOIL LINES 6A & 7A PER TDEC/CORPS FIELD REVIEW
2	7-09-13	ADDED CONSERVATION EASEMENT PER IRT COMMENTS

FIELD MAPPED HYDRIC SOIL AREAS	
SOIL FIELD AREA	ACRES
AREA 1	39.76 AC.
AREA 2	11.33 AC.
AREA 3	1.71 AC.
AREA 4	1.44 AC.
AREA 5	1.23 AC.
AREA 6	0.39 AC.
AREA 7	1.26 AC.
AREA @	3.82 AC.

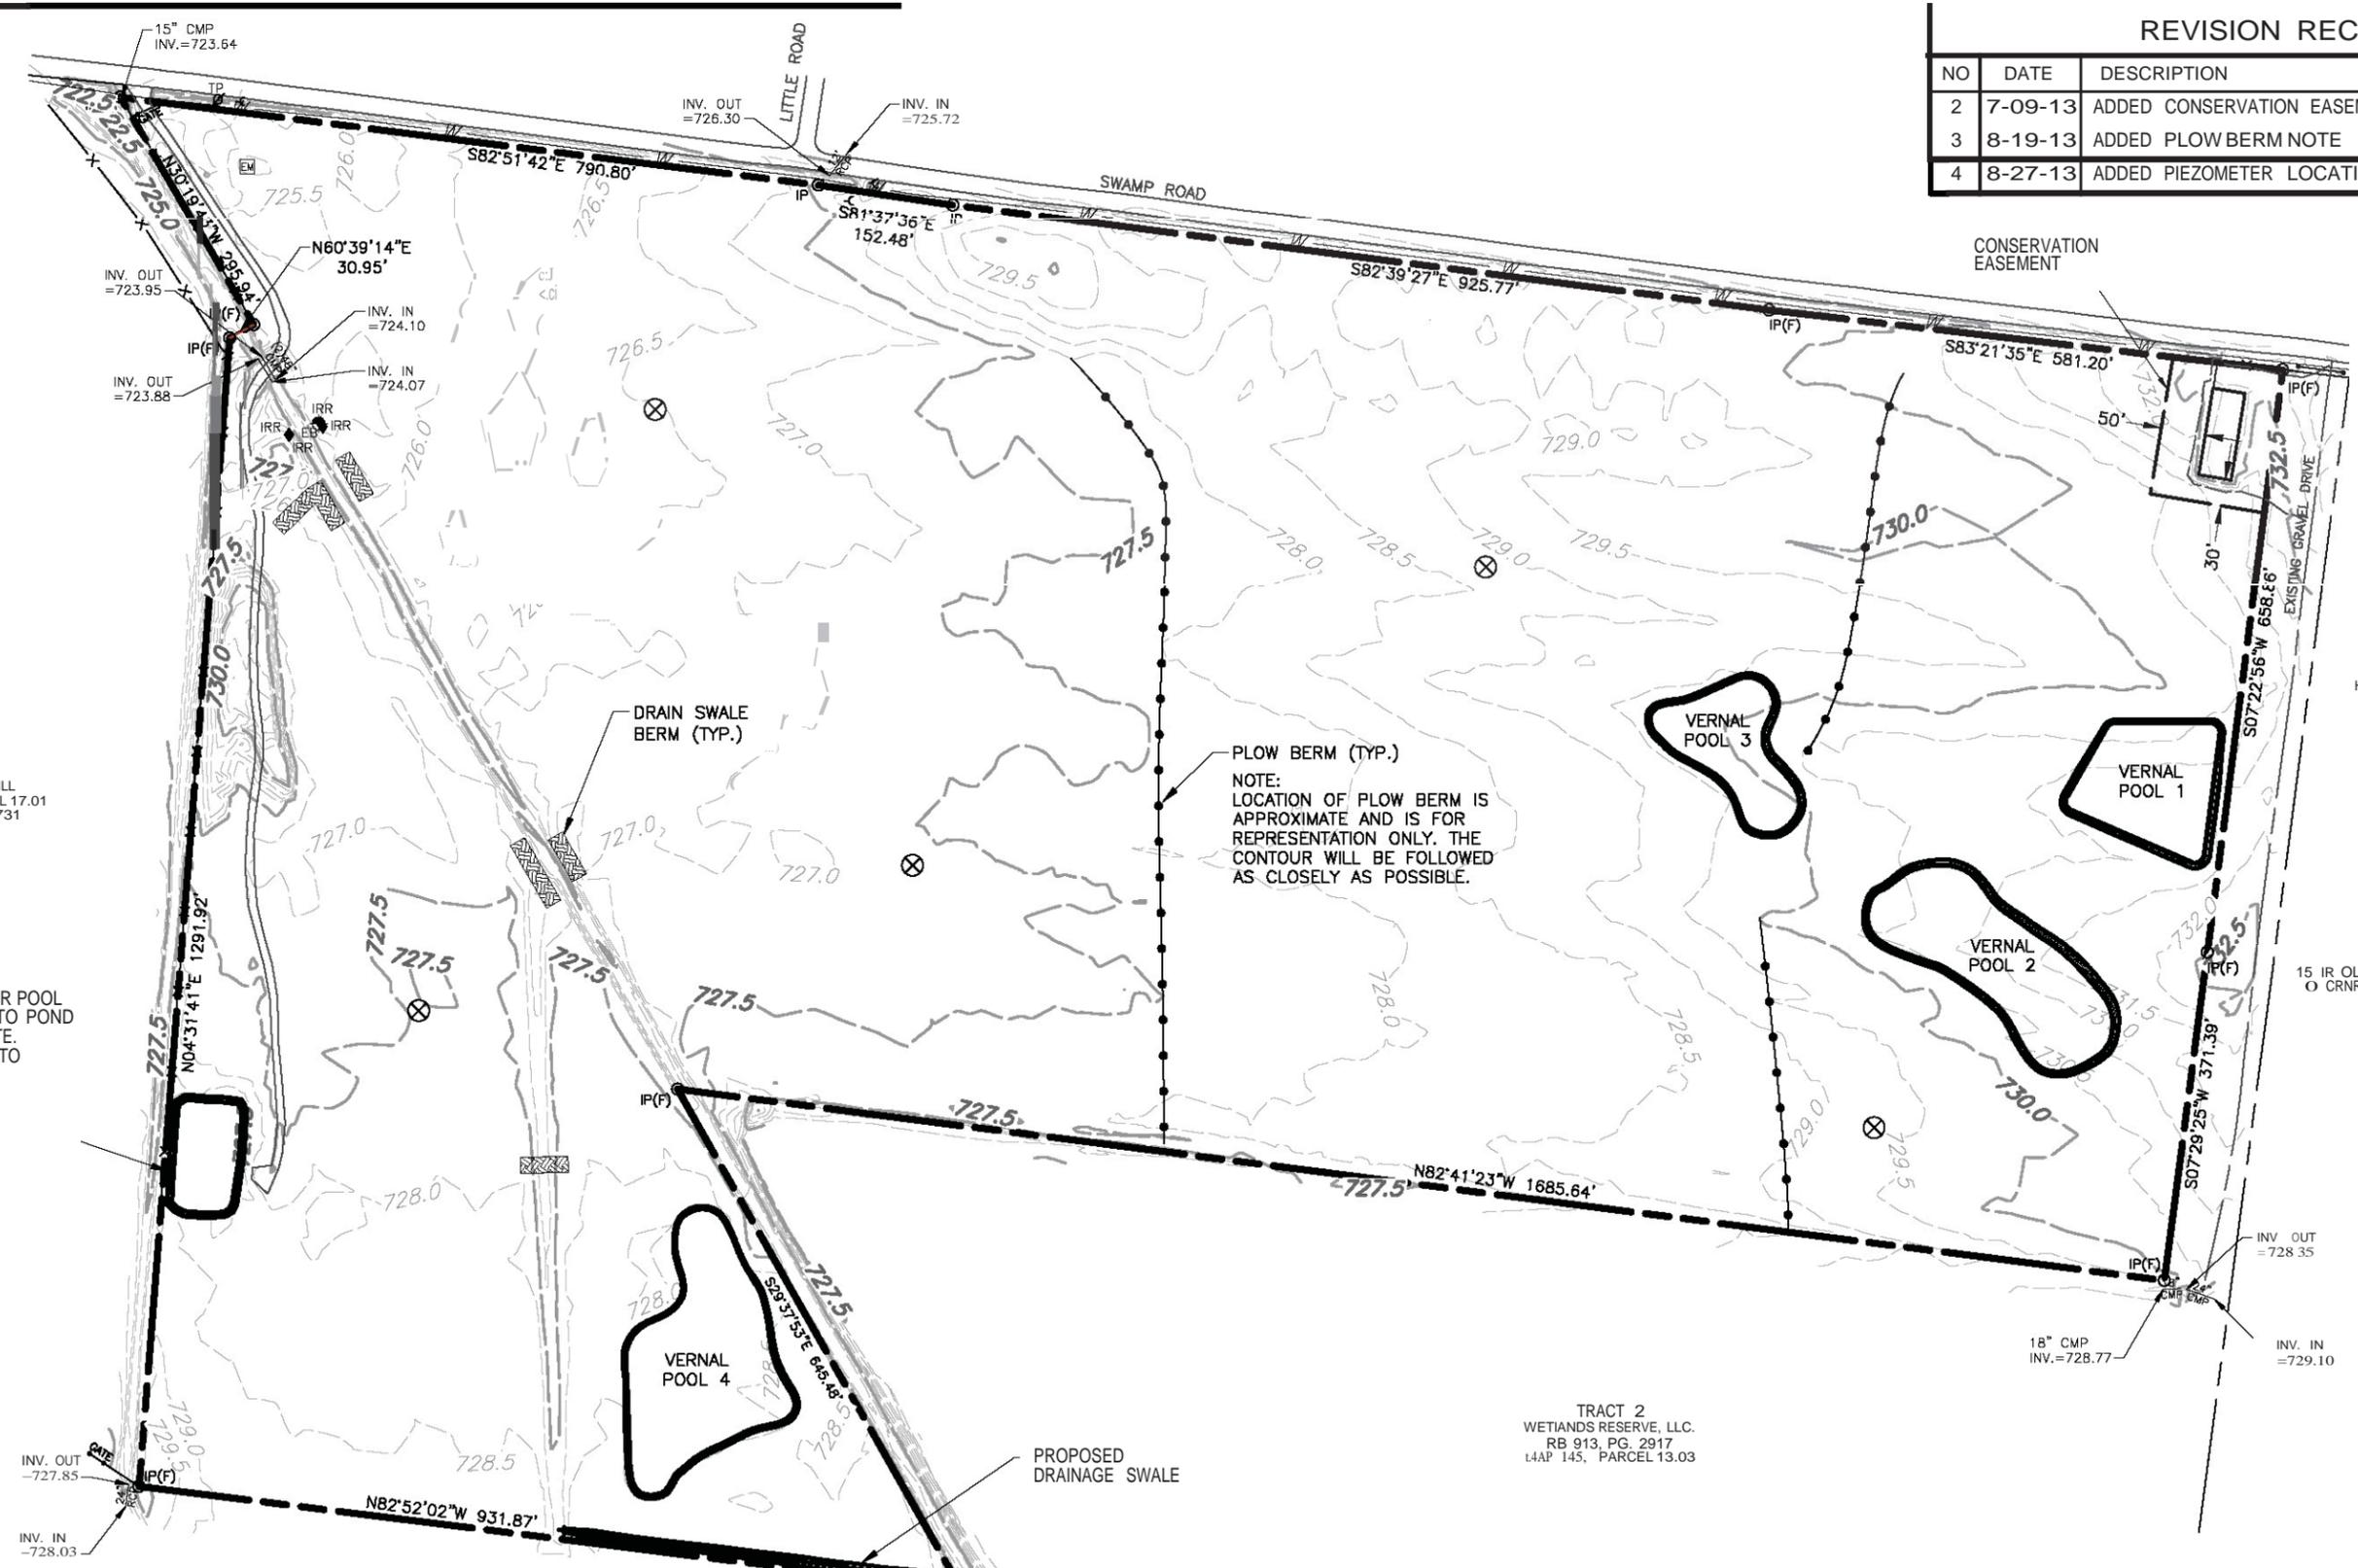
REVISION RECORD		
NO	DATE	DESCRIPTION
2	7-09-13	ADDED CONSERVATION EASEMENT PER IRT COMMENTS
3	8-19-13	ADDED PLOW BERM NOTE
4	8-27-13	ADDED PIEZOMETER LOCATION

LEGEND	
	EXI5nNG CONTOURS
	PROPERTY UNE
	ADJOINING PROPERTY UNE
	EXI5nNG GRAVEL DRIVE
	EXI5nNG EDGE OF PAVEMENT
	WOODEN FENCE
	OVERHEAD ELECT.
	PLOW BERM
	DRAINAGE SWALE BERM
	OIP(F) IRON PIN (FOUND)
	GUY WIRE
	FENCE POST
	UTILITY POLY
	ELECTRIC METm
	IRRIGATION VALVE
	TELEPHONE PEDESTAL
	WELL
	APPROX. PIEZOMETER LOCATION

The restoration of the site would be accomplished in two phases consisting of the hydrological modifications (i.e. berm construction, isolated pool development, and drainage swale blockage) and reforestation and vegetation establishment. The turf grass sod will be harvested prior to any modifications to the site. Following sod harvesting, small berms will be constructed adjacent to pond ditch along the western boundary and along the northern boundary within existing drainage swales as soon as conditions are dry enough so that areas of emergent wetland habitat can develop. A second interior plow berm will be constructed from south to north about the center of the site to slow the surface water runoff. Another plow berm will be constructed in the northeast corner of the site along one of the drainage swales. The berms will be no higher than 2.0 ft. and will serve to capture surface runoff and provide longer saturation times following rain events. Shallow (less than 18 inches) isolated depression zones (i.e. pools) will be excavated randomly throughout the Woodmont and Almaville soil map area and within the non-hydric field mapped areas to create some additional amphibian habitat zones. The remainder of the emergent amphibian habitat will be located close to each berm.

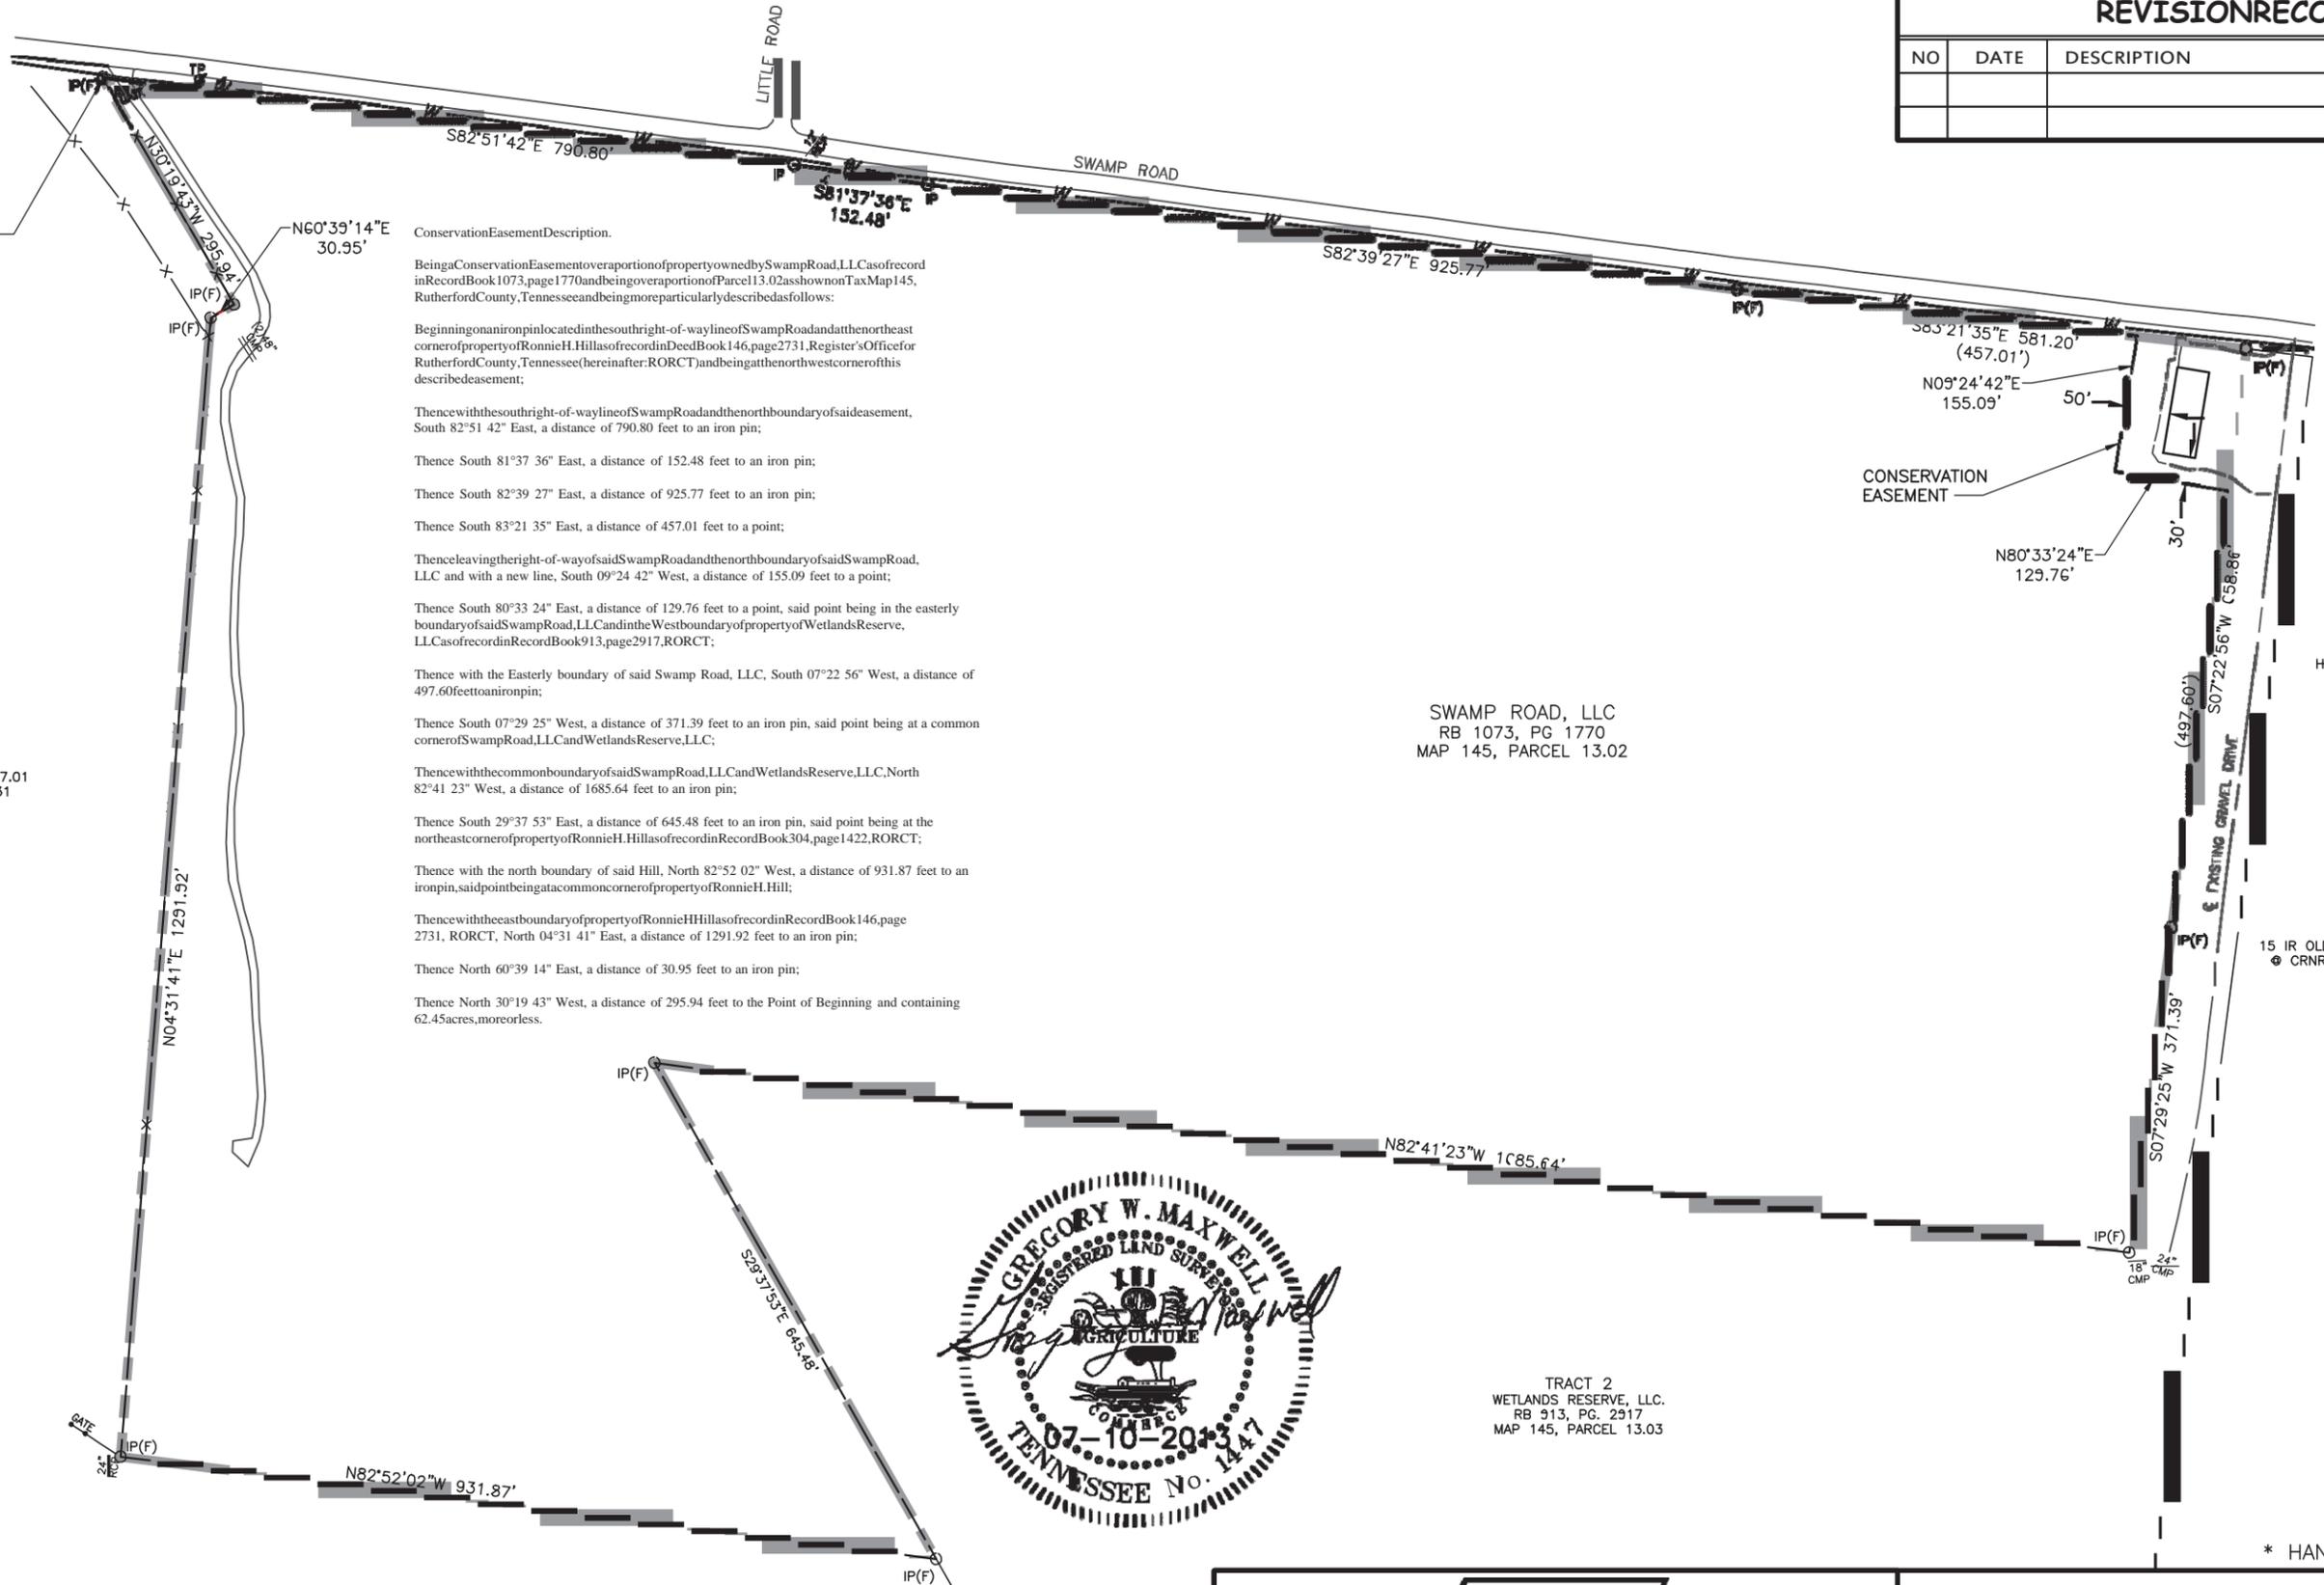
Conservation Easement Description.
 Being a Conservation Easement over a portion of property owned by Swamp Road, LLC as of record in Record Book 1073, page 1770 and being over a portion of Parcel 13.02 as shown on Tax Map 145, Rutherford County, Tennessee and being more particularly described as follows:
 Beginning on an iron pin located in the south right-of-way line of Swamp Road and at the northeast corner of property of Ronnie H. Hill as of record in Deed Book 146, page 2731, Register's Office for Rutherford County, Tennessee (hereinafter: RORCT) and being at the northwest corner of this described easement;
 Thence with the south right-of-way line of Swamp Road and the north boundary of said easement, South 82°51'42" East, a distance of 790.80 feet to an iron pin;
 Thence South 81°37'36" East, a distance of 152.48 feet to an iron pin;
 Thence South 82°39'27" East, a distance of 925.77 feet to an iron pin;

Thence South 83°21'35" East, a distance of 457.01 feet to a point;
 Thence leaving the right-of-way of said Swamp Road and the north boundary of said Swamp Road, LLC and with a new line, South 09°24'42" West, a distance of 155.09 feet to a point;
 Thence South 80°33'24" East, a distance of 129.76 feet to a point, said point being in the easterly boundary of said Swamp Road, LLC and in the West boundary of property of Wetlands Reserve, LLC as of record in Record Book 913, page 2917, RORCT;
 Thence with the Easterly boundary of said Swamp Road, LLC, South 07°22'56" West, a distance of 497.60 feet to an iron pin;
 Thence South 07°29'25" West, a distance of 371.39 feet to an iron pin, said point being at a common corner of Swamp Road, LLC and Wetlands Reserve, LLC;
 Thence with the common boundary of said Swamp Road, LLC and Wetlands Reserve, LLC, North 82°41'23" West, a distance of 1685.64 feet to an iron pin;
