**Modification Number One  
Mitigation Banking Instrument  
Water Resources, LLC  
Lick Creek Wetland Mitigation Bank Number 2  
Greene County, Tennessee**

**May 5, 2015**

**Water Resources, LLC  
4208 Eiffel Lane  
Knoxville, TN 37938-2943**

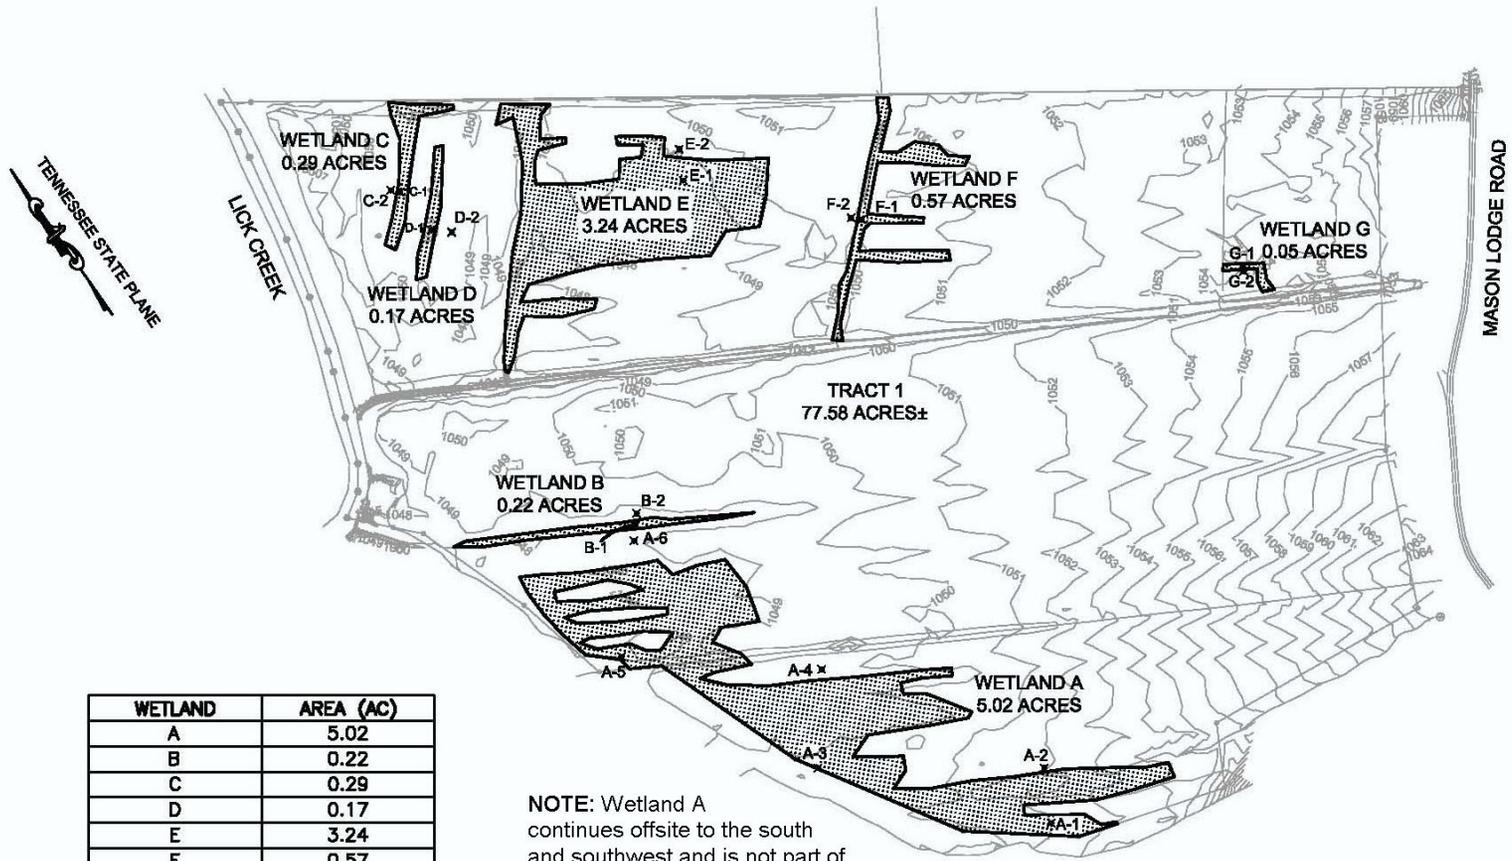
**FIGURE- 2 WETLAND MAP**

WETLAND	AREA (AC)
A	5.02
B	0.22
C	0.29
D	0.17
E	3.24
F	0.57
G	0.05
<b>TOTAL</b>	<b>9.56</b>

NOTE: Wetland A continues offsite to the south and southwest and is not part of the proposed wetland bank.

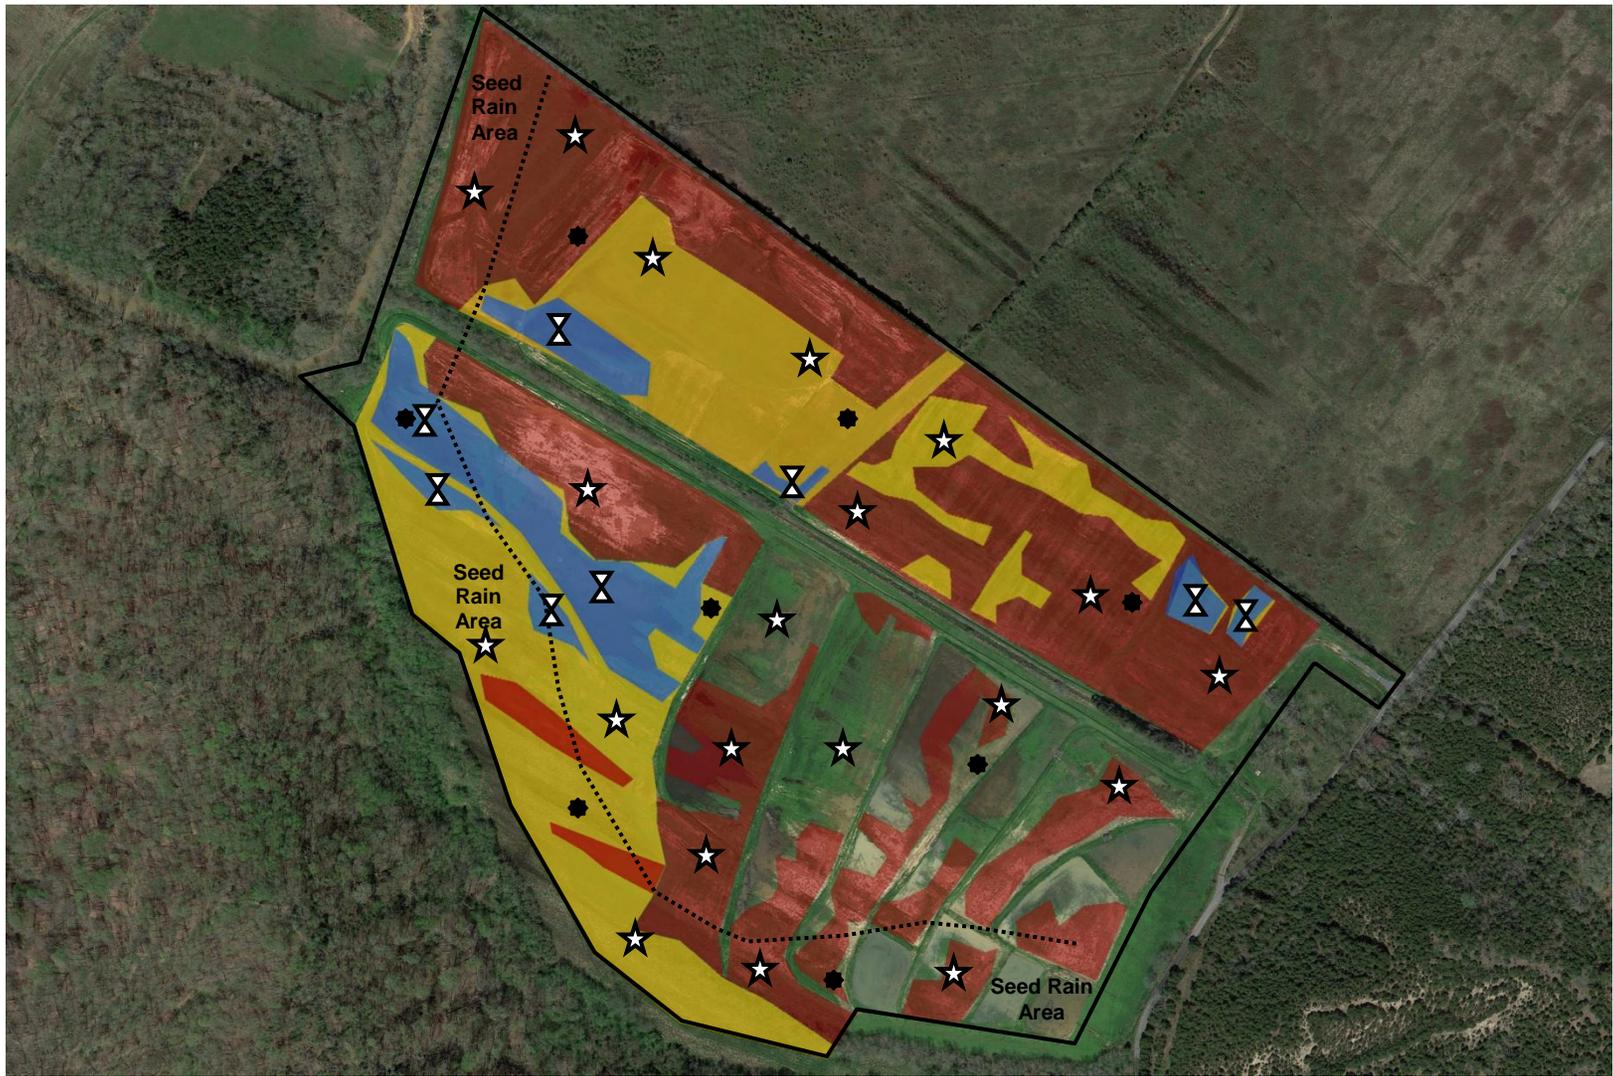
**Figure 4.** Lick Creek Wetland Mitigation Bank 2  
 Adaptive Management: Vegetation Establishment Zones  
 and Sampling Locations  
 Winter/Fall 2015  
 Google Earth © 2014 Google

| | = PFO1 Tree Establishment Areas (28.17 acres) | | = Future PFO1 Tree Establishment Areas (15.61 acres) | | = Groundwater Monitoring Well and Photo-Documentation Point |

monitoring wells. The proposed location of the monitoring wells is shown on Figure 7 in Appendix A. Water Resources recommends biweekly sampling during the first two months of the growing season and monthly thereafter. According to the NRCS National Water and Climate Center website, the average growing season for Greene Co., Tennessee, for the past 30 years, has extended from April 15 through October 23 (NRCS 2011c). While these dates will be used as a general benchmark, actual sampling will begin when soils become warm enough to support biological activity, and when such activity is actually observed (USACE 2010).
