Section IV - Problems, Needs, Opportunities and Study Objectives

The Tennessee Valley Authority completed construction of Chickamauga Lock and Dam in 1940. The U.S. Army Corps of Engineers designed the lock while TVA designed the remainder of the project. Both agencies share jurisdiction for various activities, including navigation, in the Tennessee River Valley. Periodic inspections of the dam and powerhouse are made by TVA personnel. However, both Corps of Engineers and TVA personnel are involved in the periodic inspection of the lock. In addition, the Corps of Engineers, through a January 2000 memorandum of agreement with TVA, is responsible for operation and maintenance costs associated with the existing lock.

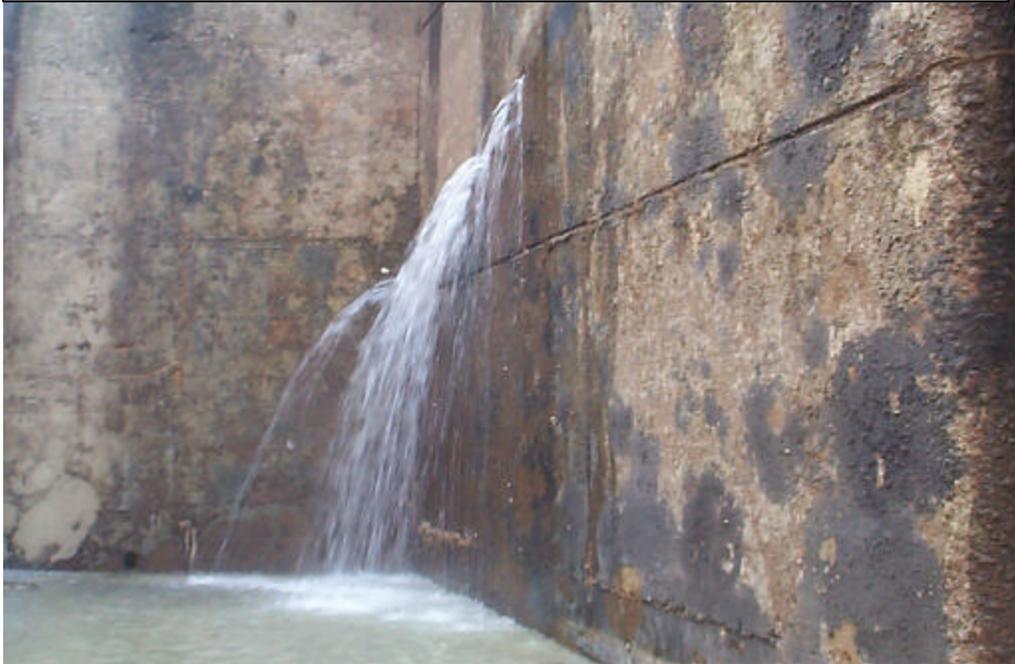
Figure IV-1 - Crack in the upper end of river lock wall during 1999 dewatering.

The Chickamauga project has suffered from the effects of AAR since shortly after completion in 1940. The first inspection of the dam was made in 1943, about 3 ½ years after construction was completed. Initially, surface cracking developed in the spillway deck and a portion of the navigation lock and eventually spread over most of the project. At the lock, major structural cracks have developed in the chamber and approach walls and have required extensive repairs (See Figures IV-1 through IV-3). Instrumentation was also installed to monitor structural movements and internal stresses.

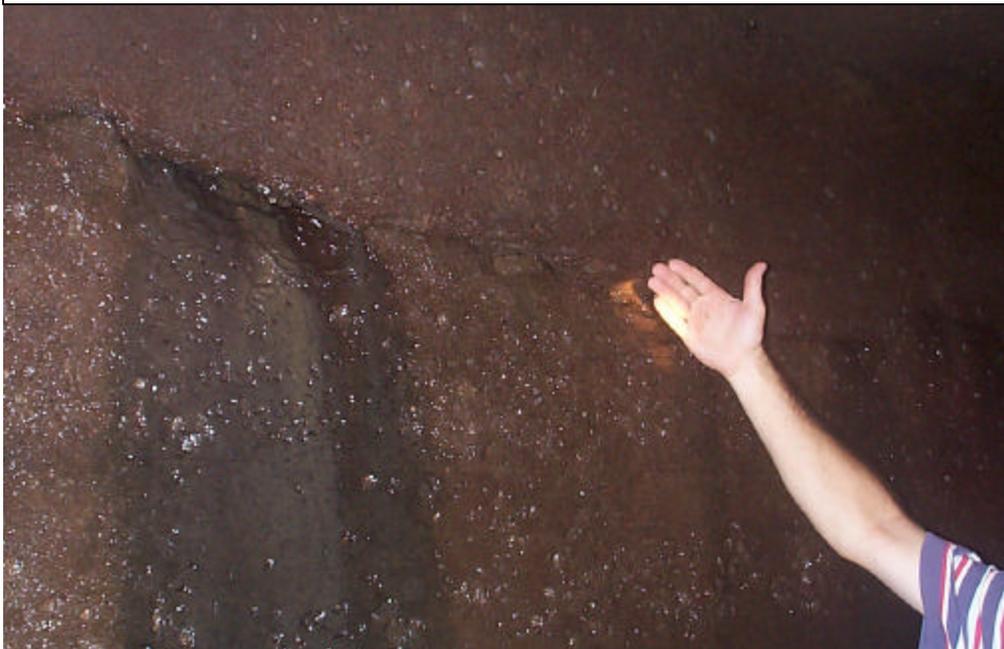
Figure IV-2 - Crack in river wall filling and emptying culvert during 1999 dewatering.

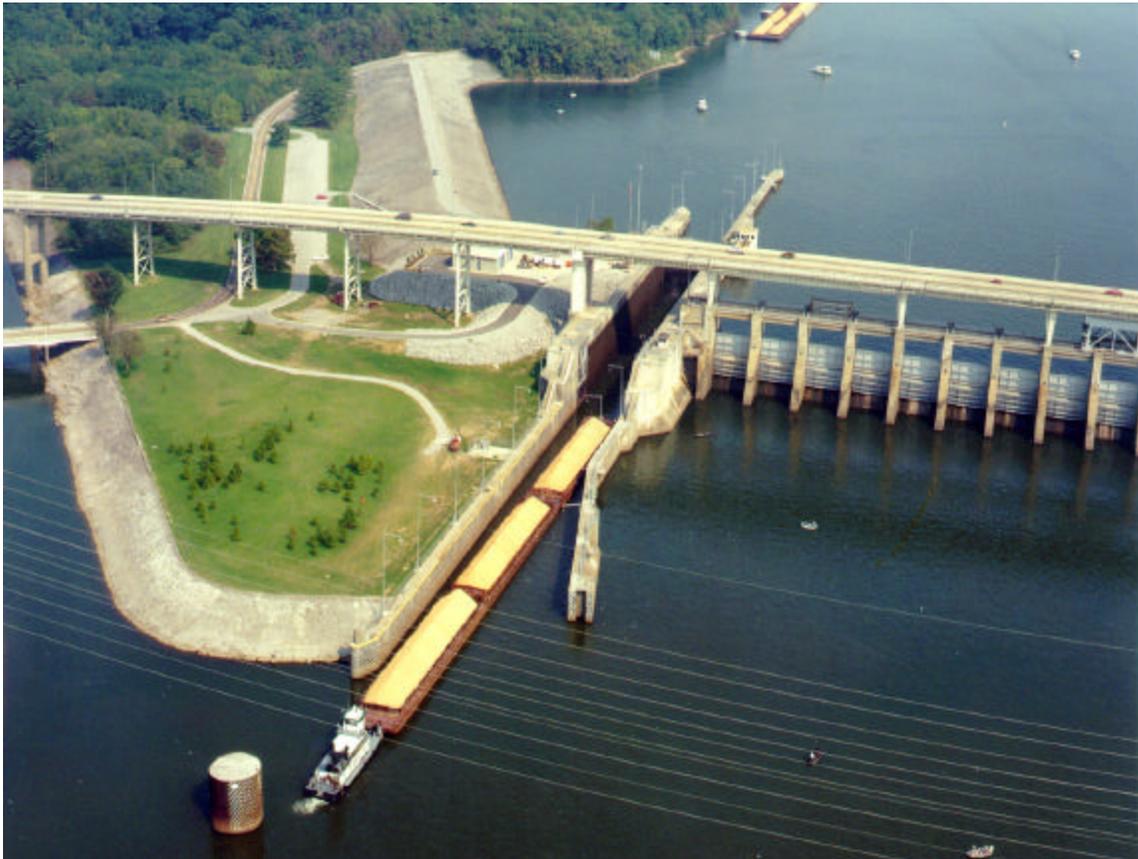
Figure IV-7

Chickamauga Lock, Tennessee River mile 471.0

The Chickamauga Project has only one chamber, measuring 60 feet wide and 360 feet long (See Figure IV-7). The lock was completed in 1940 to accommodate four standard
