APPENDIX A
ONSITE AND OFFSITE BATCH PLANT EVALUATION

SUBJECT: On-site versus Off-Site Concrete Batch Plant Analysis and Quarry Locations
Center Hill Dam Seepage Repair Project, DeKalb County, Tennessee

SEEPAGE AND REHABILITATION PROJECT CENTER HILL DAM AND LAKE DEKALB COUNTY, TENNESSEE

Prepared by:
U.S. Army Corps of Engineers, Nashville District
Project Planning Branch
Environmental Section

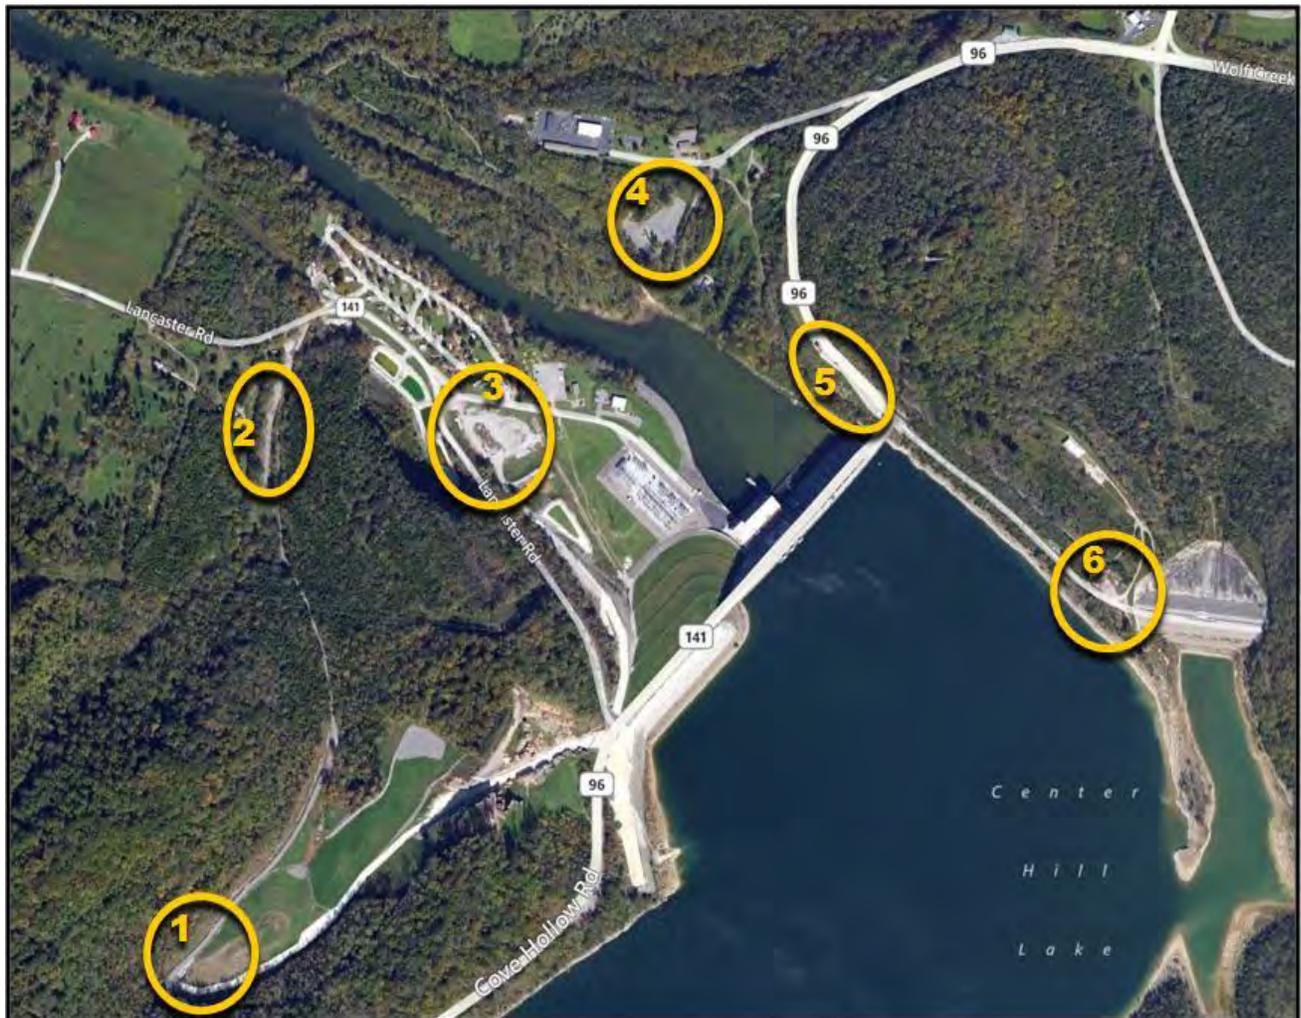
Figure 1. Center Hill Lake Project and Alternative On-Site Batch Plant Locations.

An on-site batch plant can meet the minimum forty-five (45) minutes engineering time requirements noted in Section 4. Delivery time would be minimal. Alternative on-site batch plant locations were identified (Figure 4). Each site was considered and observations noted in Table 2.

Six potential on-site batch plant locations were considered. Each on-site batch plant location would have issues due to several reasons. Three sites (1, 2, and 3) are currently committed for other uses under the barrier wall construction. Two sites (4, 5) are not practical due to public safety and emergency response conflicts. One site (6) may be used for saddle dam repairs which may select a different repair alternative that requires a unique type of batch plant. Additional on-site concerns include limited space and issues related to local delivery of materials to produce concrete on site. Traffic and related noise and safety considerations would be more adverse with an on-site batch plant that could endanger campers, fishermen, and boaters visiting the project site.

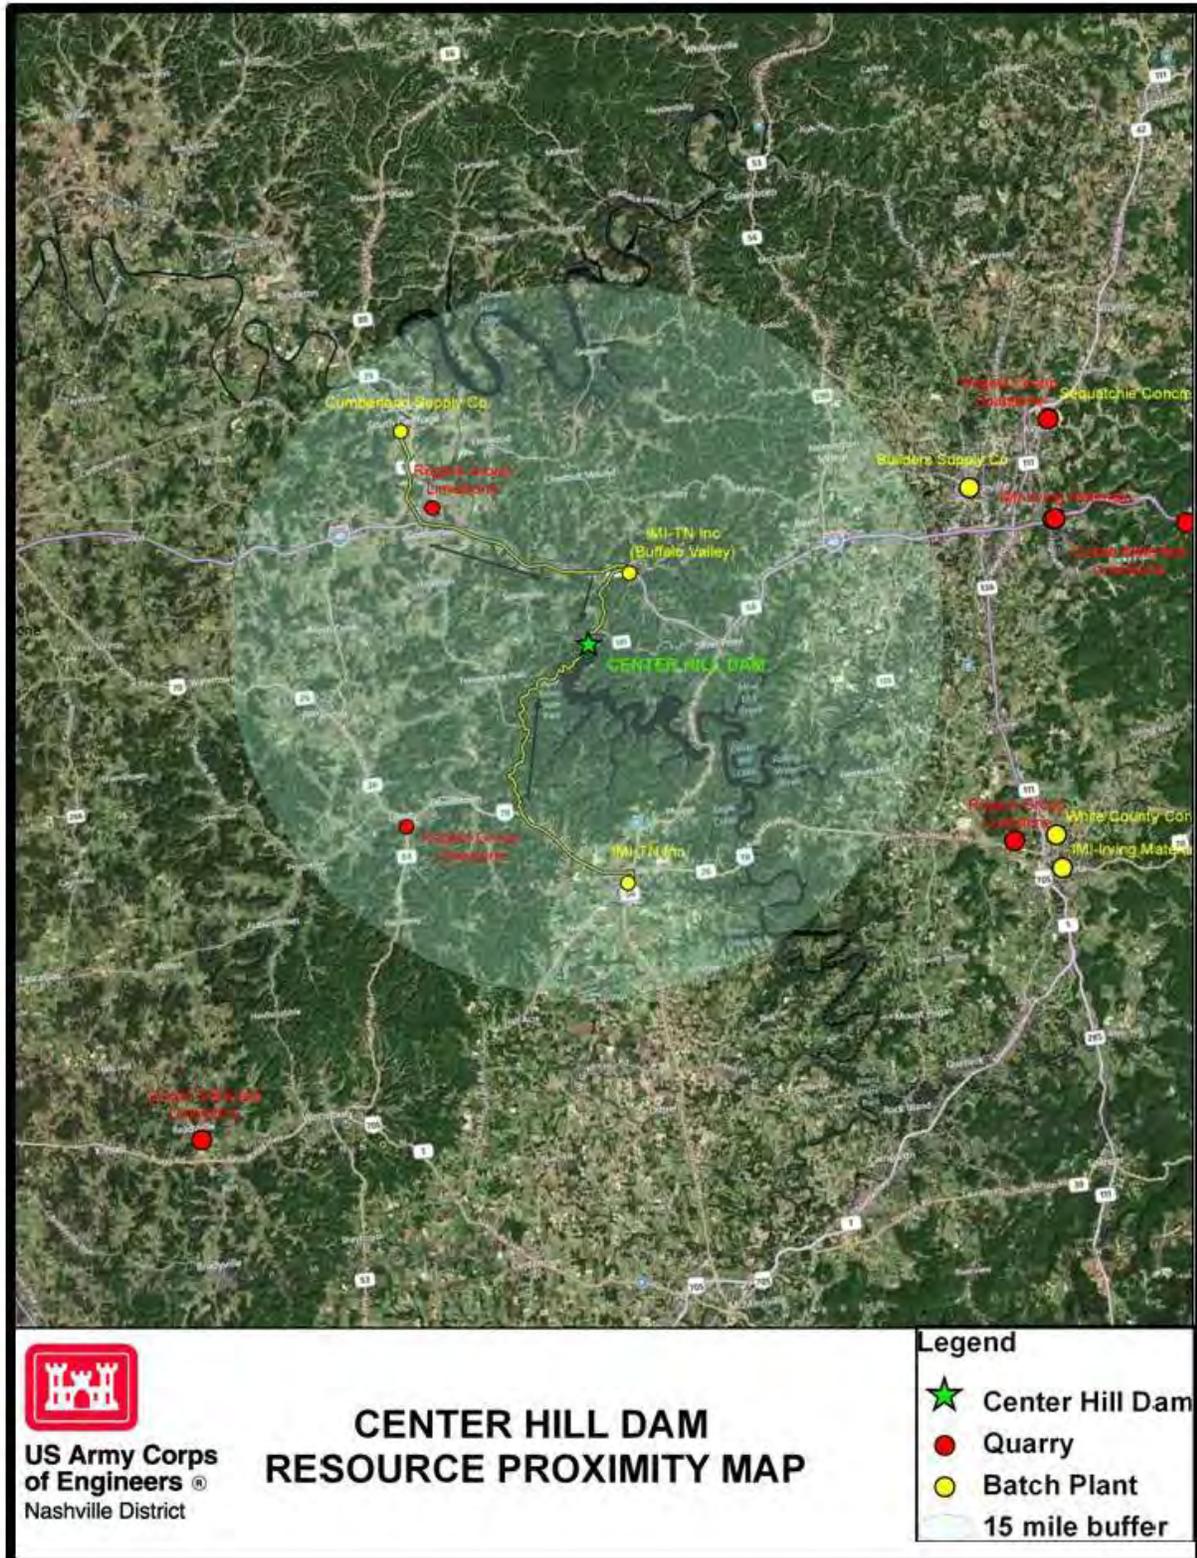
Figure 2. Quarry and Batch Plant Locations Near Center Hill Dam and Lake. Critical 15-mile radius marked.

Concrete trucks from an off-site plant would be required to meet the 45-minute engineering time requirement. Three batch plants have the potential to meet this time, although additional approval will be needed. For each of these batch plants the local communities would experience increased noise and traffic over the estimated 2.5 year life of the barrier wall construction project.

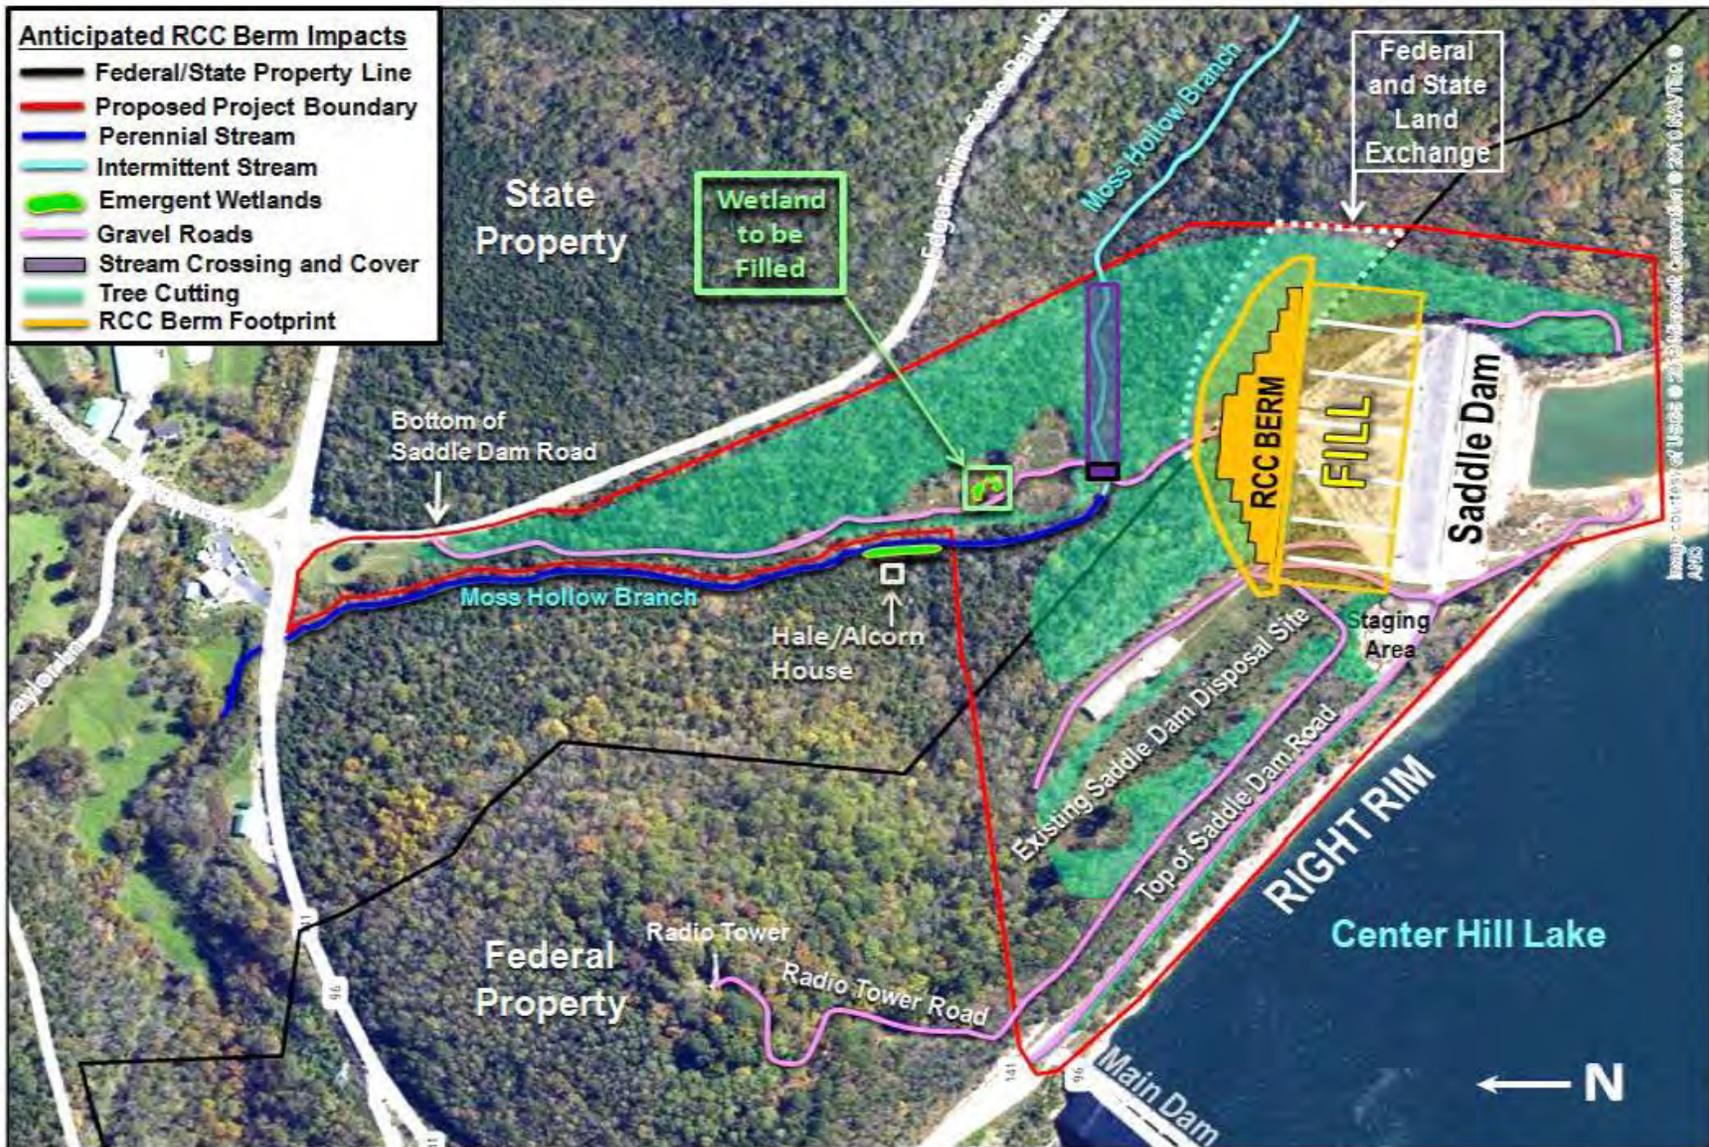
Figure 2. Right Rim Resources and Proposed Construction Features.

Table 2 provides a list of natural resources and permanent open space features (roads, grout lines, buildings, and dam footprints). Temporary open space was created by the existing fields and scrub brush and the disposal areas. Temporary open space would be allowed to revert to forest habitat via natural succession or planted with tree seedlings to replace forest habitat lost to construction of the RCC Berm alternative and left rim stabilization, sinkhole repairs, and dam safety clearing. In time, the project would look similar to pre-construction condition. Minor differences would include a permanent grassed area in the dam safety clearing zone, closed (filled then grassed) treatment ponds, and the RCC Berm. All other affected areas would eventually revert to forest. Affected resources are shown for the right and left rims in Figure 2 and Figure 3.

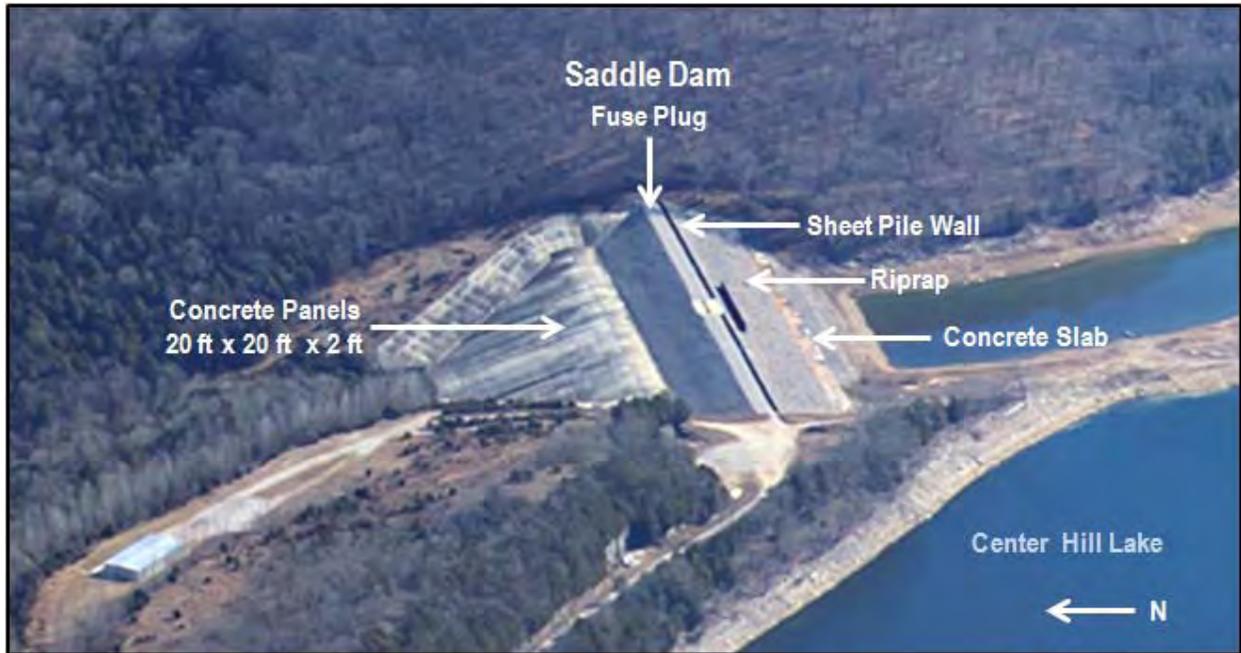
Figure 2. Existing Saddle Dam Layout at Center Hill Dam

It would be a solid concrete structure constructed with layers of compacted concrete. A 3 ft by 3 ft culvert would be constructed into the base of the RCC Berm to drain water that collects between the saddle dam and RCC Berm.

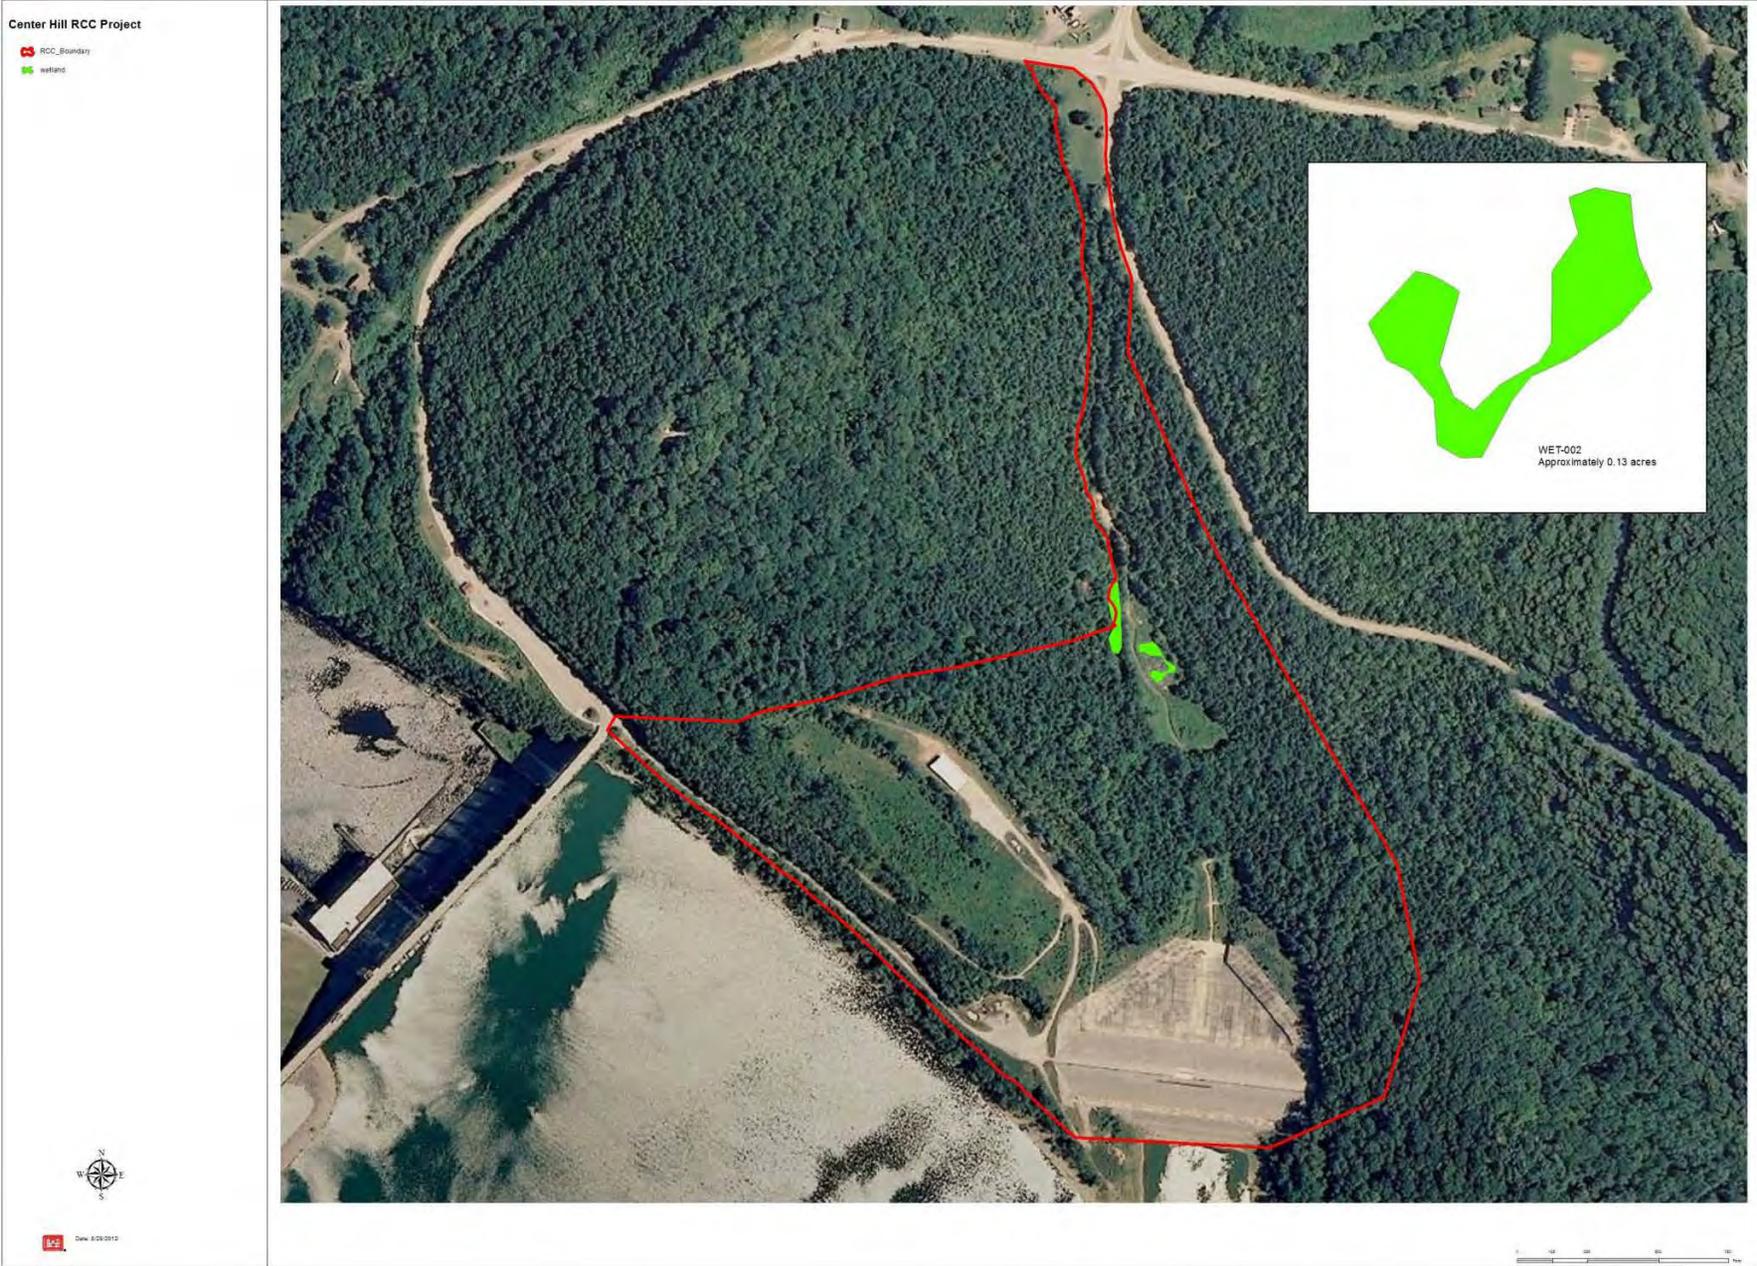
Figure 7. Proposed Fill of WET-002.

Approximately 0.13 acres of WET-002 are proposed to be filled within the proposed project footprint. An erosion control blanket and rock are to be placed over the site to contain any erosion from leaving the site. This would include WET-002. Additionally, this area is to be used
