Wolf Creek Dam Consensus Report Engineering Risk and Reliability Analysis

April 11, 2007

DSAC Class I Dams
Peer Review Panel

Site Visit Photos Referenced in Consensus Report

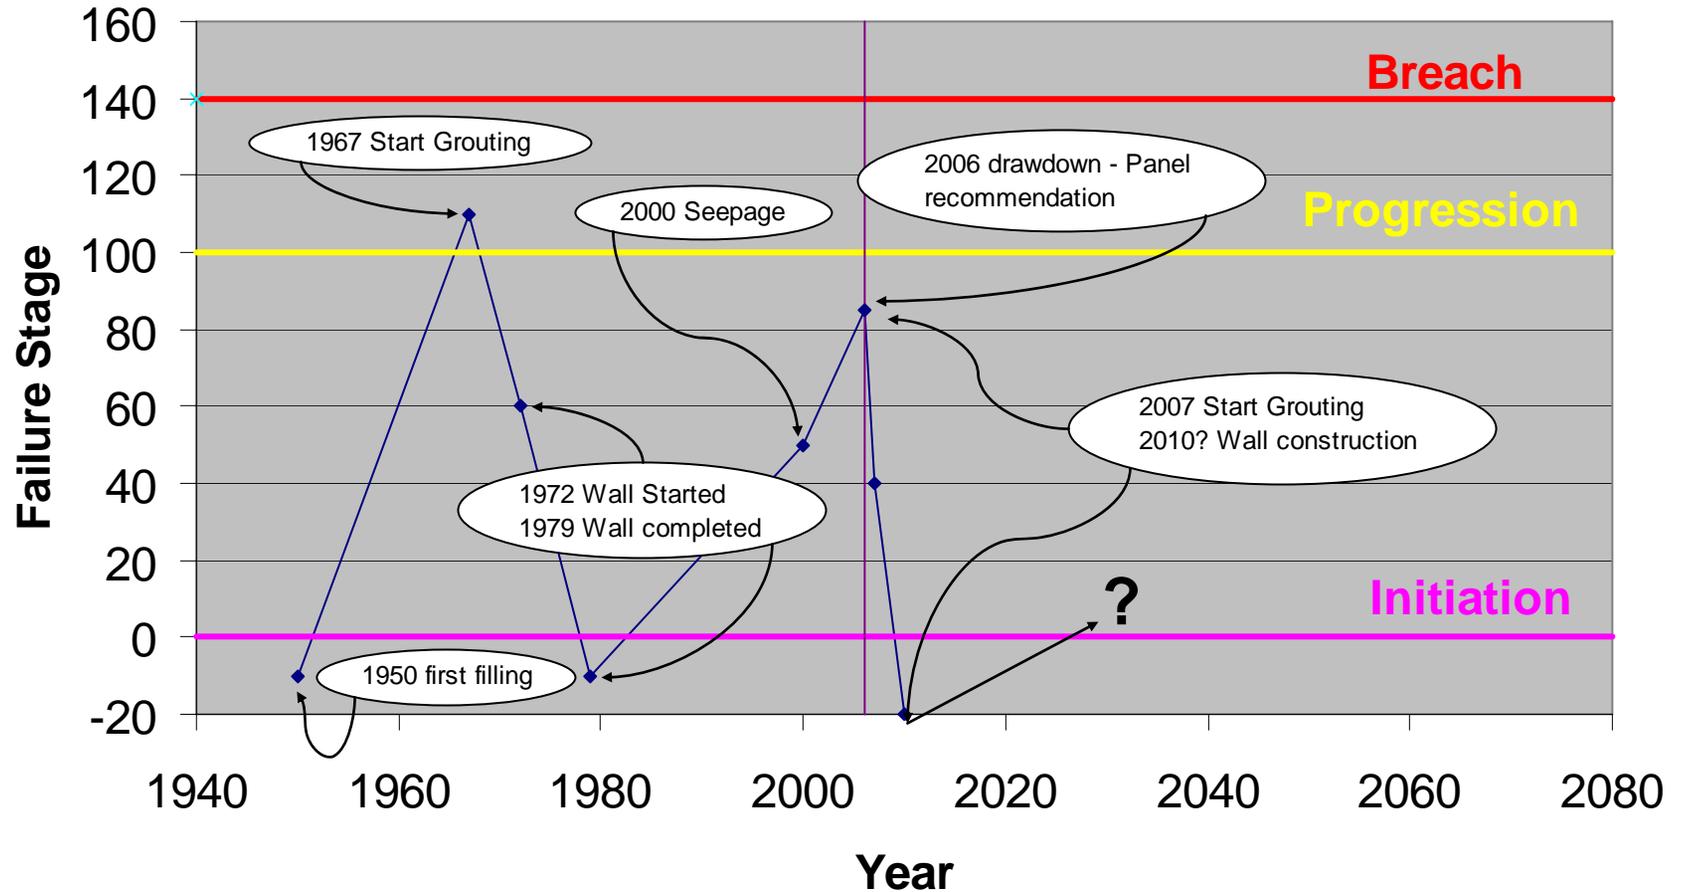
Figure 3: Timeline of Failure Stages

To further clarify the timeline related to the development of a seepage/piping related failure, the Panel has also developed an illustrative histogram whereby the seepage failure stage at Wolf Creek Dam has been given a numerical score and plotted with time. This histogram is shown on Figure 3. A score of zero represents seepage failure initiation and the beginning of the continuation stage of failure development, while the scores of 100 and 140 represent the onset of the Progression and Breach failure stages, respectively. The changes in the failure stage points on the Histogram correspond to times of intervention (remediation) during the life of the project and the subsequent deterioration along the continuum that is occurring. The last data point represents completion of the recently initiated grouting program and construction of the planned new diaphragm wall. This data point is judged commensurate with a score of 20, after which the score is estimated to increase with time, at a rate that will be slower than the rate of deterioration that starts at the completion of the existing diaphragm wall in 1979.

Seepage flow not arrested due to collapse and erosion continues until dam crest is breached due to sinkholes, crest settlement, instability of slopes, or unravelling of the downstream slope

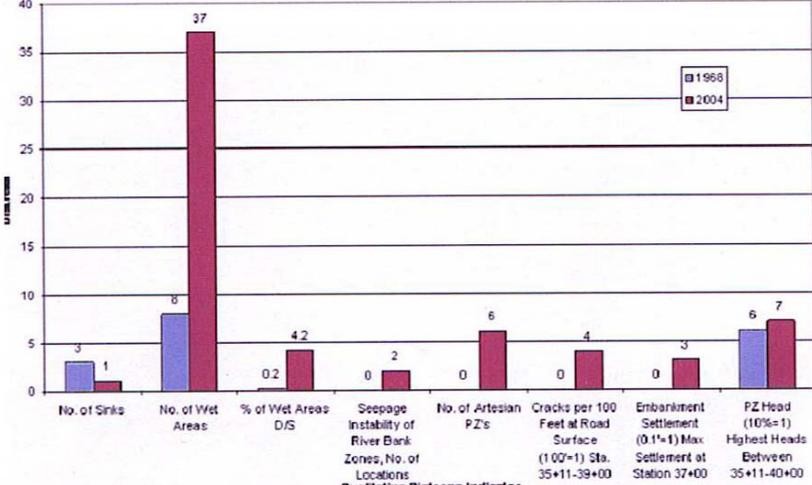
PAGE	QUOTE/CONCLUSION																											
	<p data-bbox="451 241 899 268">3.2.9 Comparison of 1968 and 2004 Distress Indicators.</p> <p data-bbox="451 281 1284 333">As shown on Figure 3-11, a contrast is drawn between the distress indicators from 1968 and 2004. Overall, the type of distress is more varied and extensive in 2004.</p> <div data-bbox="451 373 1263 930"> <p data-bbox="623 373 1097 394" style="text-align: center;">Comparison of Distress Indicators 1968-2004 at Wolf Creek Project</p>

<table><tr> <th>Indicator</th> <th>1968</th> <th>2004</th> </tr><tr> <td>No. of Sinks</td> <td>3</td> <td>1</td> </tr></table>
