**ENVIRONMENTAL ASSESSMENT
SUPPLEMENT 3**

CENTER HILL DAM SEEPAGE REHABILITATION PROJECT

**PROPOSED ROLLER COMPACTED CONCRETE (RCC) BERM
AND MEASURES**

**CENTER HILL DAM AND LAKE
DEKALB COUNTY, TENNESSEE**

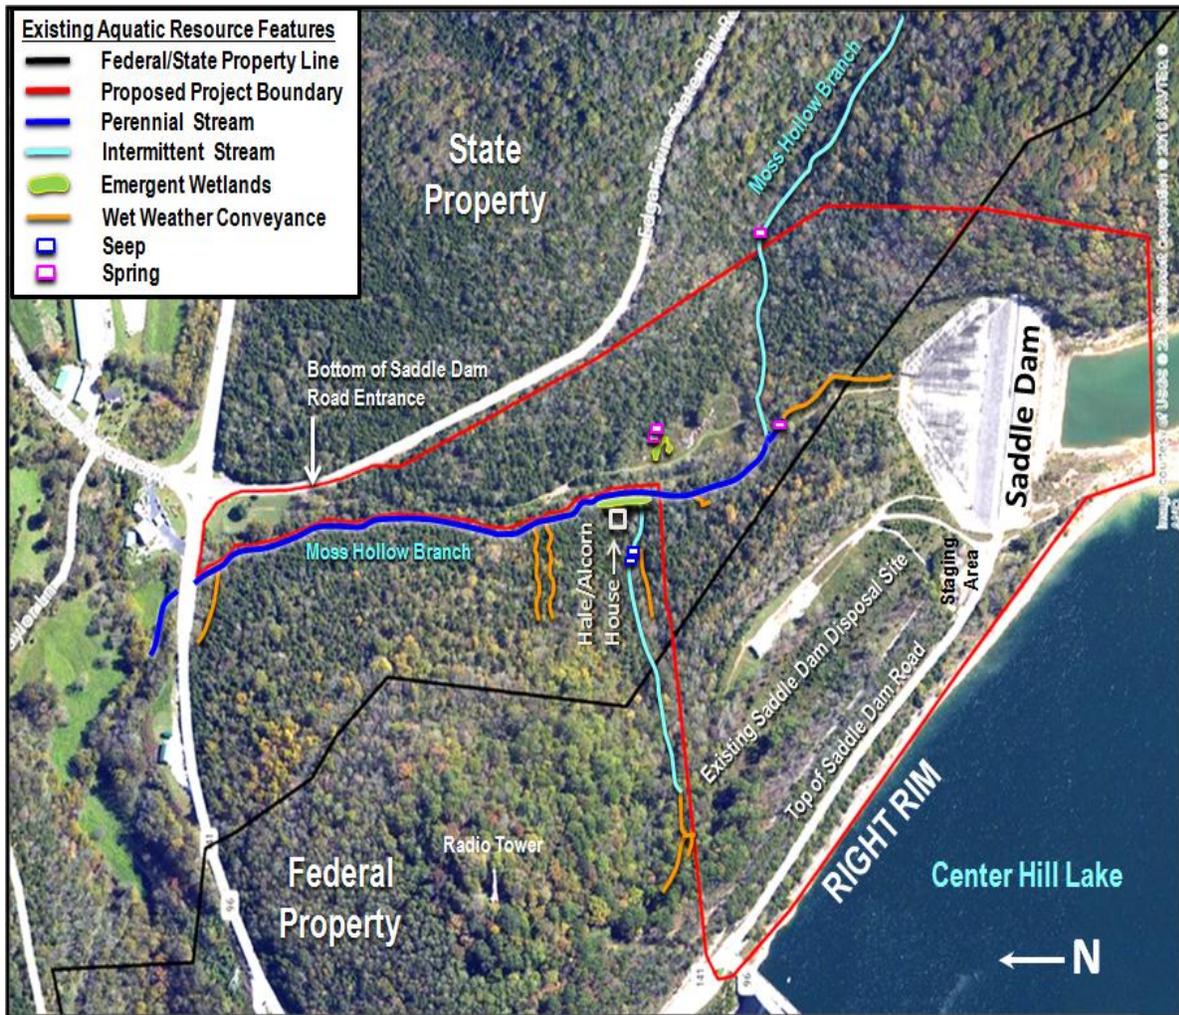
Figure 18. Right Rim – Streams, Wetlands, Springs, Seeps, and WWC/Ephemeral Stream.

On the right rim, approximately 0.34 acre of wetlands has been identified within and adjacent the proposed RCC Berm impact footprint (Figures 18 and Figure 22). Moss Hollow Branch flows through the largest wetland (Wetland 1) which is approximately 0.21 acre. This wetland is classified as a palustrine emergent wetland and is located outside the project footprint and would be avoided. The remaining wetland (Wetland 2) is located within the proposed RCC Berm impact footprint. It is classified as a palustrine emergent wetland. Wetland 2 is a depressional/slope wetland about 0.13 acre in size, and appears to be sustained by seeps. Historic documents show that the valley was farmed and that a barn was located next to Wetland 2. On state acquisition, the Park stockpiled and burned treated timbers on top of Wetland 2. These activities degraded the wetland to its low quality.

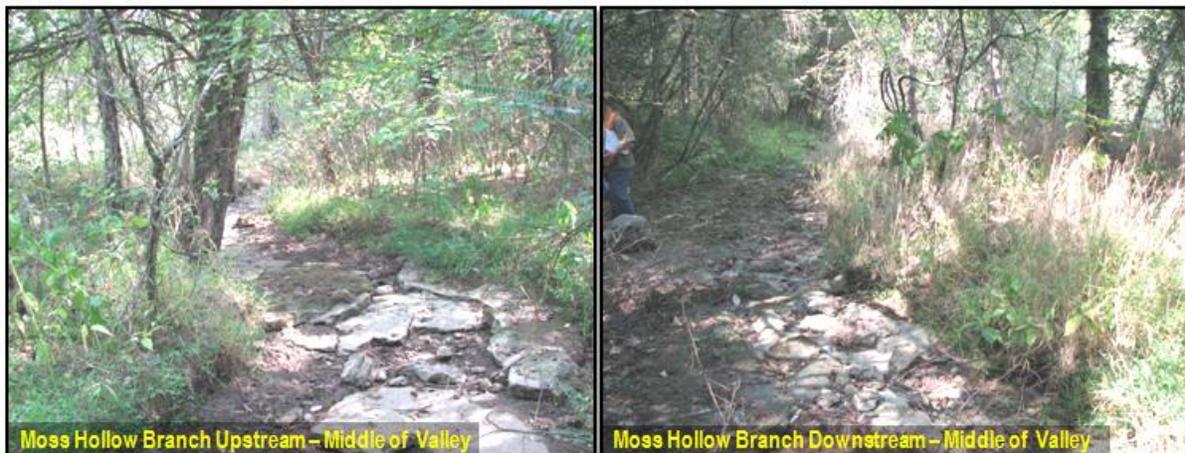
Figure 19. Moss Hollow Branch during Dry/Drought Conditions (summer)

This alternative would implement the previously approved plan (Table 1). Construction of saddle dam grout curtains and barrier wall was designed to cutoff seepage flow under the saddle dam embankment. Reduced seepage would reduce water flow into Moss Hollow Branch. However, seeps and springs originating from the hillsides would likely continue to flow to provide water to Moss Hollow Branch (Figure 19) for aquatic insects and amphibians.

On the right rim, Moss Hollow Branch is an intermittent stream with a well defined stream channel that flows through the center of the valley below the saddle dam. The stream often dries up during the summer months (Figure 19) has a flashy response to storm events. Seeps and springs often sustain flow for several weeks. When flow is present, the water is cool and clear, indicative of good water quality.

Federally Listed Freshwater Mussels: Mussels require perennial streams with fast running water and cobble, gravel, and sand habitat. Moss Hollow Branch is an intermittent stream that occasionally dries up part of the year (Figure 19). The intermittent stream adjacent the left rim access road to Highway 141 is dry most of the year (Figure 21). Both streams do not have the water or habitat to support freshwater mussels. Picnic and Quarry Springs have been walked from their springheads to the confluence with the Caney Fork Tailwater. Quarry Spring starts in the quarry, flows through a wetland, into a pond, and into Picnic Spring. Picnic Spring originates from a limestone bluff, and during low flow, the stream is a few inches deep. The substrate contains a thin layer of gravel over a hardened surface. The combined springs discharge from a culvert under Highway 141 (Figure 6) and flow over bedrock with some cobble up through the campground. The stream down-cuts into hardpan and is strewn with branches and vegetative debris to its confluence with the Caney Fork River tailwater. No bivalve shells have been observed or collected. In 2009-2010, a mussel survey was performed in the Caney Fork River tailwater, from the main dam to the confluence with the Cumberland River (Lewis 2011). Only two live Pimplebacks (*Quadrula pustulosa*) were found among the miles of relic shells of 30 species that could be identified. The 2009-2010 survey confirmed that none of the freshwater

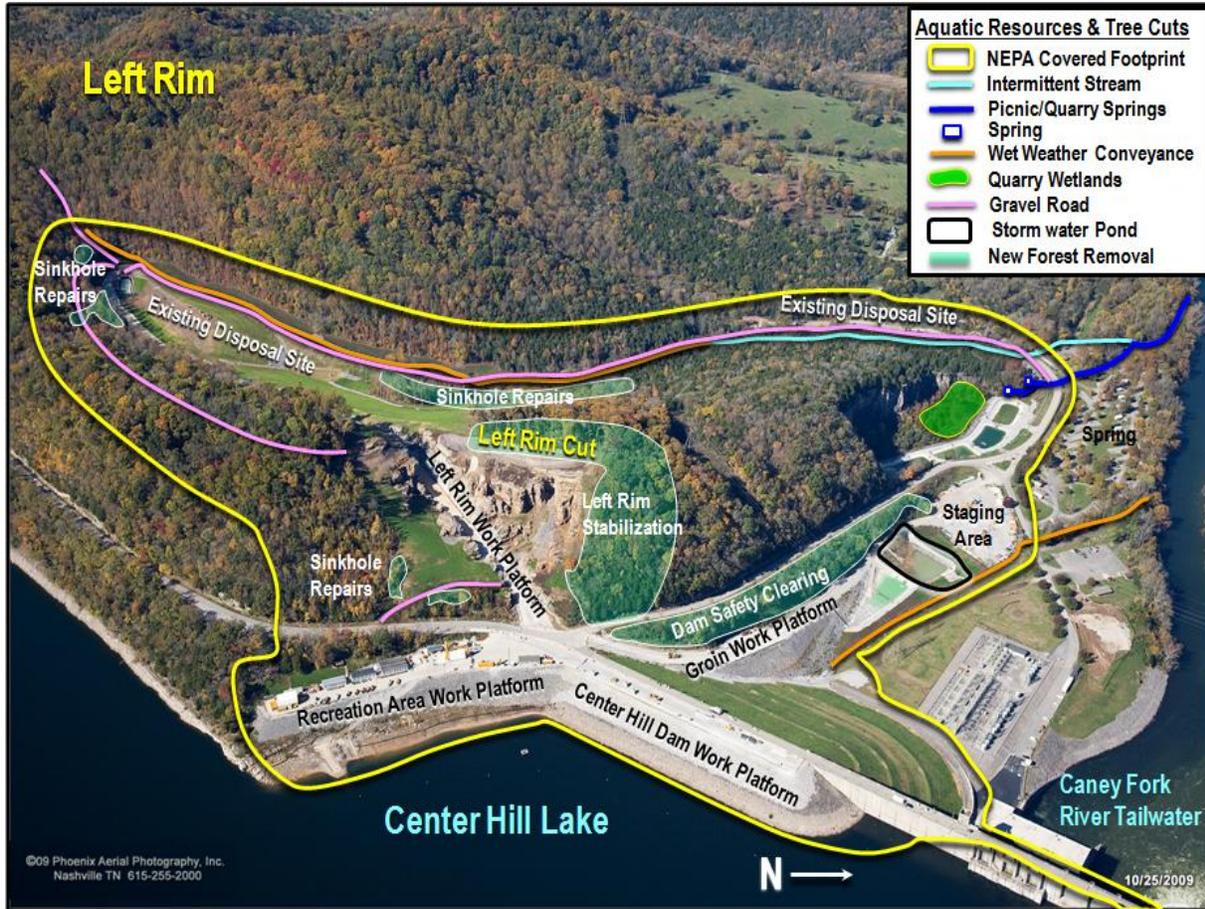
Figure 20. Left Rim Aquatic Resources and Measures Footprints.

On the left rim, approximately 0.47 acre of wetland exists in the quarry (Figures 20). The quarry wetland has been avoided. The wetland is monitored to identify and eliminate impacts from the adjacent treatment ponds should they leak. The wetland is sustained by three seeps that combine to form the Quarry Spring. The spring feeds a stream that flows into Quarry pond that discharges into Picnic Springs. The combined

The left rim potential impact footprint covers approximately 167 acres. Seventy-six acres is considered permanent and temporary open space, and 91 acres are forested (Figure 20). Permanent open space includes the earthen and concrete main dam and work platform (11 acres), groin platform, staging area, groin and quarry treatment ponds (15 acres), access road and left rim cut work platform (6 acres), logging road (1.5 acres), and the recreation area work platform (1.5 acres). Temporary open space includes the access road disposal and parking area off Highway 141 (2 acres), left rim disposal area (5 acres) and past tree removal during construction of the left rim cut (34 acres).

On March 6, 2013, the Corps contacted the USFWS regarding proposed tree removal on the left rim of less than 1 acre around the edges of the two disposal sites (Figure 20).

On June 6, 2012, the Corps contacted the USFWS regarding tree removal for the left rim stabilization and sinkhole repair alternatives (Figure 20). The USFWS noted that tree removal within these footprints were within the 1 mile radius and covered under the bat survey until April 1, 2014. Plans would be made to remove trees between October 15 and March 31. Impacts May Affect, Not Likely to Adversely Affect, gray bats and potential Indiana bats.

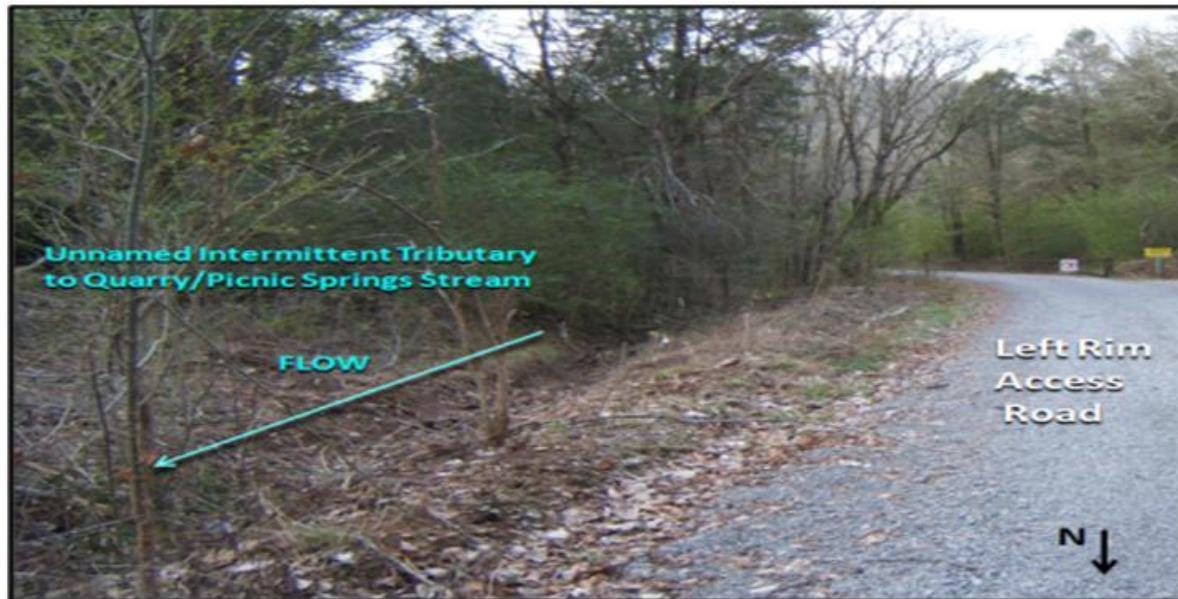
Figure 21. Left Rim Access Road – Unnamed Intermittent Stream.

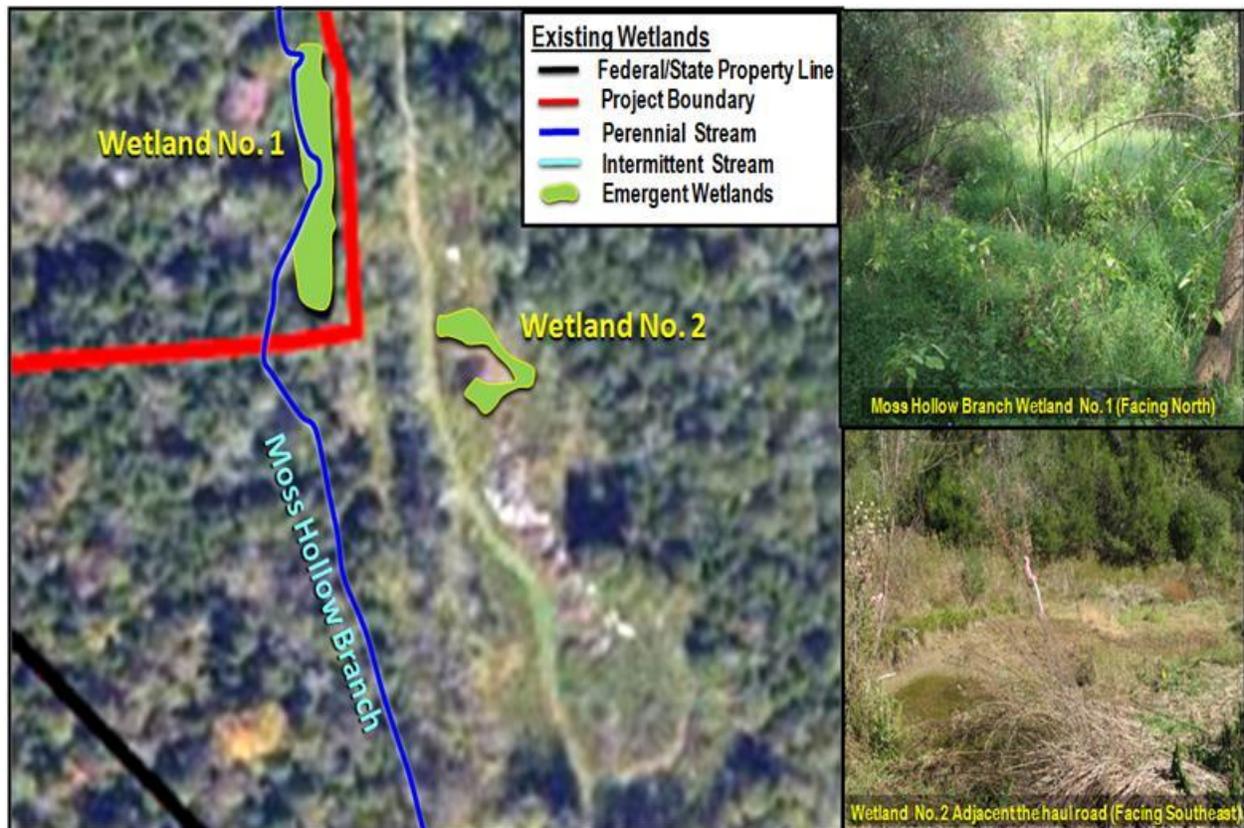
Figure 22. Existing Condition of Right Rim Wetland No. 1 and 2.

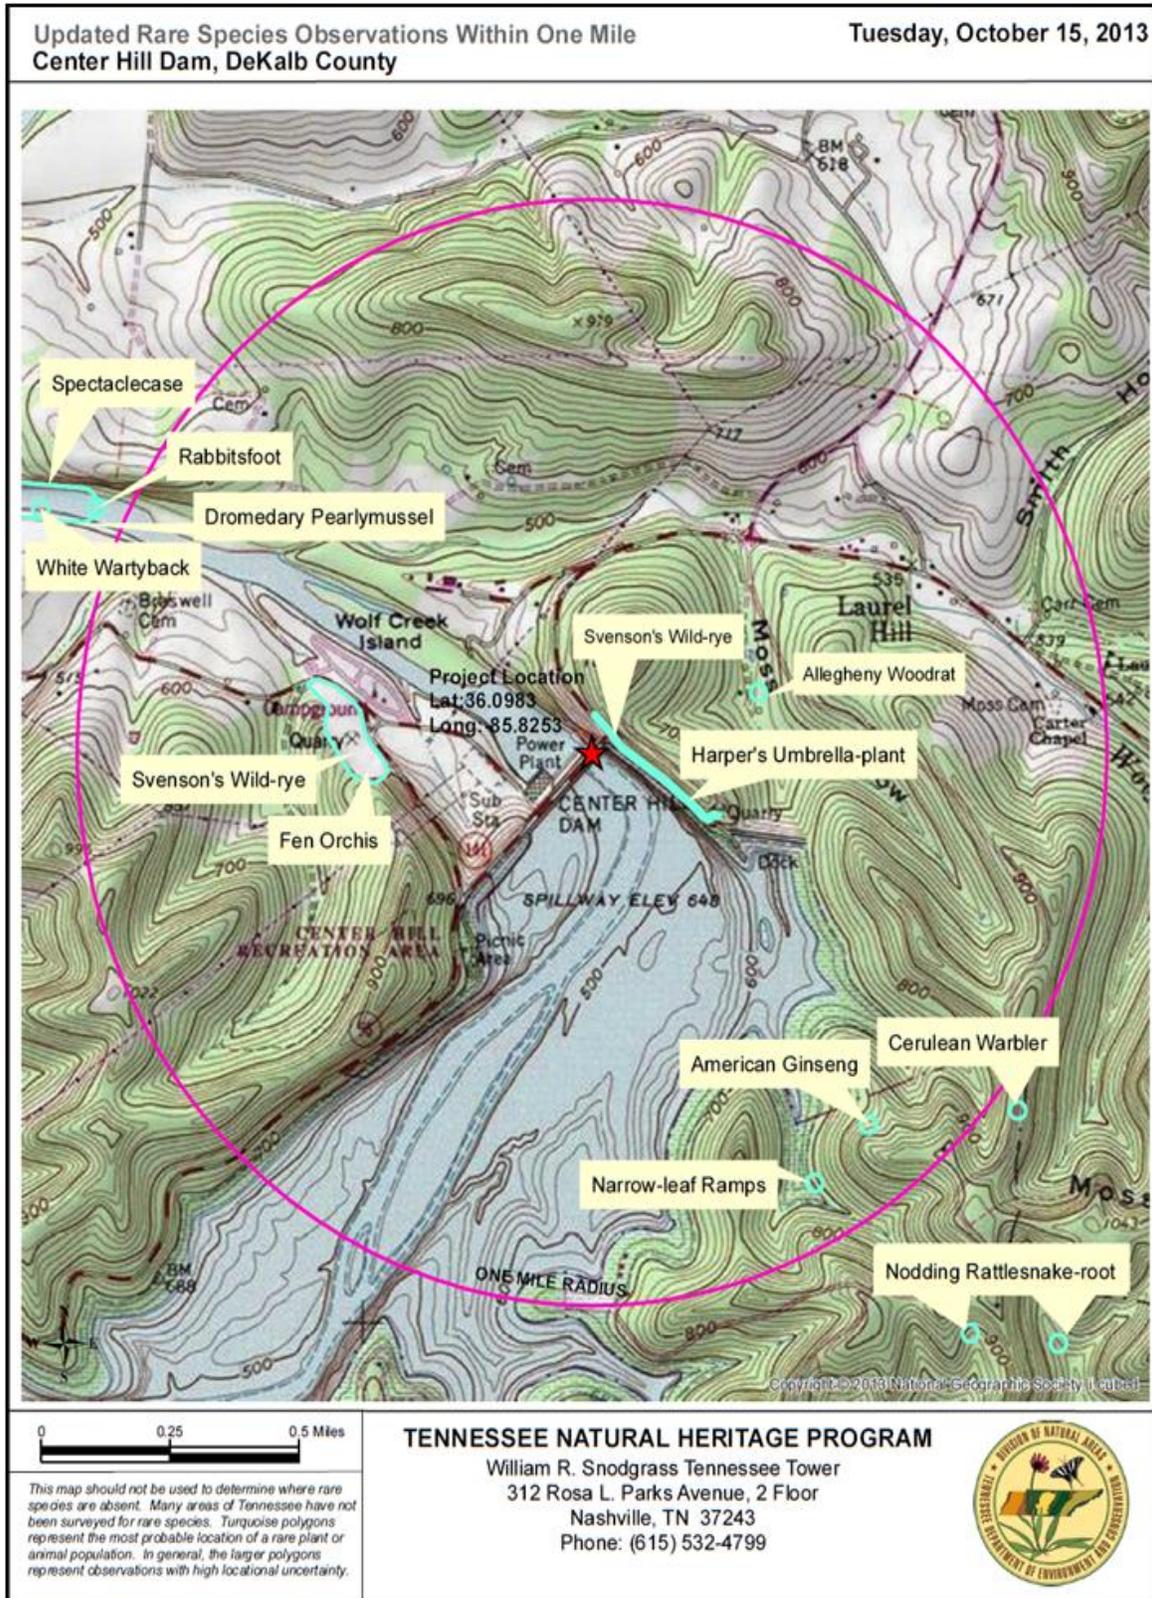
Figure 23. NHP Species Map - Listed Species with a 1-mile Radius.

To ensure that all species of concern were addressed, the USFWS (Robbie Sykes, personal communications) and DNA (Tennessee Natural Heritage Program (TNHP)) were contacted on June 27, 2013. Species within a 1-mile radius (Figure 23) and a 1 – 4-miles radius (Table 7), of Center Hill Dam were considered. Each species was then considered individually with regard to its physical location, habitat needs, or foraging area. A Biological Assessment (BA) was written for the federally listed species (Appendix D).

State species that were located in the potential impact footprints or that may use the area for nesting and foraging habitat have been noted in Figure 23. All other state species were not specifically noted because their location was outside the potential

State Listed Bird: The Cerulean Warbler is a small Neotropical migrant songbird. It spends its non-breeding season (fall – winter) in northern South America, and spends its breeding season (spring – summer) in the eastern United States. This species nests and forages in deciduous forests with tall, mature trees, near stream bottoms, along lake and river shores, or on river islands. The TNHP map shows a location record that is outside of the left and right rim impact footprints (Figure 23).

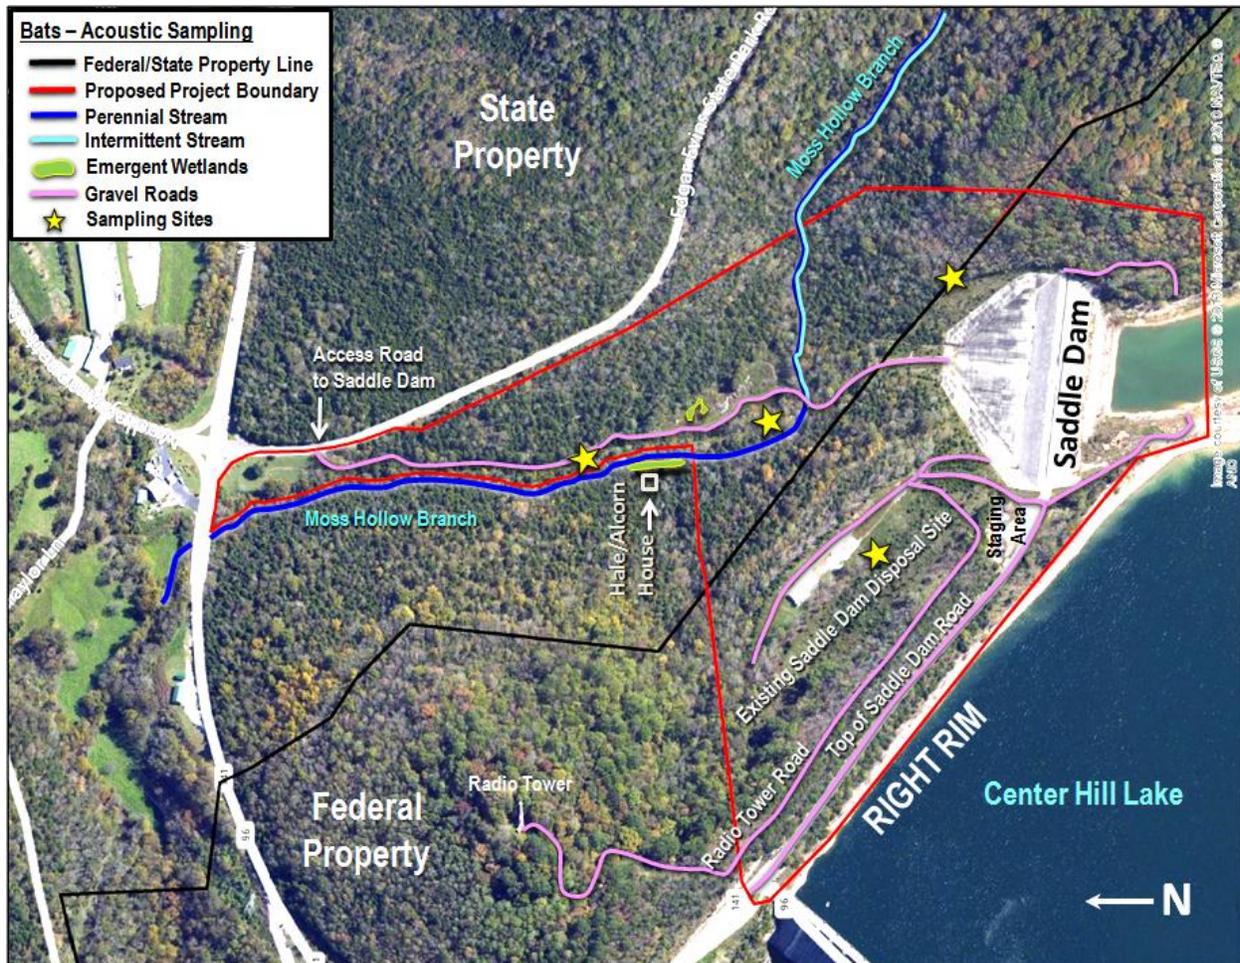
Figure 24. Acoustic Sampling Locations to Determine Bat Presence.

Federally Listed Bats: On November 30, 2011, the Corps requested USFWS assistance to conduct a preliminary survey to identify potential summer Indiana bat habitat on the right rim. Several suitable Indiana bat maternity and roosting trees and snags were located within the proposed RCC Berm impact footprint. On April 24, 2012 the Corps again met with the USFWS. Both agencies agreed that the listed Indiana bat (*Myotis sodalis*) and gray bat (*Myotis grisescens*), could potentially be present. An AnaBat Bat Detector (Harvey et al., 2011) was used for acoustic sampling to determine bat presence via echolocation calls. Corps personnel performed acoustic sampling within the proposed RCC Berm impact footprint for five consecutive nights between May 23 and 27, 2012. Acoustic sampling locations are shown in Figure 24.

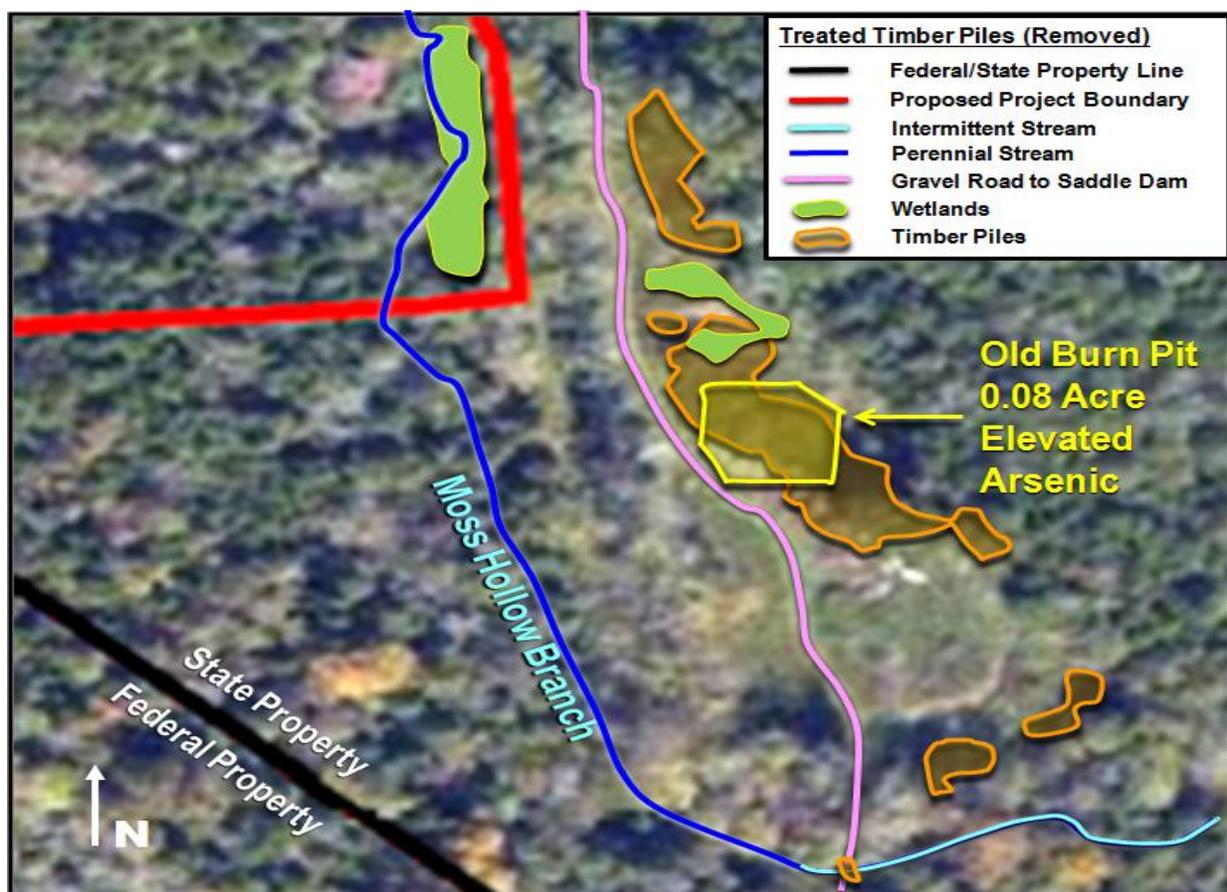
Figure 25. Treated Timber Piles, Burn Pit, and Elevated Arsenic Soil Locations.

In the right rim footprint, an open area on Park property adjacent to the access road to the bottom of the saddle dam had been used to stockpile cleared brush and pressure treated timbers preserved with chromate copper arsenate (CCA) (Figure 25). The wood came from old dismantled state park campsites and had accumulated since the 1980's. Prior to the 1980's, the wood and treated timbers were burned on site. As part of the Corp's site preparation, Phase I and II Environmental Site Assessments were completed in accordance with ER 1165-2-132. During August 13-15, 2012, the treated timber was removed from the site. The Park obtained a permit and disposed the contaminated timber piles into a State licensed and Corps approved landfill. Soil samples were collected after timber removal to determine soil contamination. Arsenic,

copper, chromium and polycyclic aromatic hydrocarbons (byproducts of fuel burning) concentrations were elevated above the local background range in the burn pit area. Except for arsenic, none of the contaminants posed an unacceptable risk to human health. The old burn pit area covers approximately 0.08 acre. There is no contaminated soil elsewhere on the left or right rim on Corps property.

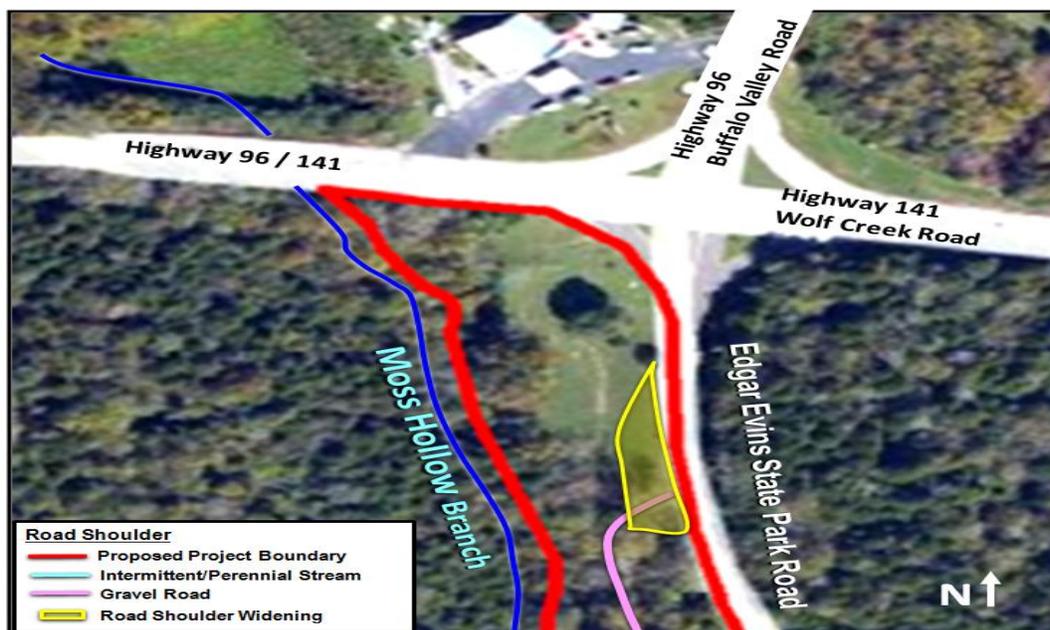
Figure 26. Intersection of Saddle Dam Access Road and Edgar Evins State Parks Road.

On the left rim, signage, speed limitations and traffic signals have been installed on the main dam due to on-going construction. The left rim cut work platform enters the Highway 96/141 intersection (Figures 5 and 20). During large storm events, debris washes down the left rim work platform and into the intersection creating a traffic hazard. The spring culvert is located under Highway 141 and Campground Road across from Long Branch Campground (Figure 6). During high flow and storm events, backwater inundates Quarry and Picnic Springs and threatens to flood Highway 141. On the right rim, the access road to the bottom of the saddle dam exits into a blind curve on Edgar Evins State Park Road (Figure 26). The access road entrance is narrow and steep.
